A Century of Geomorphic Change of the San Rafael River and Implications for River Rehabilitation

A thesis submitted in partial fulfillment
of the requirements for the degree

Watershed Science

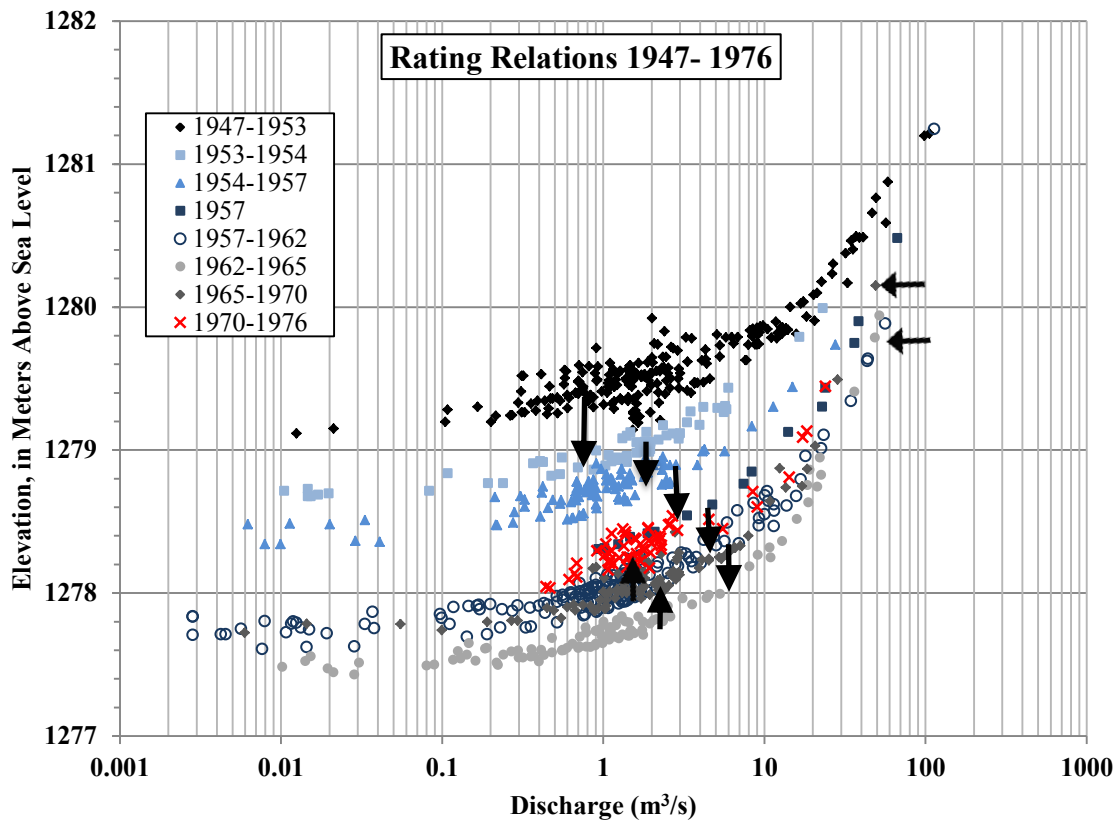
Figure 3.29. Rating relations, 1947-1976, measured at former locations of USGS gage 09328500. Downward shifts in rating relations for discharges less than $10 \text{ m}^3/\text{s}$ indicate bed lowering between 1947-1953 and 1962-1965. Upward shifts in rating relations for discharges less than $10 \text{ m}^3/\text{s}$ for the time periods 1962-1965 and 1970-1976 show that the bed aggraded. Increases in stage for discharges greater than $20 \text{ m}^3/\text{s}$ for time periods 1965-1970 and 1970-1976 are caused by reduction in channel capacity, and means that smaller floods are still capable of spilling over the banks and contributing to vertical accretion of the floodplain.

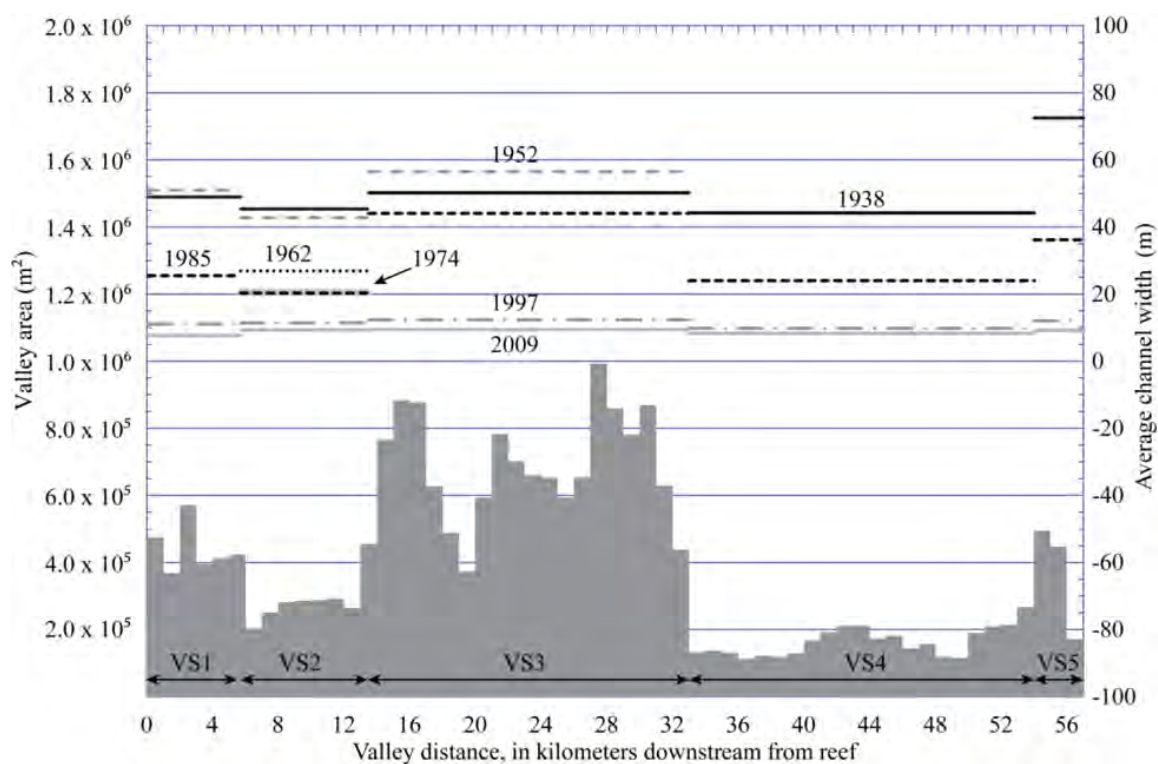
Figure 3.31. Segment average channel width determined from aerial photographs. The average width of the active channel in segment 2 did not change between 1974 and 1985 despite the large snowmelt floods in 1983 and 1984.

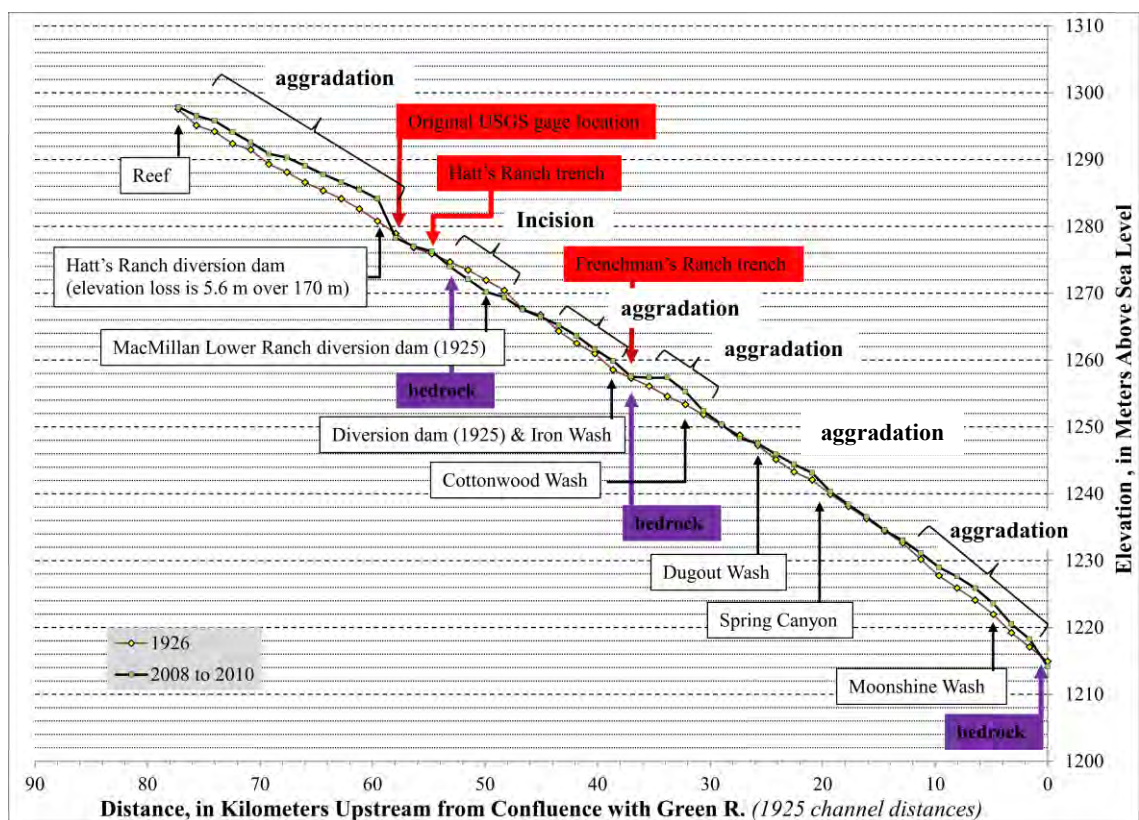
Figure 3.33. Comparison of longitudinal profiles surveyed in 1925 and again in 2008-2010. The long pro comparison shows five segments where aggradation has occurred and one segment where incision has occurred. The 1925 profile was on bedrock in two places and the recent profile is on bedrock in three places.

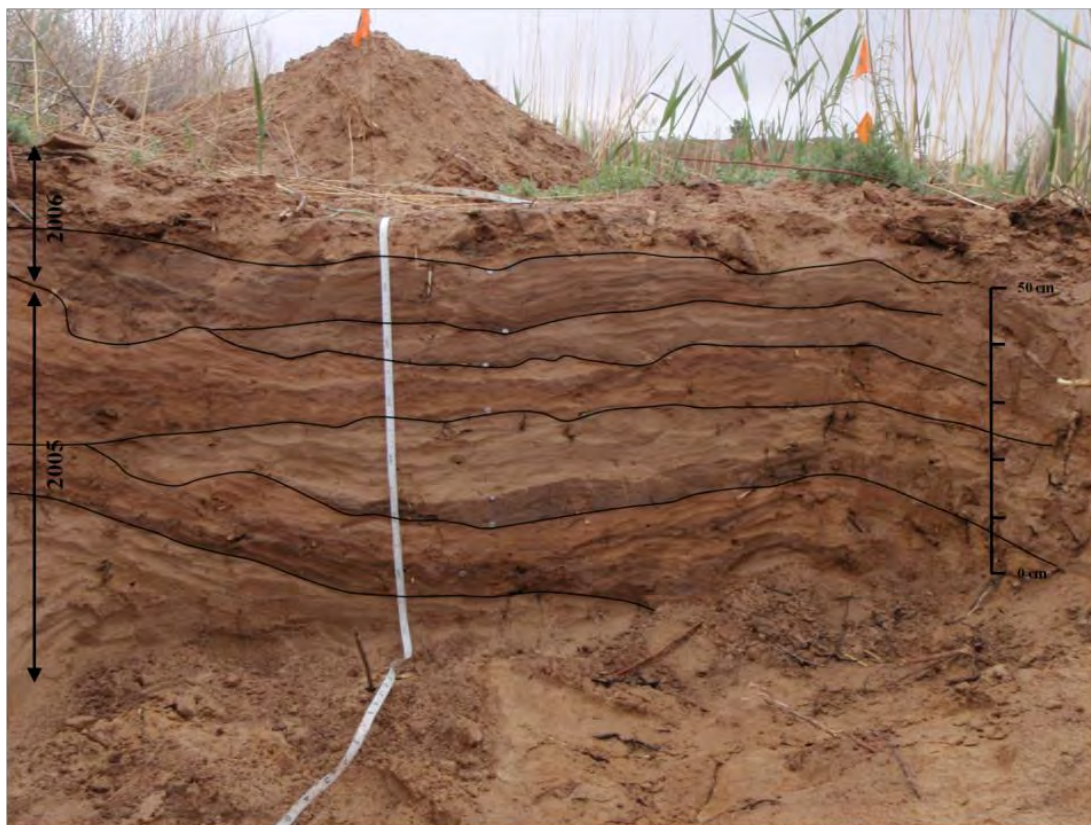
Figure 3.38. Sedimentology of near channel bench exposed in left bank trench at Frenchmans's Ranch trench. The channel is off the right side of the photo.

The vertical accretion of inset floodplains is accomplished by the construction of levees and/or benches on top of sand bars. A bench is constructed by the oblique and vertical accretion of mud and fine sand. Layers within a bench may be continuous in both the offshore and onshore directions (Figure 3.38). The contacts between the layers may either be conformable or erosional. There is no clear trend of fining upward from the bottom of a bench to the top of a bench. A preserved thin layer of duff accumulation may occur at the top of a bench.

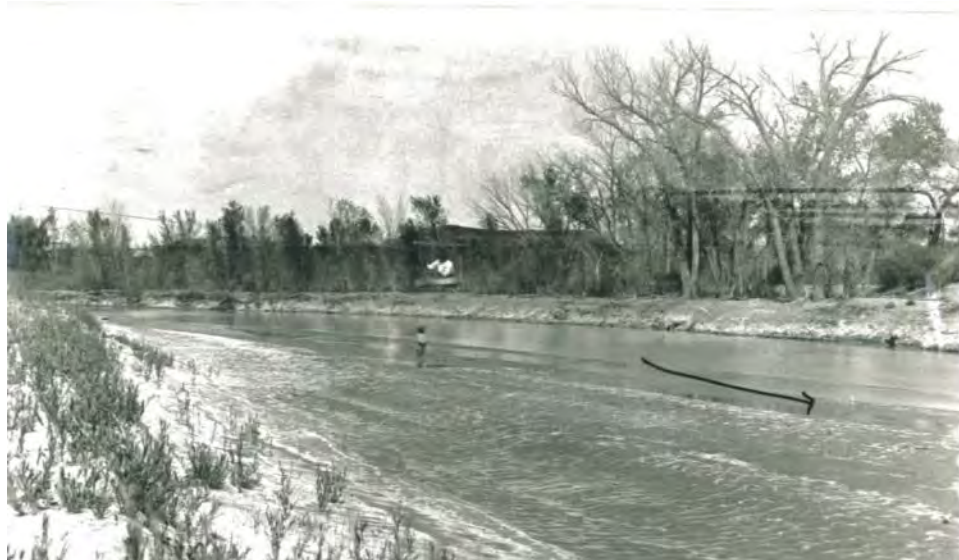
Figure 3.41. Historic photograph taken some time between 1909 and 1914. Photograph was taken approximately 20 m below cableway that was located approximately 60 m upstream from the old Highway 24 bridge. Photo was taken on right bank looking upstream. This cableway washed out in the floods of 1914. Note the person riding the cable car and the person wading in the river below the cable car. Cottonwoods line the left bank and herbaceous vegetation occupies the sandy surface on river right. An upper geomorphic surface is barely noticeable in the right portion of the photograph. The left bank appears to be eroded in the furthest upstream portion of the photograph. The original photograph is included with the station analysis reports housed at the US Geological Survey national archives.

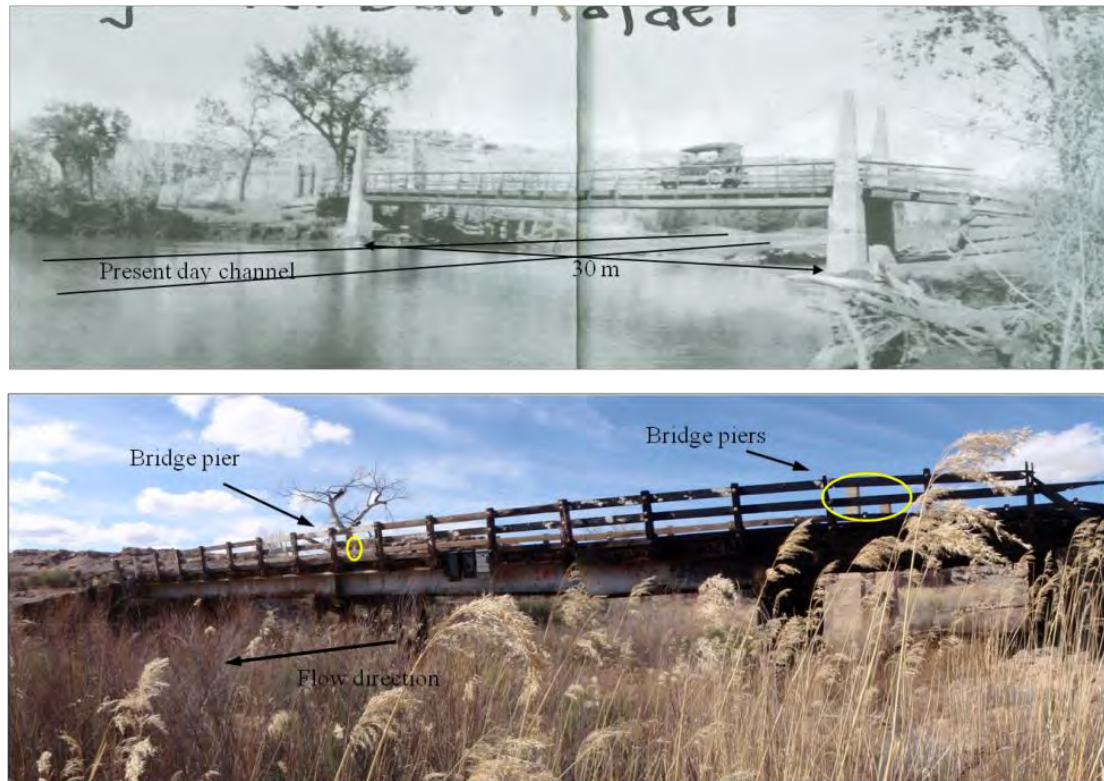
Figure 3.43. Photograph comparison at the old Highway 24 bridge on the Hatt's Ranch, looking upstream. Historic photo was taken sometime between 1910 and 1938 (precise date is unknown). Recent photo, taken on April 19, 2011, shows a newer steel and wooden bridge located in front of the piers of the original highway 24 crossing. The channel in the 2010 photograph is obscured by vegetation including phragmites (*Phragmites australis*), grasses, and tamarisk. The present day river channel is not noticeable, because it has narrowed and incised, and is obscured by the vegetated inset floodplain surfaces in the foreground.

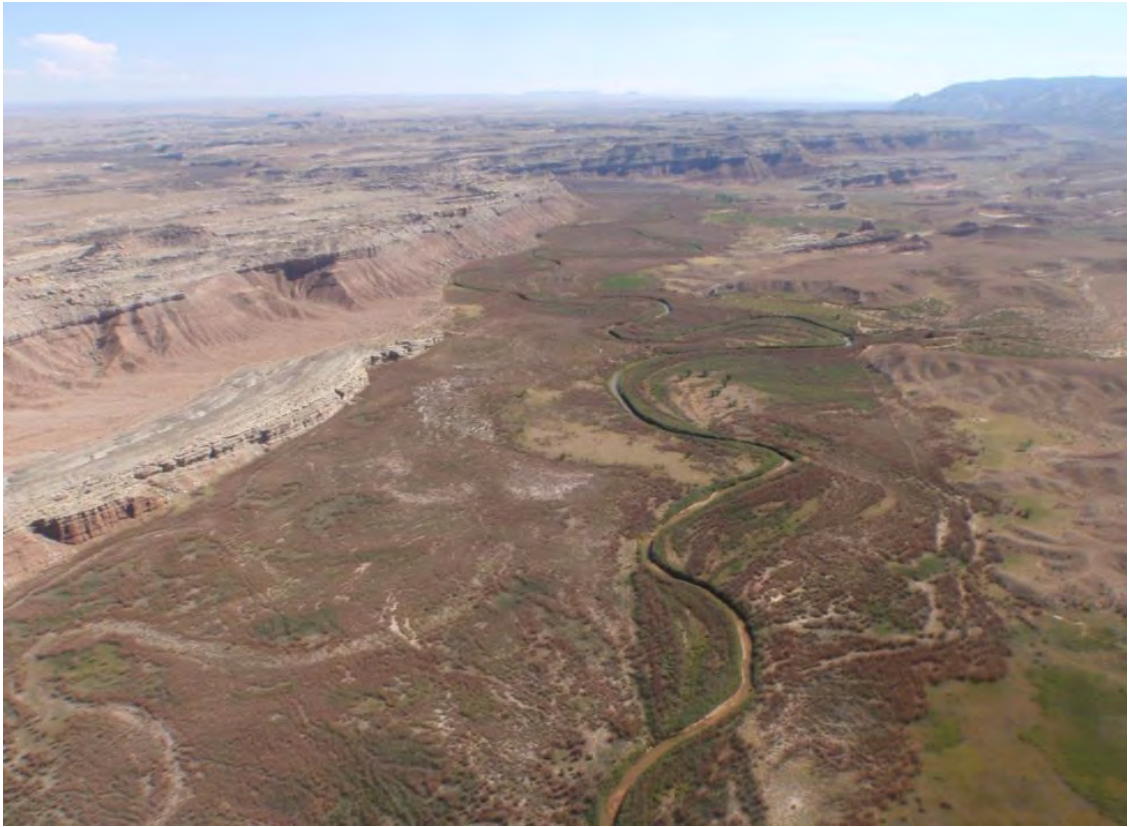
Figure 3.46. Oblique aerial photograph of valley segment one, looking downstream. Photograph was taken in August 2010. Tamarisk, which appears brown because of defoliation by the Asian leaf beetle (*Diorhabda Elongata*), has colonized much of the entirety of the alluvial valley in this valley segment. Where the alluvial valley bends toward the east, is where I-70 crosses the river.

Tamarisk has established throughout the entire study area, however, the proportion of the valley covered by tamarisk differs among valley segments. For example, most of valley segments one and two are covered from valley wall to valley wall with tamarisk (Figure 3.46 in Appendix) and have very few cottonwoods. On the other hand, there are portions of the downstream half of valley segment three and valley segment four that contain only patches of tamarisk and contain healthy mixed-aged stands of cottonwoods (Figure 3.47 in Appendix C). It is possible that both historical and present local base level controls e.g., diversion dams and the confluence with the Green River, have resulted in varying depositional histories throughout the study area, and that this variation has resulted in variation in the distribution of floodplain assemblages, which in turn has governed the distribution and type of vegetation communities among

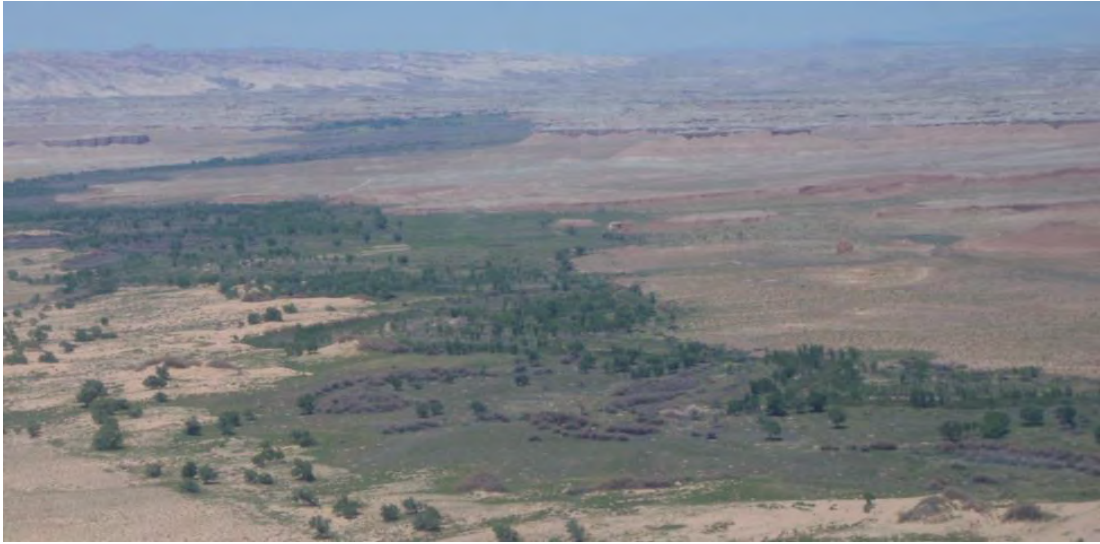
Figure 3.47. Oblique aerial photograph of valley segment three, looking upstream. Photograph was taken in August 2010. Cottonwood Creek enters the valley just downstream of the photograph. In the photograph, the riparian zone is comprised of a mix of tamarisk and cottonwoods. The defoliated tamarisk shrubs, identified in the photograph as brown/gray, have not colonized the entire width of the valley as they have done in valley segments one and two (Figure 3.46). In the foreground along the left lower corner of the photograph, wind blown sand deposits cover a portion of the alluvial valley where cottonwoods are growing. The San Rafael Swell and San Rafael Reef are seen in the background.
