## Automated Defect Detection and Classification in Ashlar Masonry Walls using Machine Learning

Valero , E, Forster, A, Bosché, F, Hyslop, E, Wilson, L & Turmel, A 2019, 'Automated Defect Detection and Classification in Ashlar Masonry Walls using Machine Learning', *Automation in Construction*, vol. 106, 102846. <https://doi.org/10.1016/j.autcon.2019.102846>

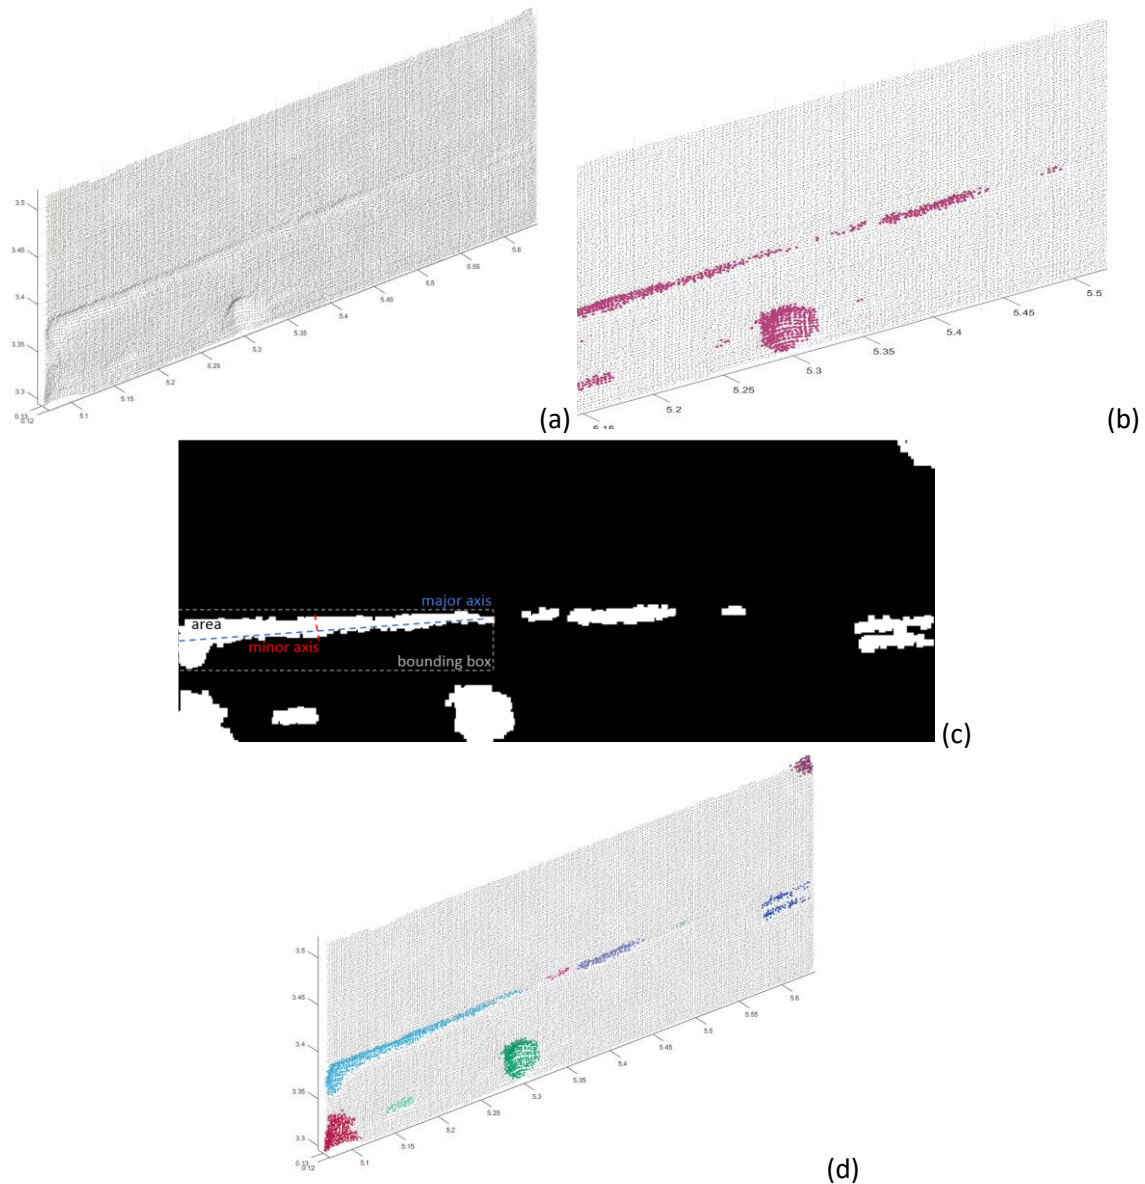
Figure 2: Process for the extraction of geometric parameters. a) Point cloud of an ashlar masonry wall. b) Outliers, highlighted in pink. c) Binary map after orthogonal projection of outliers. d) Potential geometry-related defective areas highlighted in different colours. In subfigures including axes, values are in meters.

Each masonry unit may present one or more defect. To detect different decayed areas, a binary map, with a resolution of 1mm, is created by projecting the above outliers onto the fitted plane, as illustrated in Figure 2c. Note that if two or more points are projected on the same pixel, an average value for depth is considered.

Compact regions, with a surface over 500mm<sup>2</sup>, are then segmented from one another using a region growing algorithm. Finally, the original 3D points corresponding to each detected defective area can correlate, as shown in Figure 2d. The segments, enclosed by bounding boxes (i.e. ROI), are stored as independent entities for which geometry-related metrics are subsequently calculated to characterise the deterioration patterns.

- The **number and area of unconnected defective areas** (white segments in Figure 2c) within each ashlar unit. Note that this parameter is applied only to ROIs that are entire units.

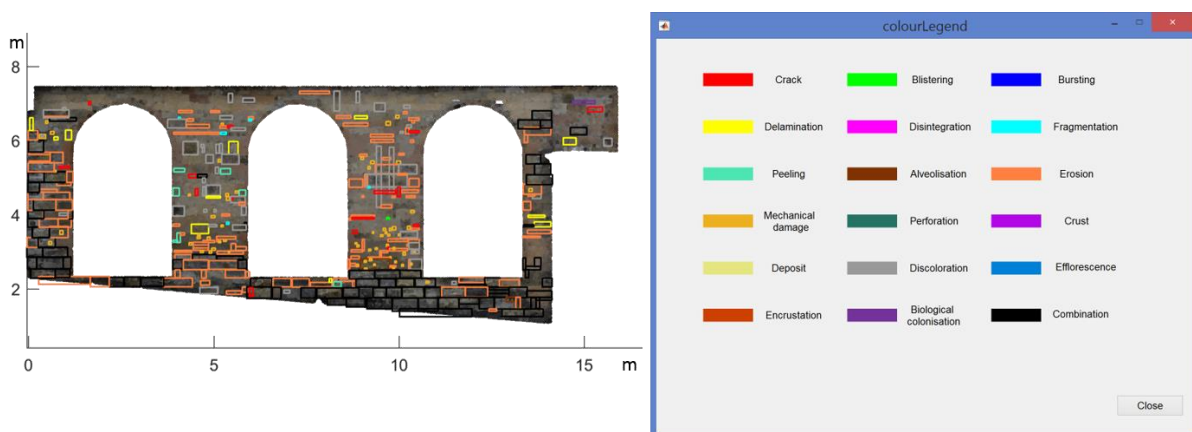
Figure 5: Defective areas labelled by surveyors.

For training the supervised classifier, deteriorated regions have been manually segmented and labelled by experienced building surveyors who specialise in stone, and following the criteria presented by ICOMOS [11] (see Figure 5). Each segment, which is marked as a rectangular ROI, contains a label indicating the defect or defects observed in the area. The selected defect parameters described in Section 3.4 are then calculated using XYZ and RGB data contained within each rectangular boundary.

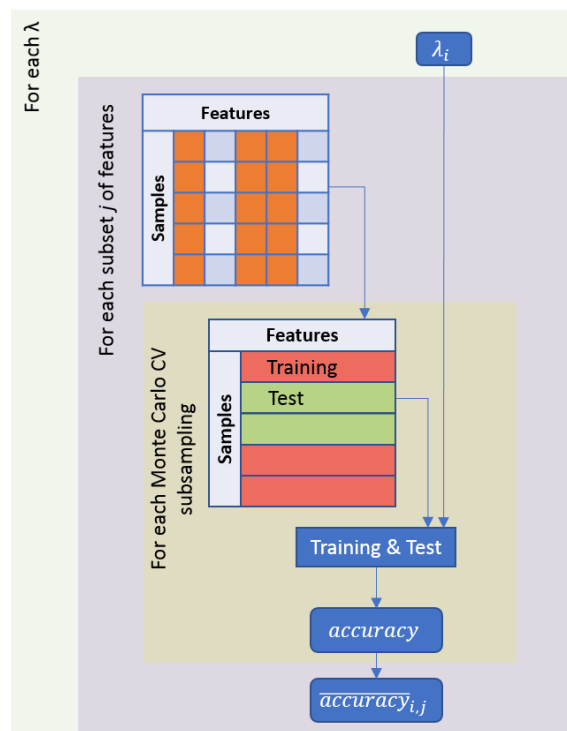
Figure 6: Strategy followed for parameters selection.

Although a number of parameters have been found to be potentially relevant to the detection and classification of stone defects, in practice a subset of those can be found to result in simpler, faster and even more accurate classification. To identify which combination of parameters (or features) provides the most accurate results, the strategy illustrated in Figure 6 is applied separately to geometry and colour-related parameters.

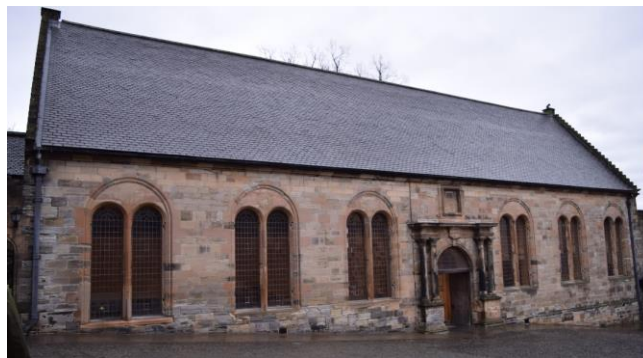
*Figure 7: South façade of the Chapel Royal in Stirling Castle.*

With respect to TLS data acquisition, four scans of the south façade of the Chapel Royal (Figure 7), were taken from strategic locations with a Leica Geosystems P40 TLS device. After a first alignment (i.e. roto-translation) of the obtained point clouds and a further fine registration, by means of an ICP algorithm [38], a dense point cloud containing 72 million points was produced for the façade (see Figure 8a). Colour information was added from a photogrammetric model produced as described below.

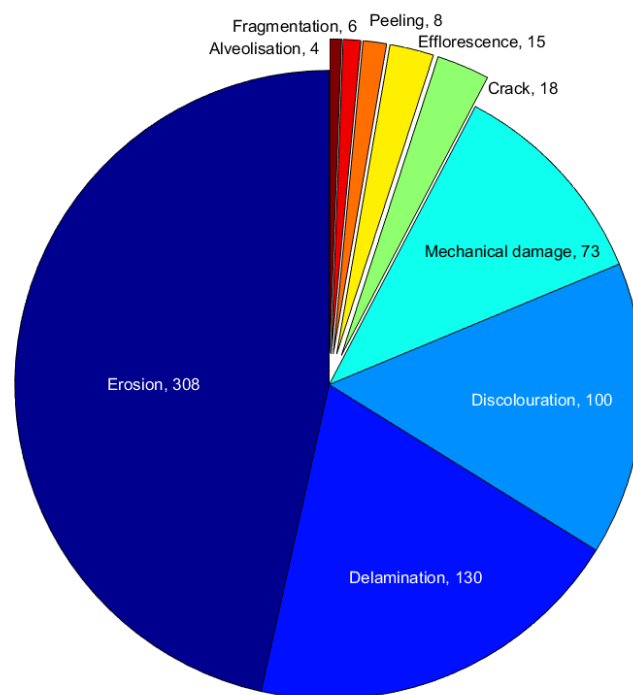
Figure 10: Distribution and frequency of labelled defective areas

The left part of the south façade of the Chapel Royal was meticulously evaluated by expert surveyors, following traditional ‘visual survey’ techniques. In this work, around 500 deteriorated ashlar regions, containing almost 650 faults, were digitally labelled by the experts using a purpose-designed user interface. The number of instances of different defects is summarised in Figure 10, which shows that not all the defects are equally present on the evaluated wall. Erosion, mechanical damage, delamination and discolouration are the most prominent faults in the evaluated façade, representing more than 90% of the defective areas, and are thus in significant enough quantities to be considered in this study.
