Coal Operators' Conference

2020

## Performance of bolting systems in tension and the integrity of the protective sleeve coating in shear

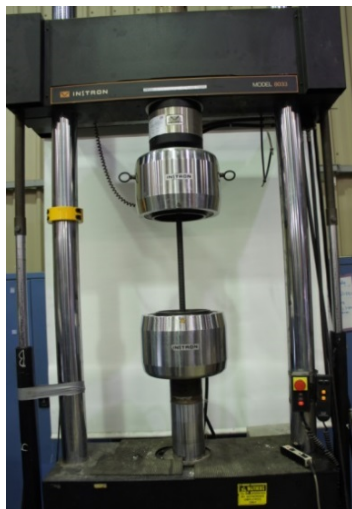
**Figure 1: 50 t Instron Universal testing machine**

The tensile strength test involved subjecting the bolt to tension until failure, to determine the Ultimate Tensile Strength (UTS), elongation at both the yield point and at failure. Three 1.0 m bolts, supplied by Dextra were tested for ultimate failure. All three 1.0 m long bolts had the threaded ends cut out, leaving the middle 600 mm central section to be tested for tensile failure. About 350 mm lengths of the ribbed bolt sections were installed between the two large grip jaws of the 50 t Instron Universal Testing Machine (IUTM) and individually tested to failure. Figure 1 shows a general view of the tested sample and Figure 2 shows the load displacement graphs of all three tested bolts. The recorded yield load, peak failure load and displacement were listed in Table 2. Typically, all bolts failed in tension at the near mid-section, characterised with early necking of the bolt along the strained length. The tensile failure surfaces of snapped bolt sections were characteristically of cone and cup shapes formation as shown in Figure 3.
