Article

# Mechanical Connectors to Enhance the Interfacial Debonding of Concrete Overlays

**Keywords:** whitetopping; concrete overlay; pavements; debonding; post-cracking strength; screws-connectors

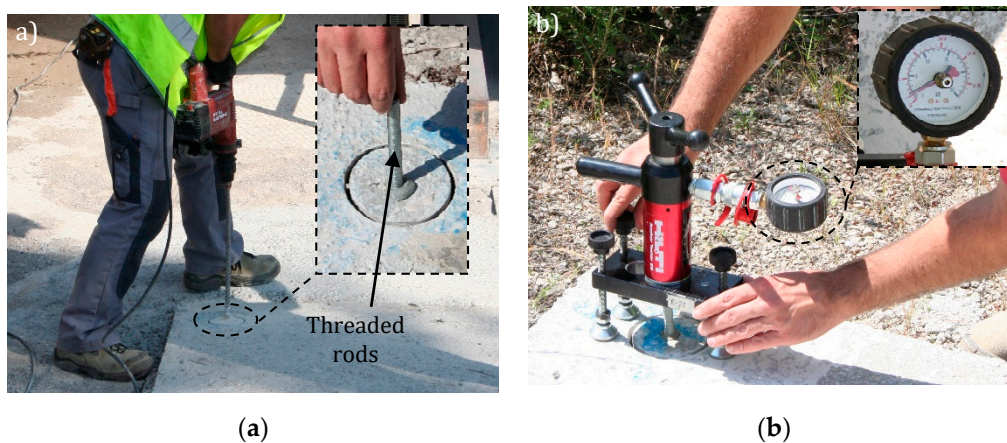
**Figure 7.** Pull-off test: drilling and placing of threaded rods (a) and anchor tester (b).

The pull-off tests to measure the tensile strength of the interfaces were performed on 7 points after 135 days. As observed in Figure 7a, the tests were carried out on 100 mm diameter cores drilled to the bottom layer of asphalt. Threaded rods were attached to drilled holes in the top side of the cores using an epoxy resin. After that, the rods were pulled using an anchor tester which indicated the maximum tensile force performed during the test with a nominal precision of  $\pm 2.5\%$  (Figure 7b).

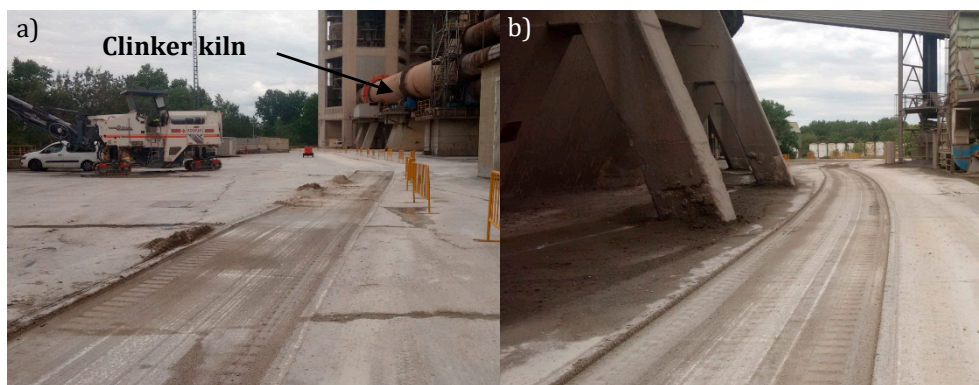
**Figure 8.** Original concrete pavement (a). The appearance of the cold-milled box (b).

The original pavement was cold-milled to leave a box with the width and thickness of the reinforcement (Figure 8b). Four rows of screws were arranged in the milled surface following the symmetrical scheme in Figure 9. Since normal and shear stresses due to direct and indirect loads mainly concentrate next to discontinuities, the double density of the screws were installed in the borders of the overlay.

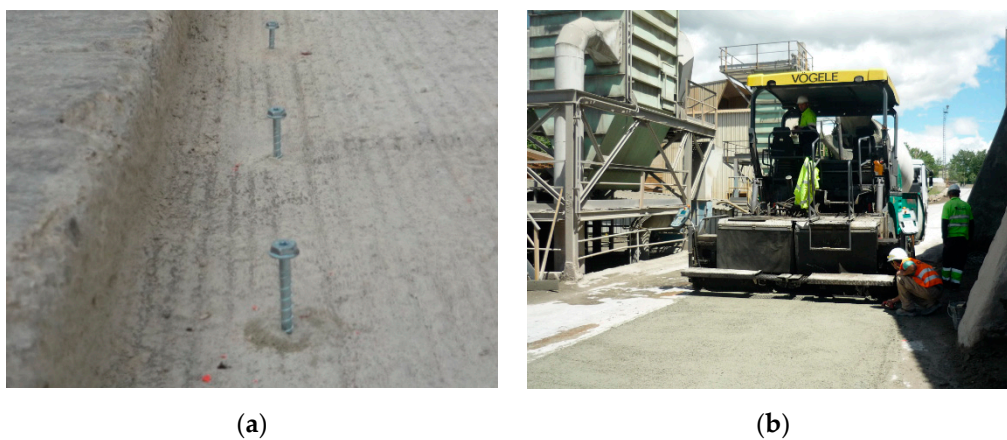
Figure 10. Screw anchors in the milled surface (a). Asphalt paver extending the concrete (b).

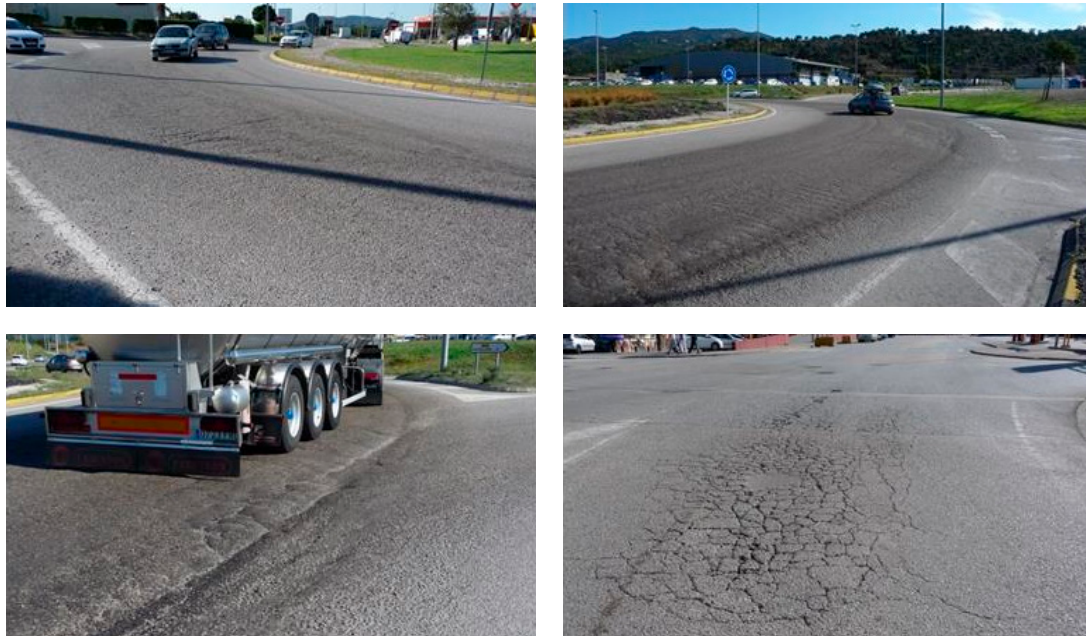
Figure 12. Previous pavement condition of the roundabouts.

Figure 12 shows the visual aspect of the pavement before restoration. The asphalt presented widespread and several damages due to fuel spills combined with traffic fatigue (bitumen loss, cracking, wheel path rutting, potholes, etc.). Visual inspection and load plate tests were performed on all four roundabouts to determine the most severely affected regions. Four areas were detected with an exceptionally low ballast coefficient ( $K_{60}$ ), while for the rest of the pavement a Winkler coefficient of 391 MPa was assumed as a representative value.

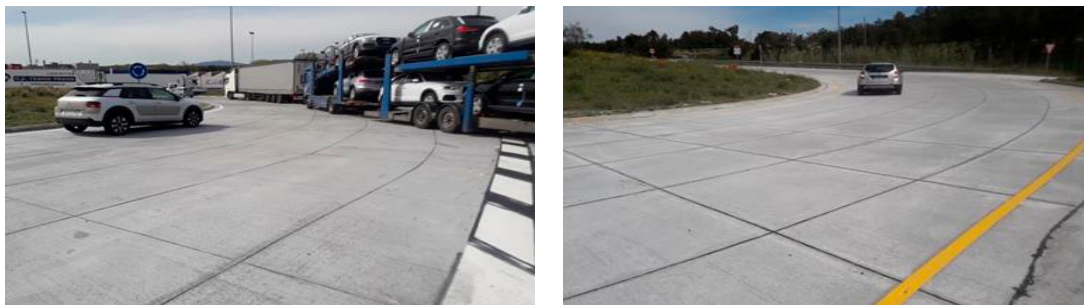
**Figure 15.** The final appearance of the roundabouts.

Figure 15 shows the finished whitetopping of the roundabouts with open traffic. The time between construction and opening to traffic was between 7 and 15 days to ensure that at least 80% of  $f_{c,f} = 5.0$  MPa was achieved. Average depths measured with the sand patch test (UNE-EN 13036-1:2010) were larger than 1.10 mm, indicating that surface finishing was suitable even for speeds higher than 100 km/h.
