## **Morphological Characterization of the Lower Reach of the Tenryu River**

# MORPHOLOGICAL CHARACTERIZATION OF THE LOWER REACH OF THE TENRYU RIVER

Guangwei HUANG

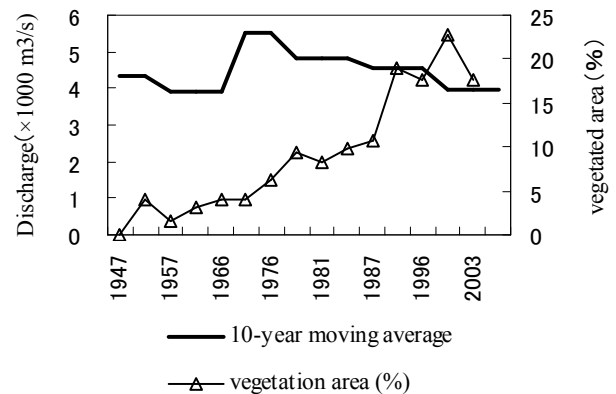
Fig.3 Changes in flow discharge and ratio of vegetated area to total channel area

Figure 2 shows the comparison of aerial photos taken in 1947 and 2004. It appears clear that the lower reach has been significantly transformed from non-vegetative to vegetated river channel. The species are mainly willow and Canada goldenrod and higher than 5m in many locations. Figure 3 shows that the vegetated area increased since 1950 and had a big jump from 1989. At present, the vegetated area accounts for about 20% of the total river channel area

in the lower reach. Also shown in Fig.3 is the variation of 10-year moving averages of the annual maximum flow discharge. It declined steadily since the mid of 1970s. As a result of reduced flow disturbance, the in-channel vegetation have developed, which in turn, exerted significant impact upon the river morphology.

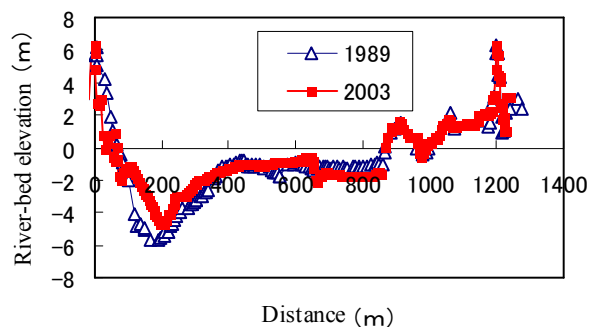
Fig.4 Comparison of cross-section at 0.4 km

Figures 4-7 show the comparisons of cross-sections between 1989 and 2003 at 0.4km, 5km, 12km and 25km, respectively. At 0.4km, the deepest part was raised in 2003 as compared to 1989. At 5km, the elevation of middle sandbar was raised but the erosion occurred on the left-hand side of the bar. As shown in Fig.8, the middle bar at 5km was forested. Due to the presence of high vegetation, the sandbar has become stable and therefore caused large dead water zone. With constricted flow area, the main channel was incised. This may be considered as the mechanism for the cross-sectional change at 5km. At 12km, the change of cross-section was also characterized with both aggradation and degradation. By comparing the cross-section plot with the aerial photo, it was found that the aggradation occurred in the vegetated zone while the incision took place in the zone next to it. At 25km, however, the cross-section did not show any significant change over a decade. Based on the above comparison, it can be realized that the channel bottom was elevated around the exit, deepened in the middle and no-change at the entrance of the river course. And the channel deepening in the middle subreach was related to in-channel vegetation growth. Figure 9 depicts the fluctuations in river bed in different sub-reaches over a longer period of time (70 yr). The general trend in the lower reach since 1960 was erosion, however, the subreach from 0.4km to 6.6km showed bottom-up in recent years. This long-term perspective supports the finding that the current river course has been flattened due to the shift from erosion to deposition in the subreach close to river mouth. Figure 10 depicts the relation between flood pulse and sandbar inundation frequency in the middle subreach. In recent years, the inundation frequency was greatly reduced even under the same flood intensity. This can be attributed to the aggradation of the bar.

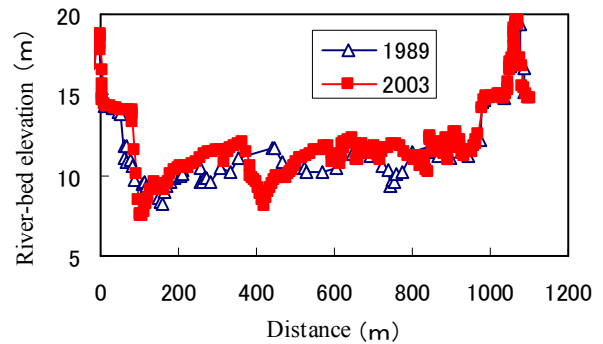
Fig.6 Comparison of cross-section at 12 km

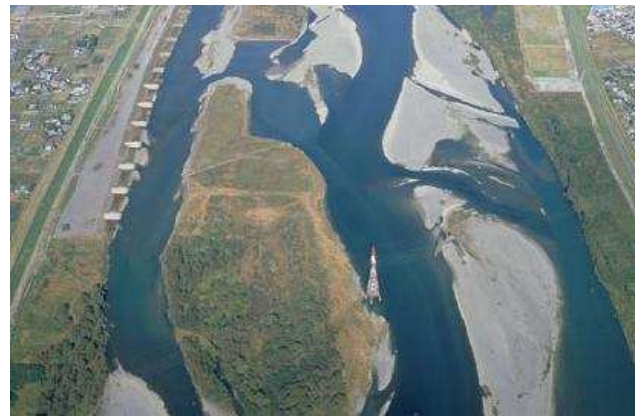
Fig.8 Aerial photo for the site of 5 km

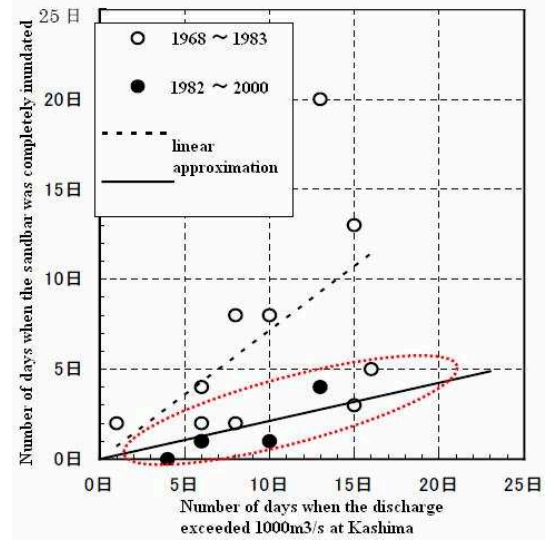
**Fig.10** Reduction of inundation frequency over forested bar
