Conference Paper, Published Version

## **A Case Study of the Possible Effects of Long-Term Climate Change on Bridge Scour**

Conference on Scour of Foundations  
Nov 17-20, 2002  
Texas A&M University

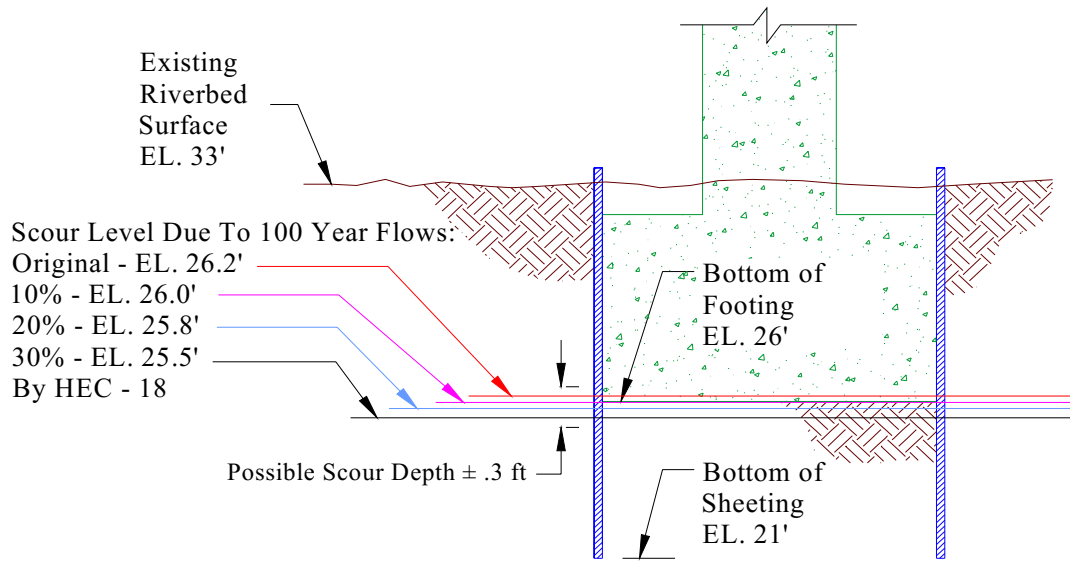
**Figure 2. Bridge Footing and Calculated Scour Depths (from Bettencourt et al. 2001)**

Each bridge is a three span, simply supported steel stringer bridge with an 8-inch reinforced concrete deck and a bituminous concrete wearing surface. The center spans are 57 feet long, and the two end spans are 35 feet long center to center of bearings. The bridge piers have a 20-degree skew to the roadway. The existing substructure consists of two reinforced concrete stub abutments with U-back wing-walls, and two reinforced concrete bent type piers on reinforced concrete spread footings. The piers are not protected against scour. The abutments are dry at normal flow conditions, and are armored with 2-foot diameter granite block riprap. The spread footings are bearing on medium dense fine to coarse sand, with traces of inorganic silt. The riverbed material consists of a thin layer of sand and gravel overlying a thick layer of medium dense fine to coarse sand, and a deeper layer of clayey silt. The existing riverbed surface is at elevation 33 feet above sea level (see Figure 2). The bottom of the footing is at elevation 26 feet; thus 7 feet deep is the critical scour depth.

Table 1 shows that the bridge is in danger of becoming scour critical at the present 100-year flood. We calculated a present scour depth of 6.8 ft, which leaves only 0.2 ft. of soil above the base of the footing. This is not viewed as a “stable” structure and thus some type of rehabilitation or reconstruction is necessary. The table also shows that, as expected, the scour depth increased as the flow increased and that a 10 % increase in discharge will result in the critical scour depth of 7 feet or greater. A computed critical scour condition for this bridge would elevate it from an FHWA/MHD scour rating of 5 (stable) to an FHWA/MHD scour rating of 3 (scour critical) rating. Note also that these results must be considered within the context of a possible error of 0.3 ft as mentioned earlier.
