## **Comparison of static and dynamic load tests on bored piles in glacial soil**

# COMPARISON OF STATIC AND DYNAMIC LOAD TESTS ON BORED PILES IN GLACIAL SOIL

**Abstract:** BAW and BAM have performed a large scale comparison and calibration test on static and dynamic load capacity evaluation of bored piles in glacial sandy soil. The test was performed using eight piles at the BAM test site for technical safety at Horstwalde 50 km south of Berlin. The test area has been prepared and investigated in great detail using boreholes, cone penetration tests, pore pressure sensors and geophysical methods to assure controlled conditions for all piles and tests. The piles (10 m length, 0.9 m diameter) are mainly friction piles (low toe resistance) and have been checked by integrity testing. Five piles have been tested by five contractors using the dynamic method in a blind experiment, the other ones piles by static load and/or later on by the dynamic method. Some piles have been equipped with additional fibre optic instrumentation which proved to be robust and helpful in interpreting the results of static, dynamic and integrity tests. We have experienced a deviation of the dynamic load test

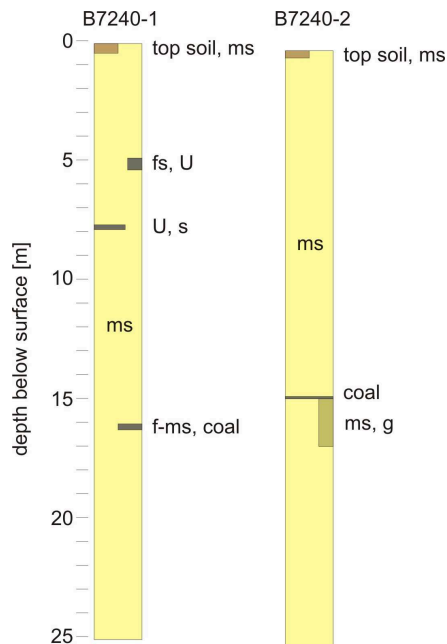
**Figure 2: Soil profile of boreholes B7240-1 and B7240-2. Main material is ms-fs, mixed with varying content of silt, coal, and gravel.**

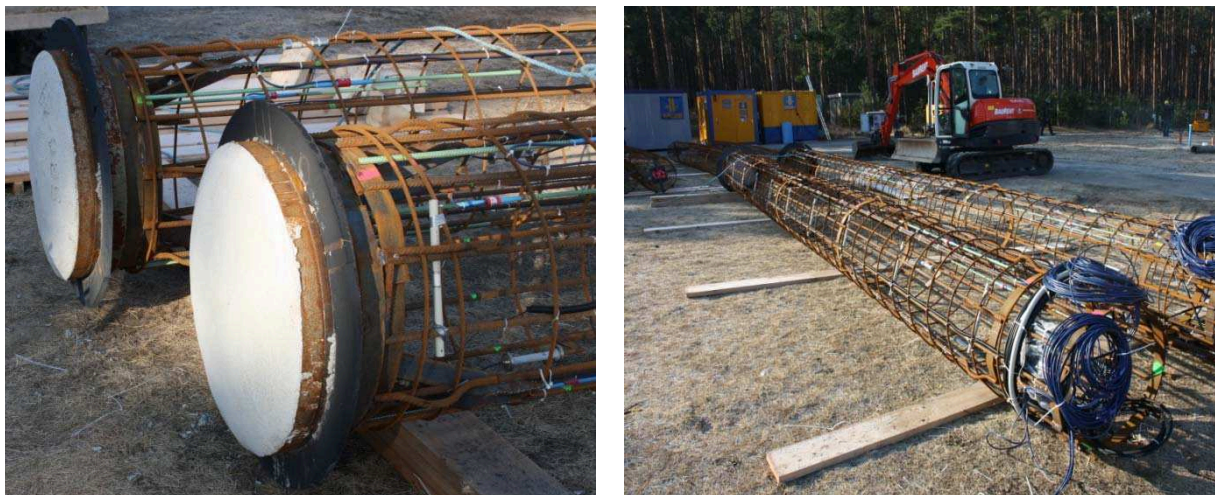
**Figure 5: Reinforcement cages of piles P1 and P2 with instrumentation. Toe load cells and various strain gage, fiber-optic and ultrasonic sensors can be seen on the left.**

The fiber optic sensors in Pile P2 delivered valuable insight. We have to be able to back-check the values measured by the toe load cell, which have been under discussion at a certain point of the investigation. Newly developed, very fast sensors helped in the interpretation of integrity tests. Details are given in Schilder et al. (2013).

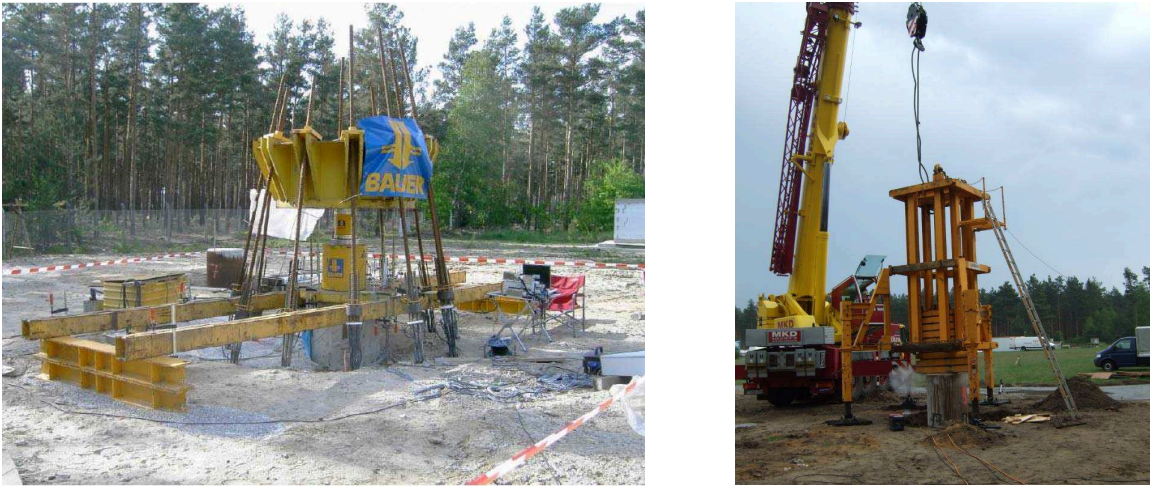
Figure 6: Static and dynamic load test setup at BAM-TTS.

The static load tests have been designed and performed according to the German Recommendations on Piling (DGGT 2013). For the static tests a loading platform on top of the hydraulic jack was used, which transferred the load via 12 anchors in 14.5 to 20.5 m depth (Figure 4). The anchors have been installed after pile construction. Piles were equipped with load cells on top and at toe level as well as vibrating wire and fiber optic strain sensors at three levels (Figure 4, Figure 5). Additional ultrasonic sensors were accidentally damaged during construction. The static load tests (Figure 6) have been performed by Bauer AG.

Dynamic load tests have been performed by five independent test crews. Each crew tested a virgin pile and re-tested one or more additional piles. They have used the same drop weight of 11 t (Figure 6), but have been requested to bring their own instrumentation. The crews used two or four sets of strain sensors and accelerometers and were allowed to set up their own schedule (number and height of weight drops). However, they were asked to work according to the German Recommendations on Piling (EA Pfähle). All crews used equipment of PDI, Inc. Data evaluation and interpretation was made by the CAPWAP method. This method uses a simplified 1-D model of pile and subsurface and an inversion strategy to fit the data. Results are values for skin friction and toe resistance. Even a simulated static load test curve (neglecting creep) can be calculated. It has been seen that there is room for interpretation, as some parameters have to be set by experience and data may contain errors or effects not taken into account by the model. Again, all consultants used the same software (PDI Inc.).

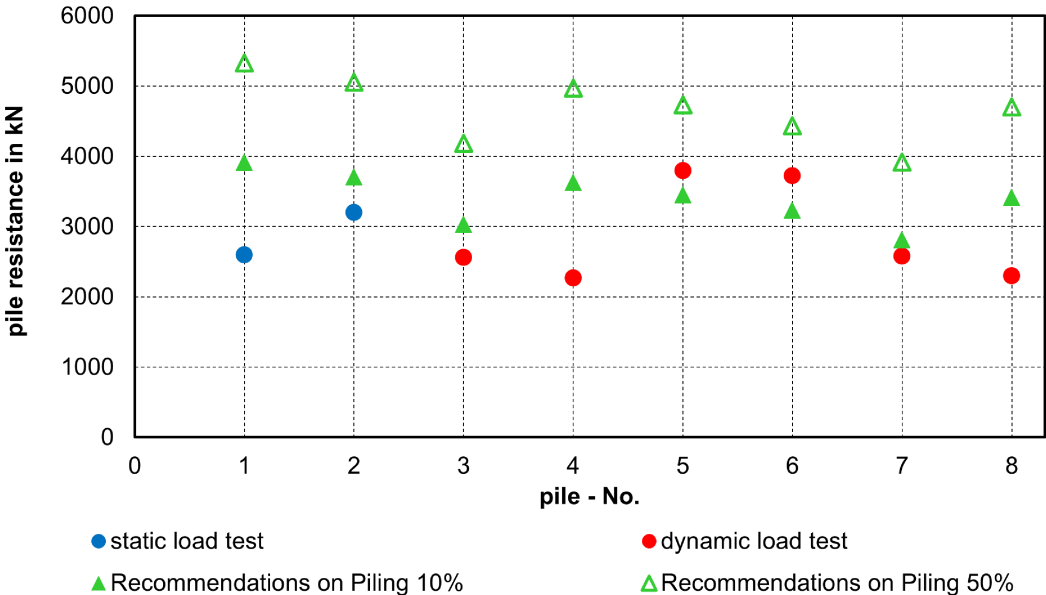
Figure 7: Result of static and dynamic load tests (blind test) in comparison to values expected after EA Pfähle (DGGT, 2013).

Figure 7 shows the result of the static and dynamic load tests (on virgin piles) compared to the expected resistances calculated according to the German Recommendations on Piling (EA Pfähle, DGGT 2013) separately for all piles using the nearest CPT. In general, all values are much lower than the average load resistance according to EA Pfähle (50% values in Figure 7), which emphasizes the benefit of any kind of testing in general. However, they are in the same order of magnitude as the lower 10% percentile. The dynamic load test results in the blind test show significant scatter, which only partly can be explained by subsurface inhomogeneities or differences between piles (note difference between both static load tests). Figure 8 shows also the results of re-tests for all piles. Symbols represent different test crews. There seems to be a bias between different interpreters. The ratio between skin friction and toe resistance varied as well between consultants.

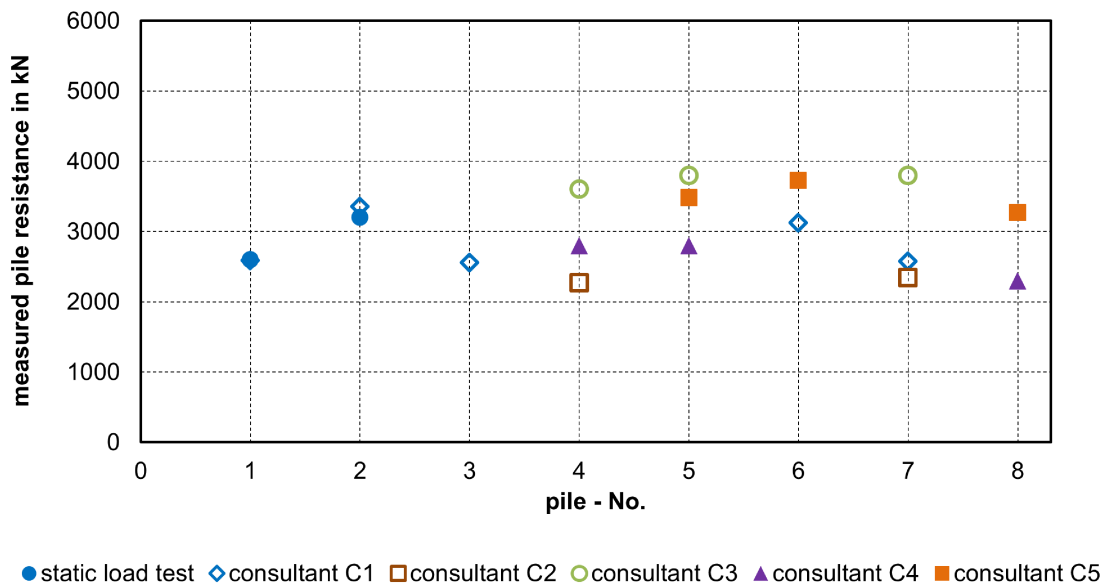
**Figure 8: Result of static and dynamic load tests (blind test, except for piles 1 to 3) for the five test crews. For pile 1, static and dynamic results are coincident.**

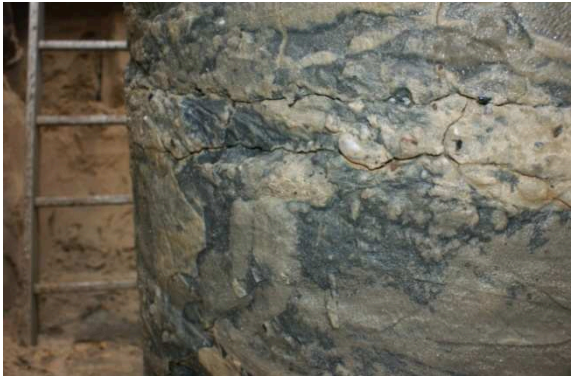
Figure 11: Pile P7: Left: excavated pile. Top. Cracks at 3.75 m depth below top of pile.

In by far the most cases, piles are not damaged significantly by dynamic load tests. However in this study we have used quite large drop heights (about 1 m in some cases) and a large number of blows (more than 10 in some cases). In addition, the toe resistance of the piles is due to soil conditions comparably weak. This resulted in settlements per blow (max. 30 mm) above the recommended limits (3 to 5 mm). The consultants have been free in parameters choice and have known that these piles will not be used after the tests. Most of the (compressive) stress wave induced by the weight drop is reflected at the toe as tension, which might lead to tension cracks at a point which is determined by geometry and material parameters. To validate this hypothesis we have excavated two piles (P4 and P7) up to a depth of 4 m below surface. Figure 11 shows the excavated pile P7 with cracks at exactly

the position estimated by the integrity test. Results for P4 have been similar, but cracks were closer to the pile top. The cracks have probably appeared just after the first blows. Thus this may have influenced at least the test results achieved at a later point. This effect cannot be quantified, but has made the data evaluation for the test crews at least more difficult.
