Conference Paper, Published Version

Huang, Ming-Wan; Cheng, Meng-Hsiung; Liao, Jyh-Jong; Pan, Yii-Wen (2008): Rapid Bedrock Erosion in the Taan River, Taiwan. In: Sekiguchi, Hideo (Hg.): Proceedings 4th International Conference on Scour and Erosion (ICSE-4). November 5-7, 2008, Tokyo, Japan. Tokyo: The Japanese Geotechnical Society. S. 361-366.

RAPID BEDROCK EROSION IN THE TAAN RIVER, TAIWAN

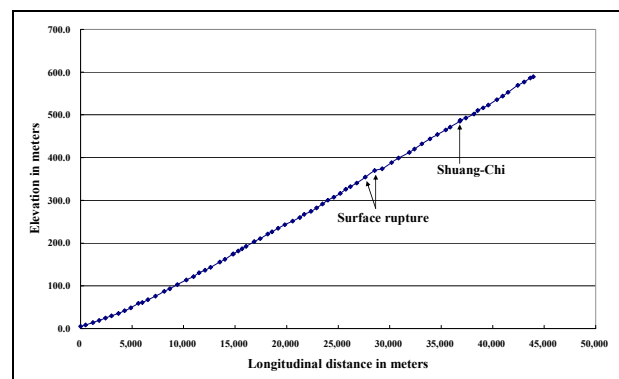
Figure.2 Longitudinal profile of the Taan River, 2004.

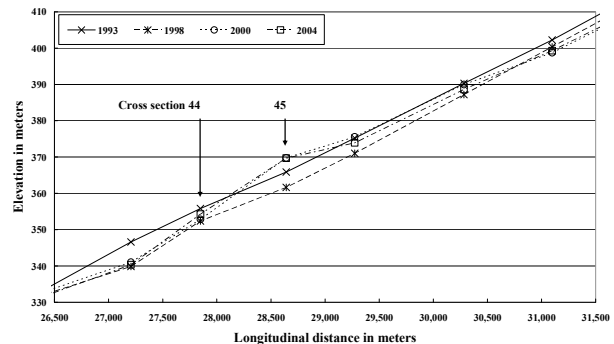
Figure.5 Longitudinal profiles of the Taan River in uplifted area.

In **Fig.5**, the longitudinal profiles of year 1993,

1998, 2000, and 2004 are drawn side by side for comparison. Note that the uplift zone is between cross-sections 44-45. From 1993 to 1998, due to gravel mining, the average height of riverbed was descended with 2-6 meters. After the 1999 Chi-Chi earthquake, the elevation of the river bed in 2000 is higher 1-8 meters than that in 1998. For year 2000 and 2004, the elevation was about the same at cross-section 45, but increased 1.4 meter at cross-section 44. In general, the uplift structure has slowed down the degradation upstream, and prohibits part of sediments transportation; as a result, the degradation of downstream channel is increased.

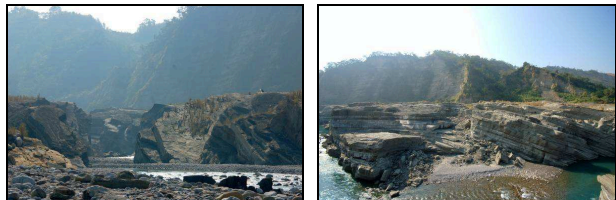
(a)Outlet of zone 1, dipping downstream. (b)The border of west limb and flatten top.

All the strata of anticline structure belong to the late Pliocene Cholang Formation, but strata attitude are different in three zones (**Fig.4**). According to the field observations, the erosion conditions in these zones are different. In zone 1, bedding planes are dipping downstream and the outcrop of sandstone stratum found here is relatively fresh (**Fig.8a** and **Fig.8b**) than in other zones. It maybe inferred that, while the weak siltstone, mudstone, or shale are eroded from the bedding planes, the strong sandstone will dislodge rapidly along the joint plane and displacing by gravity or flood. It is also noted that there is no flute or pothole in this zone. In zone 2, the bedding is almost flat; erosion processes are

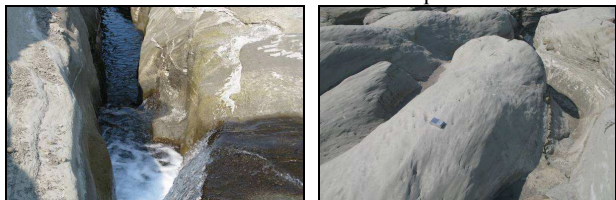
(c)Zone2, narrow deep channel. (d)Zone 2, large flutes on thick sandstone.

dominated by both abrasion and plucking. Dislodged blocks (Fig.8e), stages developed along sandstone layers (Fig.8f), large flutes and narrow incised channel (Fig.8c and Fig.8d) all exist in this zone. There is a knickpoint (waterfall, Fig.8g) in the border of zone 2 and 3, which shows the resistance to erosion is much greater when the bedding is dipping upstream (Zone 3). The resistive phenomena of zone 3 can be observed along the channel (Fig.8h).

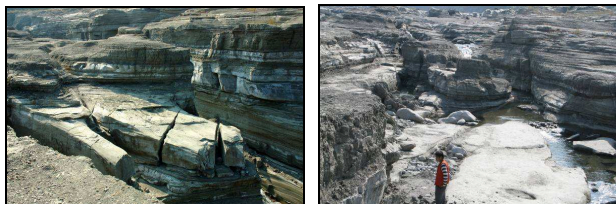
(e)Zone 2, huge dislodged block. (f)Stages formed by resistive sandstone.

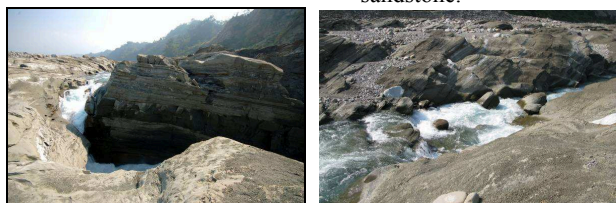
(g) The border of zone 2 and 3, (h)Zone 3, more resistive dipping upstream.
