Conference Paper, Published Version

Nakato, Tatsuaki

Erodibility Tests of Shale-Rock Samples Taken from Bridge Pier Construction Site on the Mississippi River

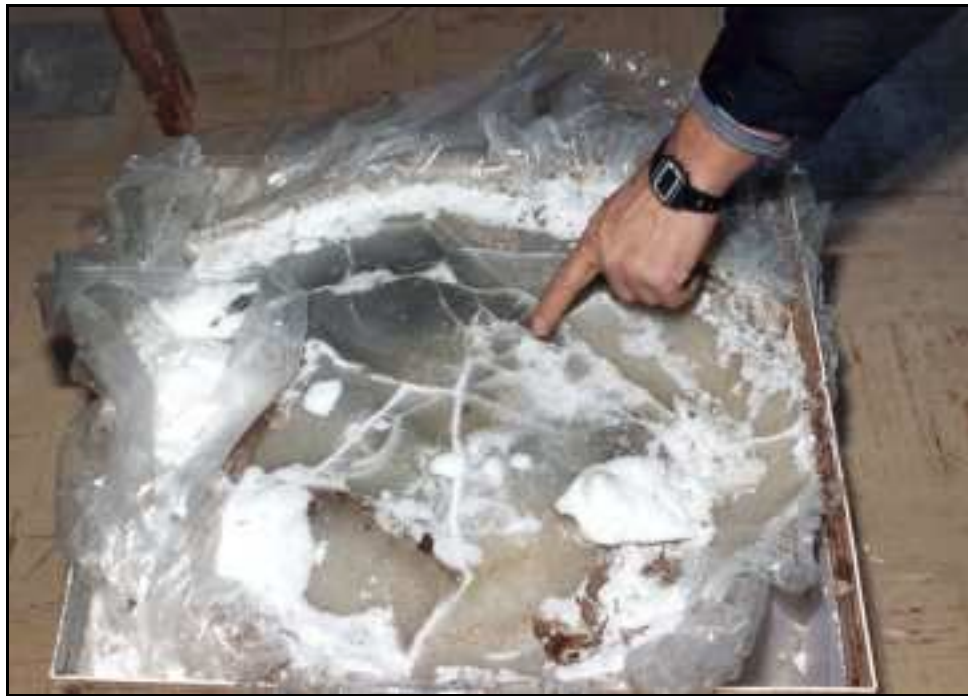
Figure 3. Snow-covered rock sample when delivered

Two boxes containing the Extraction 1 sample and the Extraction 3 sample were delivered to IIHR by IADOT on 12 December 1991. The sample condition was not good, as can be seen in Figure 3 for the Extraction 3 sample. Apparently, the samples were kept outdoors and were exposed to severe cold weather conditions. The wax was cracked due to expansion of the shale. When the wax was removed, the surface of the Extraction 3 sample (EXT3) was found to be wet and soft like clay. In order to obtain a hard surface sample, the soft material was scraped and washed off.

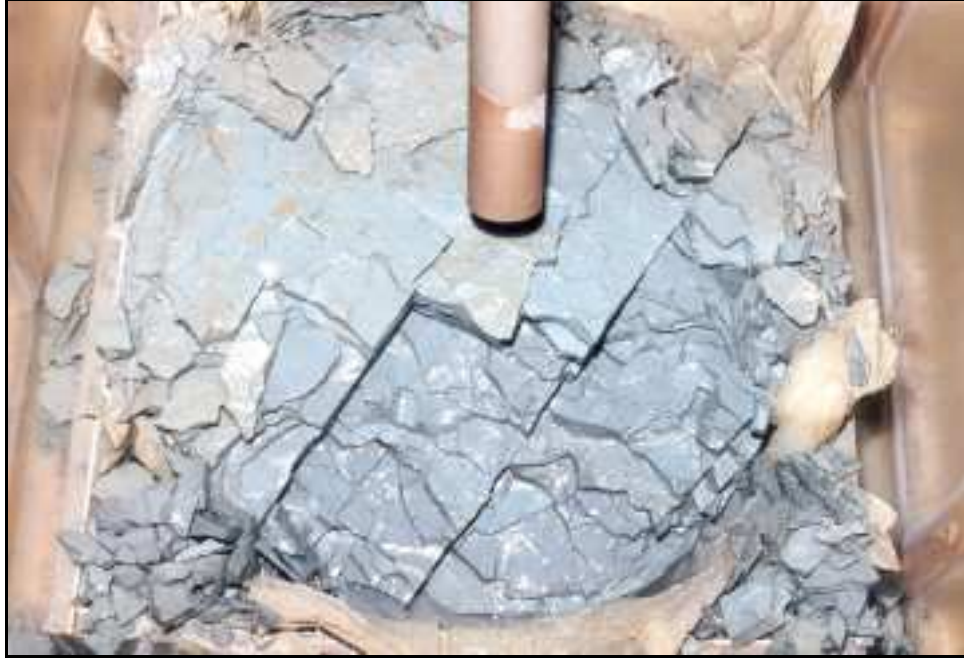
Figure 5. Surface condition of EXT3 sample after 13.5 hrs

The final phase was run for 13.5 hrs. at a jet velocity of 4.57 m/s. Immediately after starting the pump, numerous small shale fragments, 2.5 - 3.8 cm in diameter, were observed peeling off. After 7 hrs. of testing, the tank was dewatered and several photographs were taken. It was clear that significant scour and deterioration of the shale surface occurred with this high jet velocity. This series was stopped after running for 13.5 hrs., at which time the largest scour depth measured was 15.2 cm. The centerline scour profile is depicted in Figure 4, and a plan view of the specimen is shown in Figure 5. Shale flakes which were peeled off the sample were smaller than about 5.1 cm (examine Figure 5 with the fact that the jet pipe diameter was 5.1 cm).

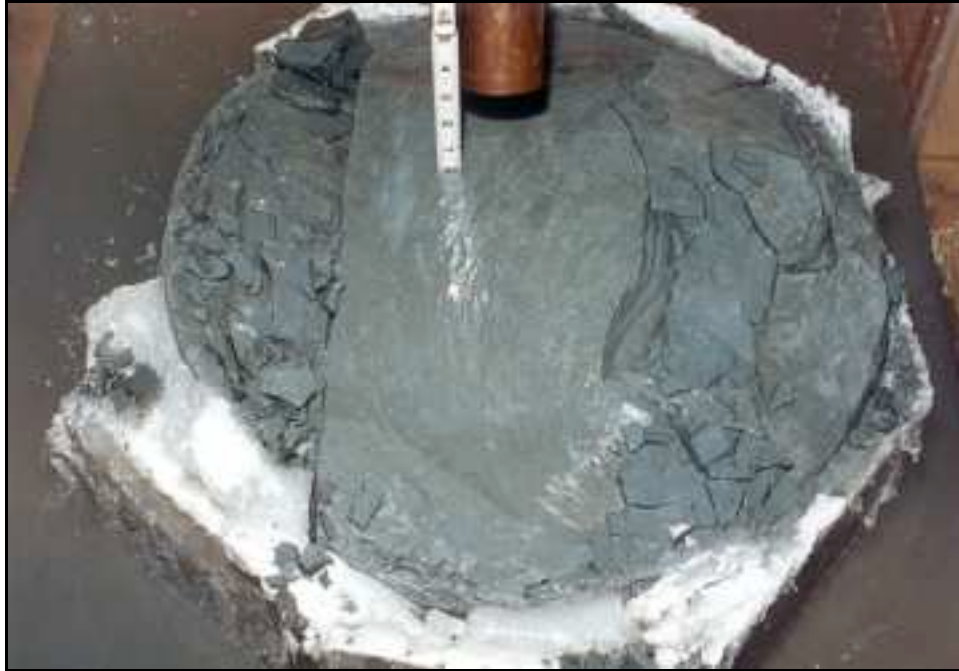
Figure 7. Undisturbed shale surface after removing deteriorated material (EXT1)

According to IADOT (Rost, Field Report dated 29 August 1991), the second box contained three shale pieces of varying sizes and shapes. The bottom piece was from Extraction 2, and the other two upper pieces were from Extraction 1. When wax was removed for the first time, no visible sample boundaries were detected. Therefore, this shale sample was called EXT1 for convenience. As done for the EXT3 sample previously, the soft deteriorated top surface was removed first. The sample surface was then washed with a garden hose and fractured surface materials were removed prior to testing. Fortunately, a smooth solid surface layer appeared in this sample, as shown in Figure 7. A smooth initial centerline surface profile was able to be measured this time.

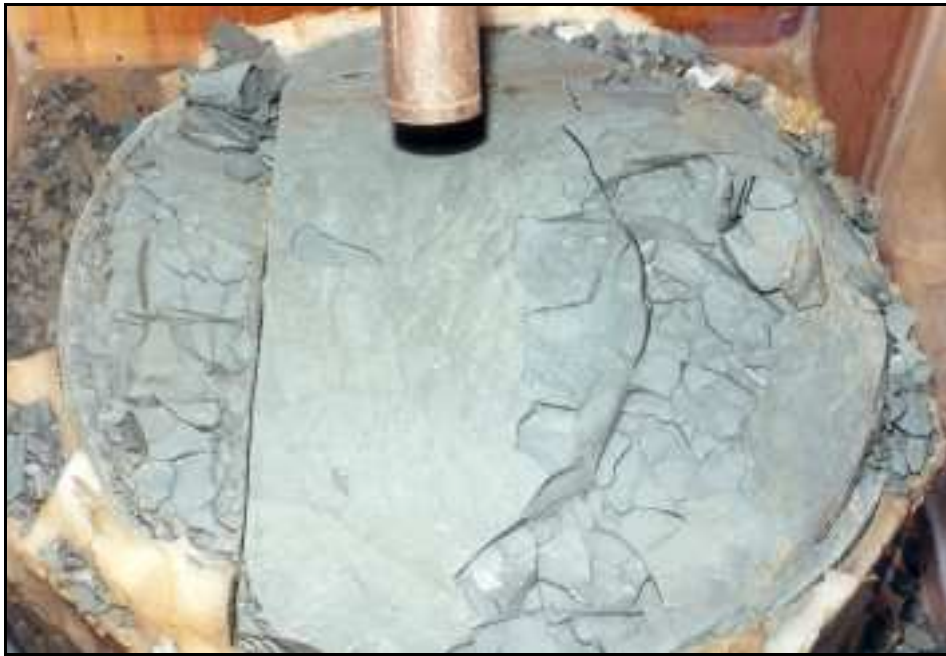
Figure 8. Surface condition after 41 hrs. of testing with a jet velocity of 2.44 m/s (EXT1)

The first test was conducted with a jet velocity of 1.83 m/s. Even after 19 hrs. of testing, practically no flaking took place. When the jet velocity was increased to 2.44 m/s, some minor flaking took place, as seen in Figure 8. Although the central

part of the sample surface remained unchanged except for one minor flaking near the jet nozzle, side areas surrounding the central piece deteriorated considerably.

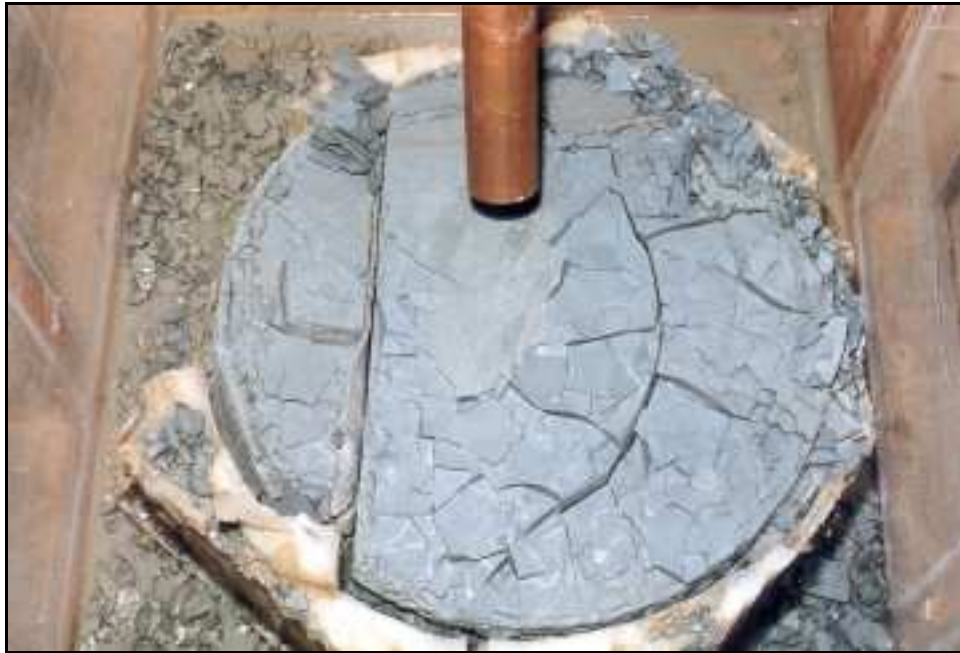
Figure 9. Surface condition after 38.5 hrs. of testing with a jet velocity of 3.05 m/s (EXT1)

When the jet velocity was increased to 3.05 m/s, some loose materials peeled off immediately. However, the surface profile of the solid central part remained unchanged even after 31.5 hrs. of continuous testing. At run time of 38.5 hrs., a distinguishable scour was observed, as shown in Figure 9. The measured surface profile is also plotted in Figures 10 and 11. It was determined that approximately, 1.3 cm of the shale material was scoured between 31.5 hrs. and 38.5 hrs. This series of testing was finally stopped after 88.5 hrs. of testing. A large scour hole was discovered, as shown in Figures 10, 11, and 12. The deepest part of the scour hole was approximately 12.7 cm below the original surface elevation.

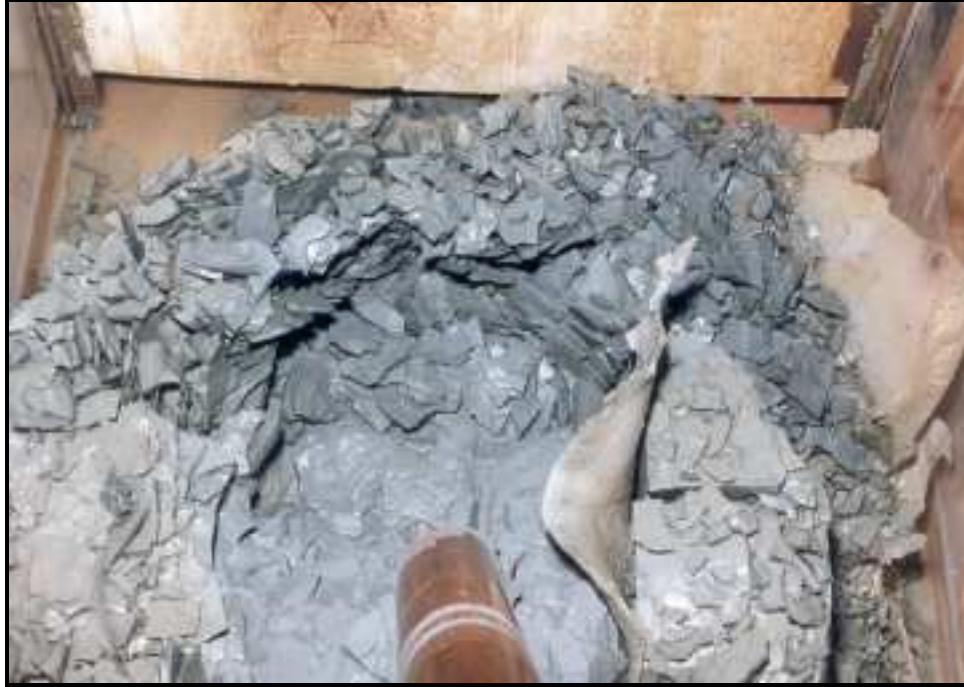
Figure 12. Scour profiles obtained with EXT1 sample with a jet velocity of 3.05 m/s
