Oberhagemann, Knut; Diggelmann, Philemon; Mukhles-Uz-Zaman Understanding Falling Aprons - Experience from the Lower Brahmaputra/Jamuna River

UNDERSTANDING FALLING APRONS – EXPERIENCE FROM THE LOWER BRAHMAPUTRA / JAMUNA RIVER

Knut OBERHAGEMANN¹, Philemon DIGGELMANN² and MUKHLES-UZ-ZAMAN³

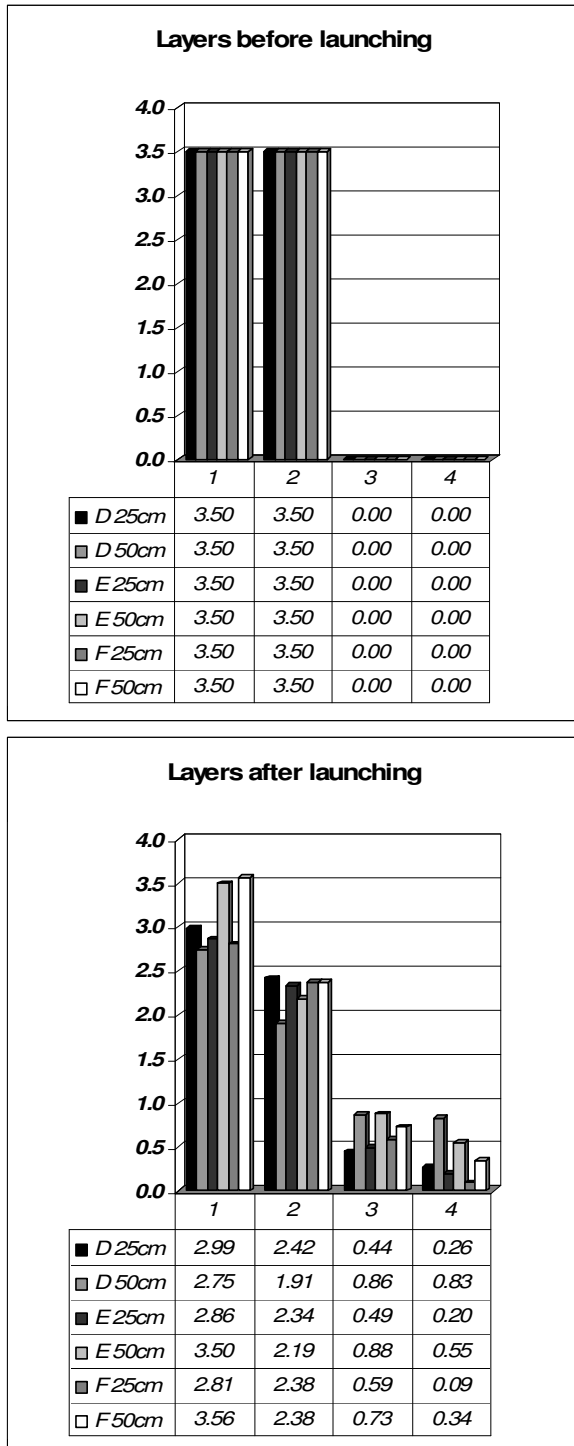
Fig.4 FAP 21⁸⁾ model tests - layer thickness before and after launching. The concrete blocks were placed along the toe in two parallel segments named 1 and 2 and launched down the slope after scouring. Here they were counted again in two segments named 3 and 4.

More recent studies in Bangladesh confirm that launching results in single layer coverage. The two Flood Action Plan study components FAP 1⁷⁾ and FAP 21⁸⁾ conducted extensive model studies on falling aprons. **Fig.4** from FAP 21 shows the distribution of layers of concrete blocks before and after launching. (References “D” to “F” indicate different revetment sections along the bank, D being the most upstream and “F” the most downstream.) Two concrete block sizes were tested, 25 cm and 50 cm. The coverage on the launched slope is less than one layer thick. FAP 1⁷⁾ describes the launching process and the coverage after launching: “About one layer of blocks covered the eroded slope below the apron setting level.” It adds: “The natural process of self-armouring the slope by the launching apron therefore seems to be favouring one layer of blocks. However if more blocks are present for launching

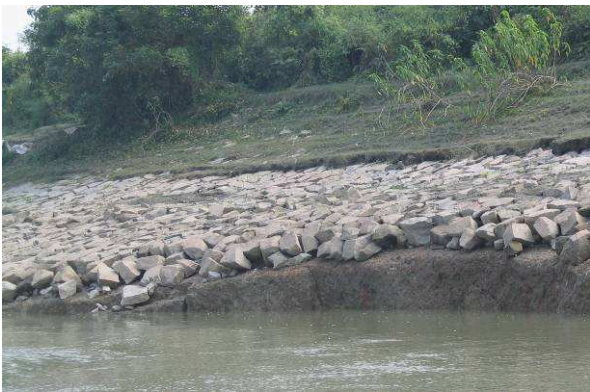
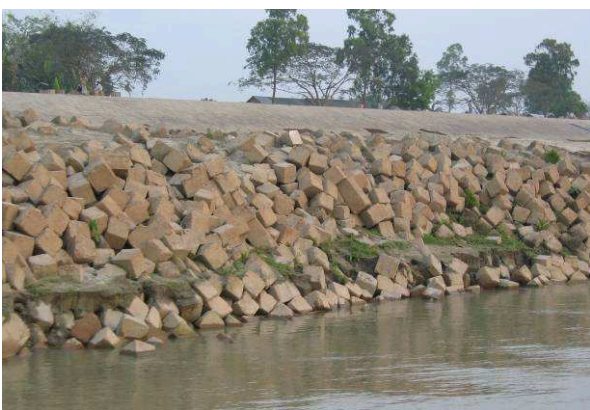
Fig.6 Steep cohesive banks cannot be covered with falling aprons

- (i) more cohesive strata that form steep banks (**Fig.6**). The upper photo shows the failure of pitched rock on clayey soil, and the lower one shows that even a higher pile of concrete blocks does not cover the steeper cohesive bank properly but leaves an unprotected gap above the low water line.
- (ii) recently deposited, very loose sands that are not geotechnically stable at the launched angle (ref. Chap. 2.2).

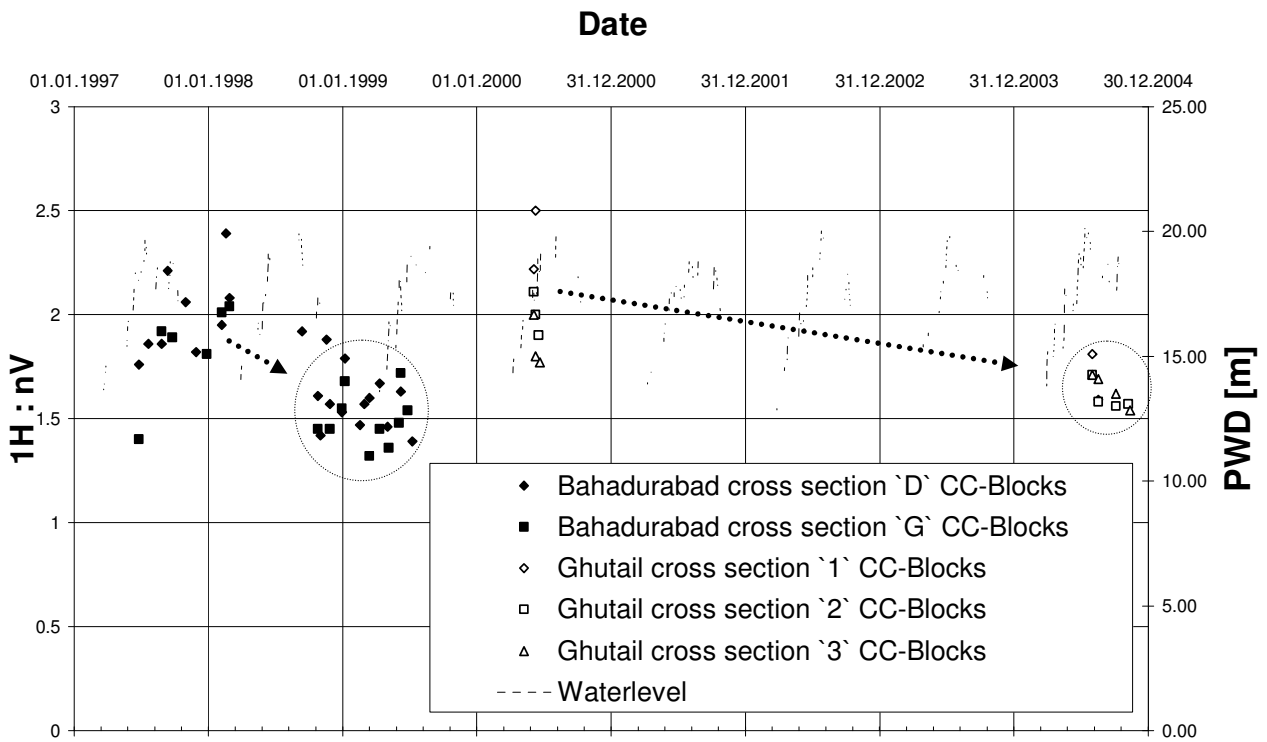
Fig.8 Development of water levels and slope over time
