Conference Paper, Published Version

## **Rapid Assessment And Treatment Of Post-Fire Erosion Hazards Using Innovative Data Collection And Assessment Tools**

# **RAPID ASSESSMENT AND TREATMENT OF POST-FIRE EROSION HAZARDS USING INNOVATIVE DATA COLLECTION AND ASSESSMENT TOOLS\***

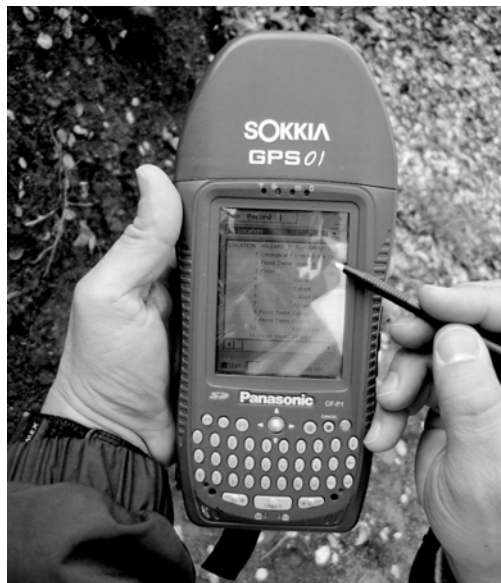
Figure 3. Jetstream equipped PDA for consistent field data gathering.

The ground survey teams employed ruggedized personal digital assistants (PDAs) equipped with integral global positioning systems (GPS) running the rapid development relational database engine Jetstream™ for consistent data gathering (Figure 3). Information was gathered on drainage features, surviving vegetation, hydrophobic soils, burn severity, receiving waters, infrastructure, and surviving homes. The PDAs were downloaded every night into a whole-project field data management system and correlated with the aerial and site photographs.

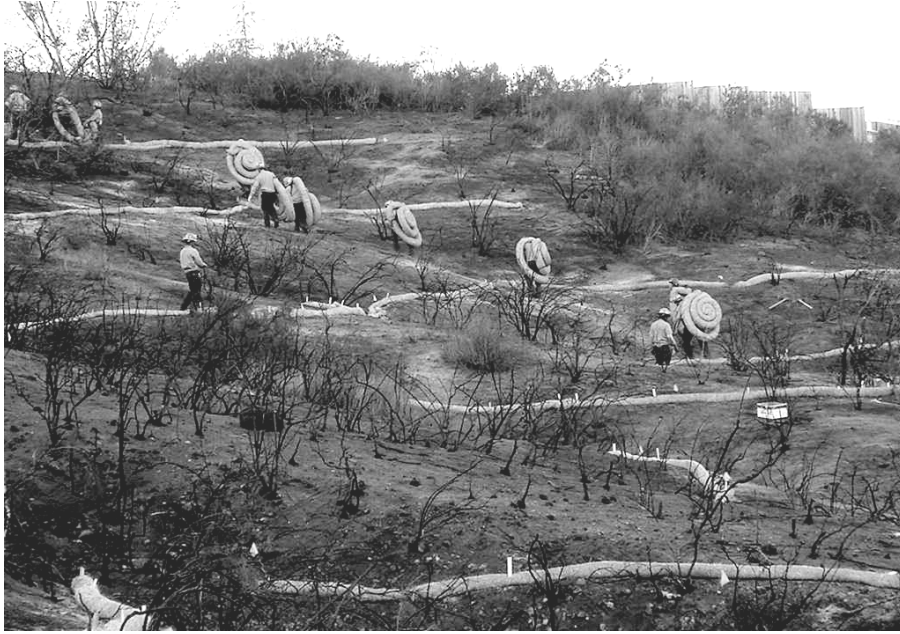
Figure 4. California Conservation Corps installing fiber rolls.

As the mitigation plans were finalized, materials were ordered and labor forces were contracted. Labor forces included hand labor crews (e.g., California Conservation Corps and Urban Corps) who were trained to construct temporary grade control measures, barriers and diversions, and slope interrupter devices (Figure 4). Experienced hydraulic erosion control contractors were retained to apply hydraulic mulch (wood fiber, tackifier, native seed, and mycohizae) and bonded fiber matrix (Figure 5). Construction contractors were retained to install trash racks and debris flow devices (e.g., k-rail).

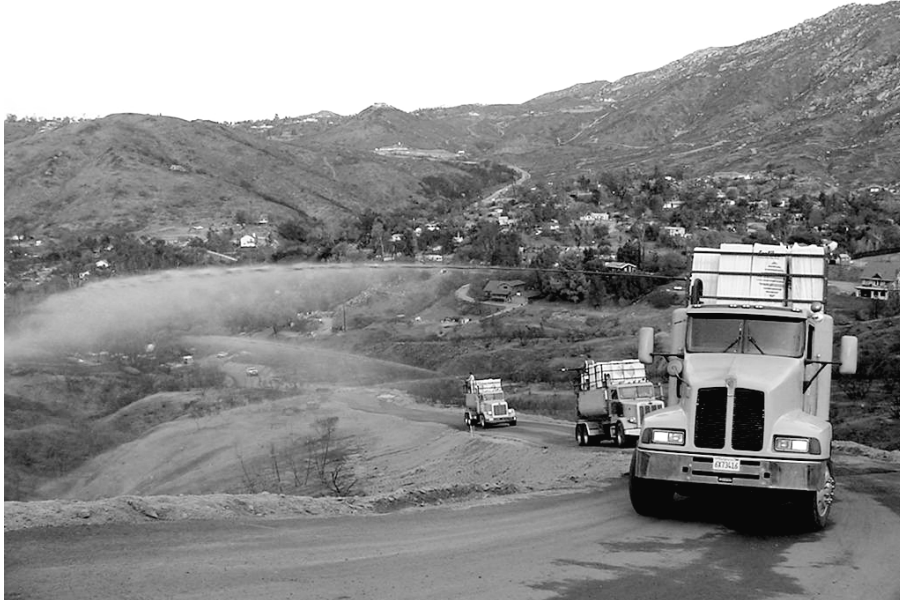
Figure 5. Hydraulic mulch application.
