Melville, Bruce W.; Coleman, Stephen; Hoe, David
Countermeasures for Scour at Spill-Trough Bridge
Abutments

Melville, Bruce W.; Coleman, Stephen; Hoe, David (2002): Countermeasures for Scour at Spill-Trough Bridge Abutments. In: Chen, Hamn-Ching; Briaud, Jean-Louis (Hg.): First International Conference on Scour of Foundations. November 17-20, 2002, College Station, USA. College Station, Texas: Texas Transportation Inst., Publications Dept.. S. 749-763.

Countermeasures for Scour at Spill-Through Bridge Abutments

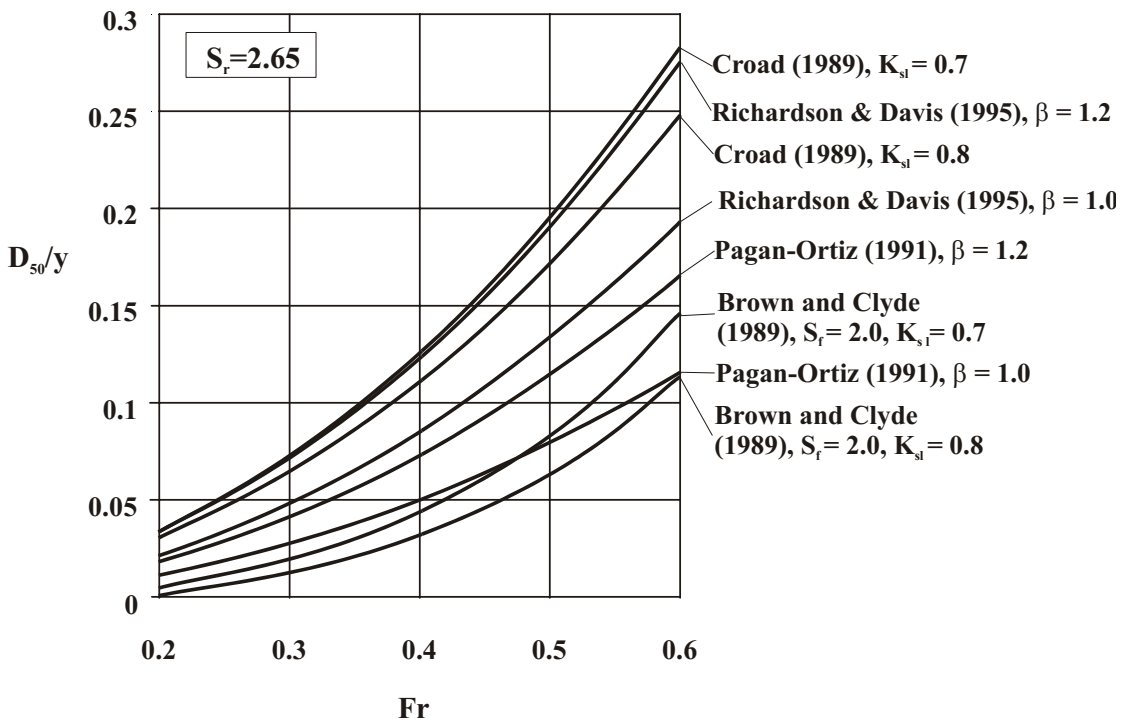
Figure 1 - Comparison of equations for riprap sizing at bridge abutments

A graphical comparison of the various equations for $S_r = 2.65$ is shown in Figure 1. It can be seen that the various equations give a wide range of recommended riprap sizes for a given flow. The equations given by Croad (1989) and Richardson and Davis (1995) give larger riprap sizes in comparison with the other equations, whereas the equations given by Brown and Clyde (1989) and Pagan-Ortiz (1991) give relatively smaller riprap sizes.

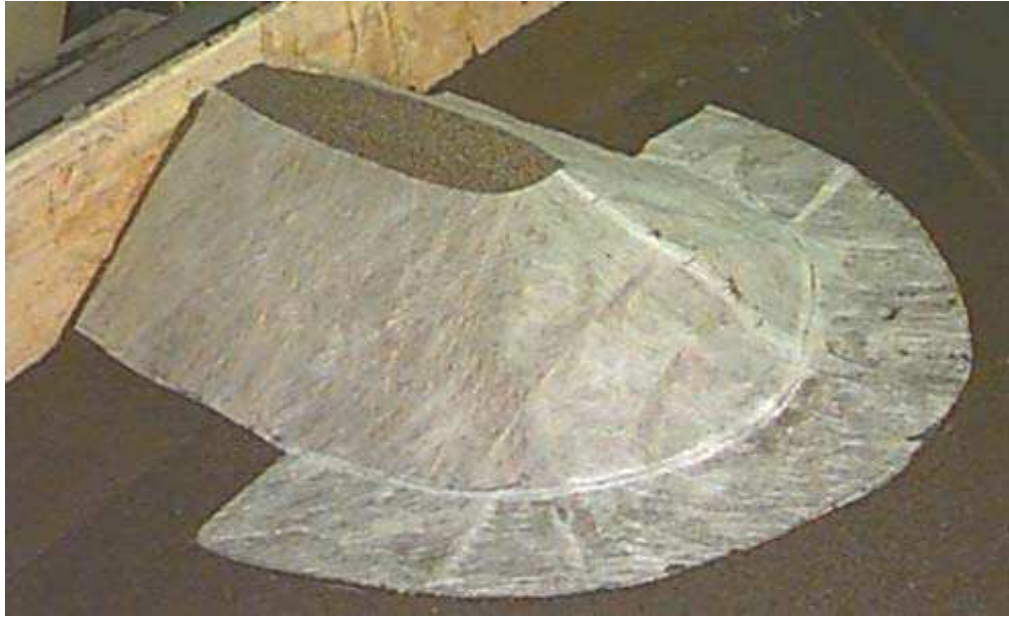
Figure 4 – The filter fabric placed over the sand embankment ready for placement of cable-tied blocks

The median sizes, D_{50} , of the three uniform riprap sizes used in the riprap experiments were 16.3, 21.5, and 27.8 mm. The riprap was placed on the embankment slopes to a thickness of $2D_{50}$. An apron of the dimensions required was placed on the bed around the embankment. Commercially-manufactured ceramic bathroom tiles, of dimensions 25 mm x 25 mm and 5 mm high, were used to represent the cable-tied blocks. A synthetic filter fabric was used in most of the cable-tied-block tests, Figure 4. All tests were conducted at the same flow depth ($y = 150$ mm), under clear-water conditions on the

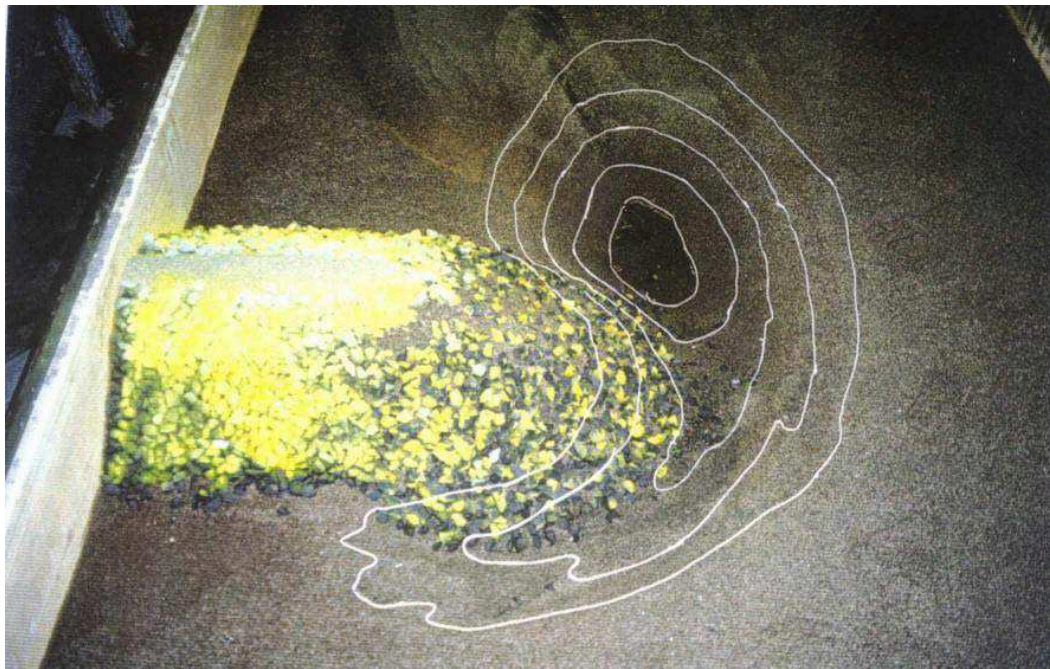
Figure 5 – Typical scour hole developed at an abutment (of no failure) with riprap protection, viewed from downstream

For a riprap apron of $W = 0.3$ m, no abutments failed. A typical test result is shown in Figure 5. This would indicate that an apron width of twice the flow depth ($2y$) is adequate for abutment protection under clear-water conditions, and within the limits of these tests. However, the results show that this is a conservative solution. The apron width can be reduced, and the extent of the apron in terms of θ and ϕ can be reduced also. The results suggest that there is a relationship between the total area of apron and degree of protection. The suggested form of this relationship is shown in Figure 6, which shows a clear zone of partial failure. Note that the values for the tests using a 0.3-m apron have been omitted, to allow the remainder of the data points to be seen more clearly.

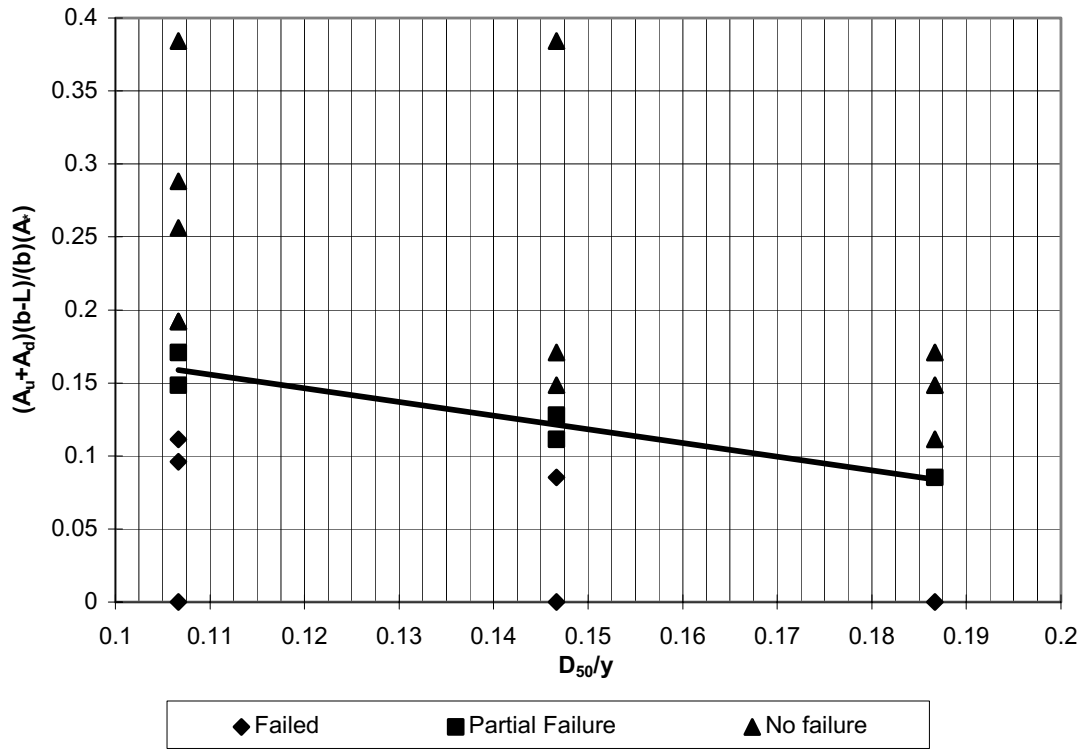
Figure 6 - Relationship between apron extent and riprap size.

The variable on the y-axis of Figure 6 is $\left(\frac{A_u + A_d}{A_*}\right)\left(\frac{b-L}{b}\right)$, where A_u is the area of riprap protection of the apron on the upstream side of the abutment, and A_d is the equivalent area on the downstream side. A_* is the area of riprap protection as recommended by current guidelines ($W = 2y$), with θ and ϕ equal to zero. These areas exclude the riprap area on the embankment slope. The first term in this expression can be expressed in terms of the parameters W , y , θ , ϕ , and an additional parameter r , which is defined as the radius of the toe of the spill-through abutment. The second term is the contraction ratio (β) for the channel. The line shown in Figure 6, defining the failure limit, can then be expressed as

$$\frac{W}{y} \left(\frac{0.5W + r}{y + r} \right) = \left(0.5 - 1.82 \frac{D_{50}}{y} \right) \frac{1}{\beta} \left(\frac{180}{180 - (\theta + \phi)} \right) \quad (2)$$

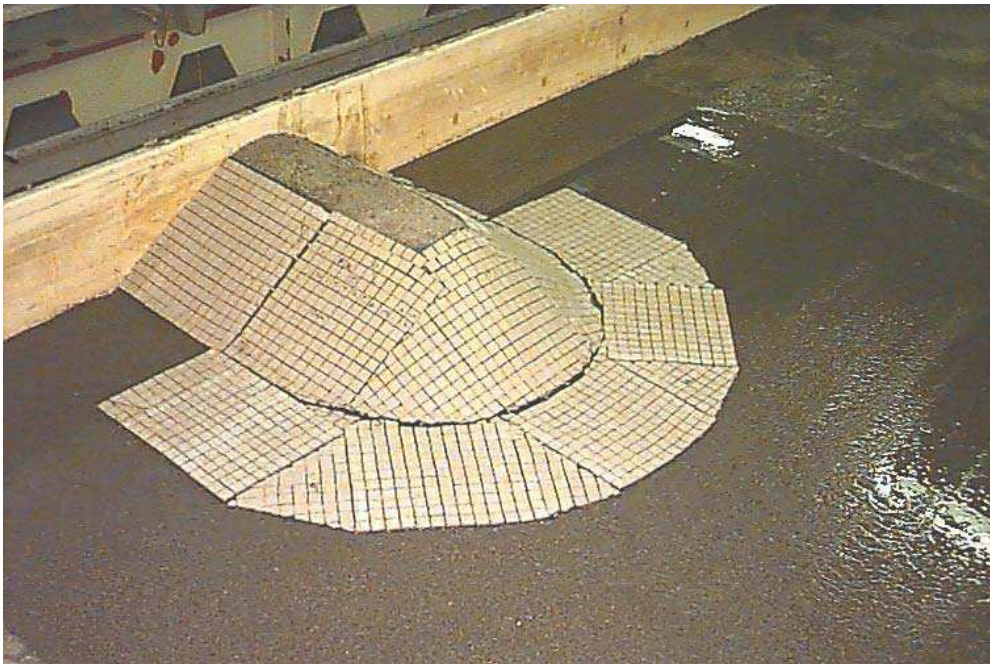
Figure 7 – The standard apron used in all cable-tied block tests

For the cable-tied block experiments, the standard layout used in all experiments is shown in Figure 7. This layout did not provide adequate protection for flow conditions approaching $V/V_c = 1.0$. In an attempt to improve the protection, additional cable-tied blocks were added for the final three experiments of $V/V_c \rightarrow 1.0$, as shown in Figure 8.

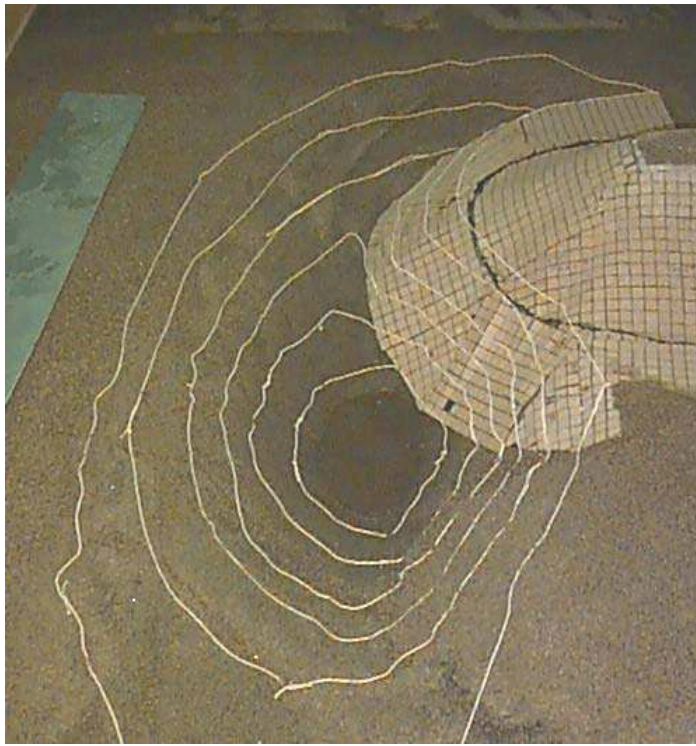
Figure 10 – Scour hole development for Test 4 using cable-tied blocks, with $V/V_c = 0.66$, viewed from downstream

The relative performance of riprap and cable-tied blocks is highlighted by comparing the results for riprap-Test 17 and cable-tied block-Test 4. For these tests, the experimental conditions were similar, the velocity ratios being 0.73 and 0.66, respectively. The scour depth reductions for these two tests were 42% and -11%, respectively. The scour developed in each of these tests is shown in Figures 9 and 10.

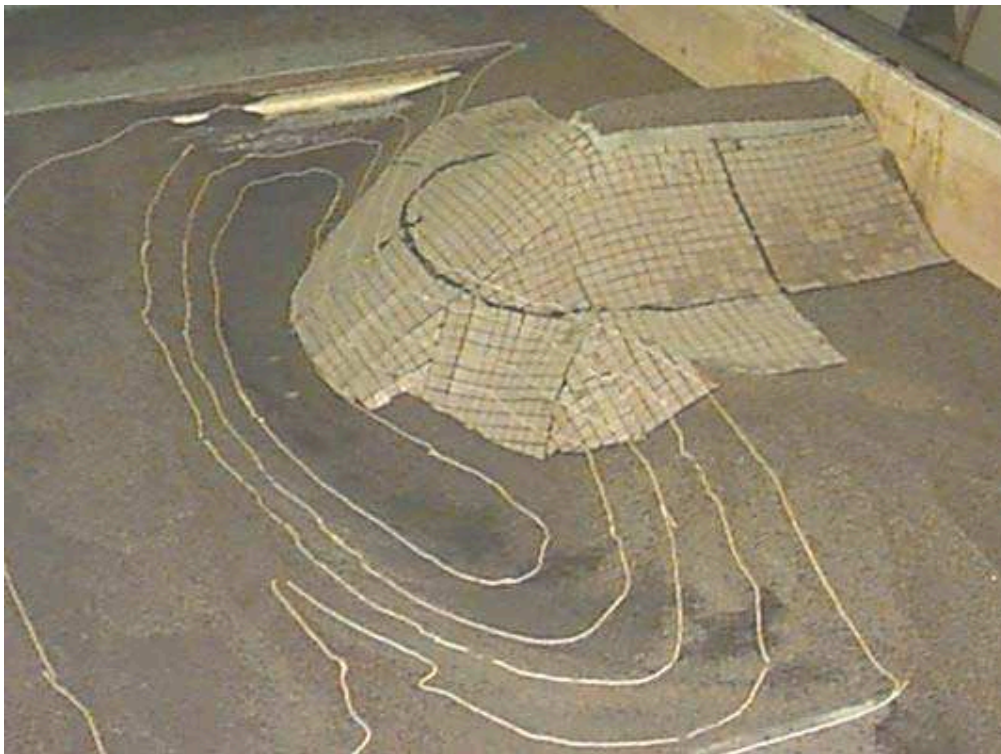
Figure 11 – Typical scour hole development for cable-tied block protection (Test 5), viewed from downstream. In this test, the protection was deemed not to have failed

The level of protection required using cable-tied blocks increased with increasing flow velocity. The effect of increasing flow velocity is seen by comparing Tests 5 and 6, for which $V/V_c = 0.80$ and 0.86 , respectively. Test 5 (Figure 11) was adjudged to be a success, because the fill material did not slump near the top of the fill slope and an
