Conference Paper, Published Version

## **Dynamics of Erosive Processes in the Nizhnayaya-Volga Prikaspiy Region**

## DYNAMICS OF EROSION PROCESSES IN THE NIZHNYAYA-VOLGA PRIKASPIY REGION

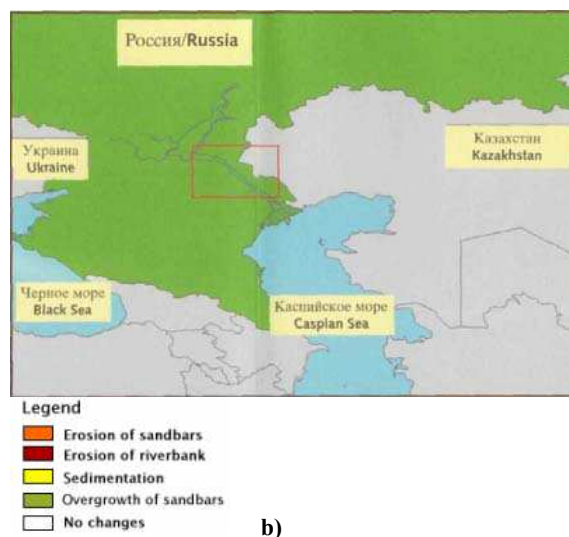
a)

**Fig.1** Morphological changes of Volga-Akhtuba floodplain in 1986-1996 (a) and scheme of geographical location (b).

The analysis of satellite pictures of the floodplain territory for the period 1985-2001 and field observations of key sites of the floodplain were conducted to perform this work.

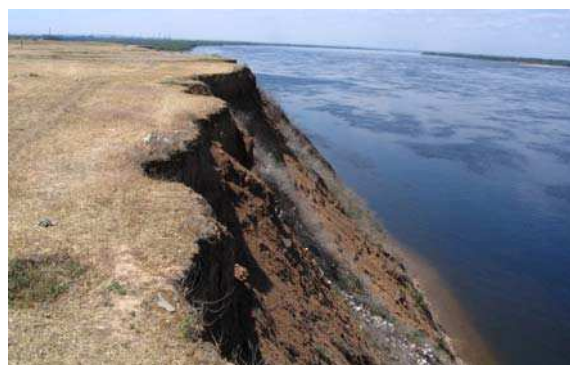
**Fig.2** Erosion of a slope on a Svetly Yar site

Riverside ledge on Svetly Yar site is steep, in the top it is vertical and more flat only in the south part of the area. The slope altitude is from 25 up to 30 m above the low-water level in Volga River. Edge is plain, sandy-clay, with a bias to a channel under a corner 7-10°, width is 15-20 m (Fig. 2).

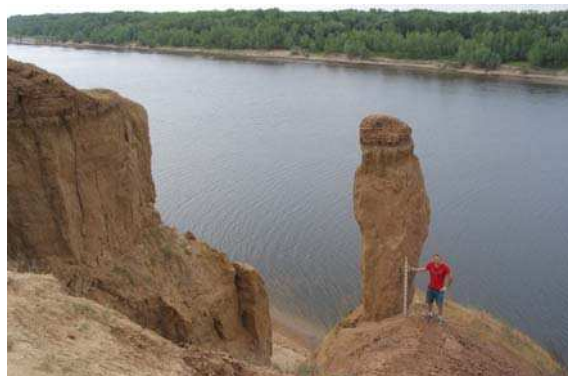
**Fig.4** An erosive slope of Akhtuba River valley

Within the limits the Akhtuba River valley has a sharp turn, this causes an activity of erosion on this site. The valley is asymmetric: its left bank is abrupt, and right is flat (Fig. 4). The width of a channel at horizon of water minus 9-10 m makes about 125-130 m. Depth of the river varies from 0,5 up to 2,5 m, and the greatest depths are dated for the left bank.
