Ranga-I Bridge Pier Scour In Bouldery Bed - A Case Study

BRIDGE PIER SCOUR IN BOULDERY BED - A CASE STUDY

RK DHIMAN
Deputy General Manager
Project Zaranj
Seema Sadak Bhawan,
Delhi Cantt, Naraina,
New Delhi - 110 010

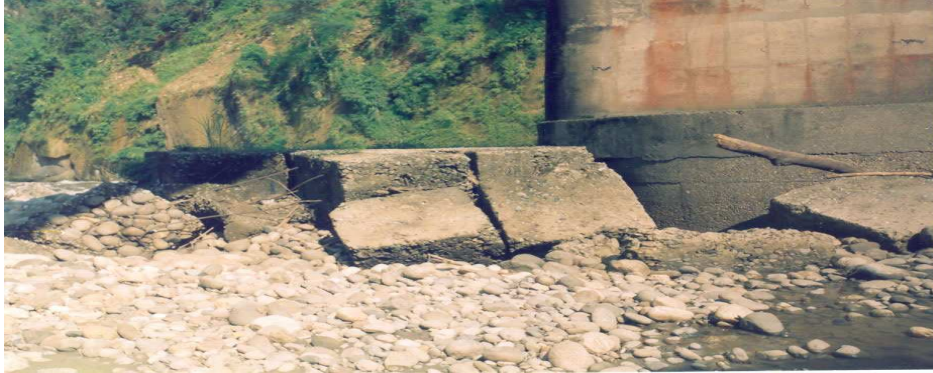
6 During Jun (1968) there was heavy flood with increased discharge about 1.6 times the designed discharge, affects the pattern of flow around the pier which was observed as oblique. This enhanced discharge caused heavy scour around the pier of central foundation and reoriented the flow on right channel only. Observations of scour was kept and bridge behaved well but from 1979 onward increased scour had been observed. Rehabilitation measures were taken after examination of the condition to arrest the scour. For this purpose concrete block were laid around the foundation as per practice in vogue. There had been instances when most of the concrete blocks made

around the pier were either washed away or dislocated due to water force. Scour remained within the designed limit.

To control the scour damage during past years PCC blocks were cast during the years 1981, 1984 and 1985. A few of these blocks got dislocated and later on all the blocks were interconnected. Under pinning of the blocks was also done. In fact the more damage was noticed due to oblique flow hitting the pier at angle and on left bank there was very less flow. There is sharp turn on D/S leading to sudden change in flow pattern. Detailed examination of the problem was done during 2000 keeping in view the past scour and rehabilitation measures taken so far. Following were observed (Fig.4) :-

- (a) Flow in the channel is oblique and maximum flow is going through the right side of the span.
- (b) All the PCC blocks need to be made matching with the bed level in order to avoid the obstruction of flow and to avoid formation eddies.

Fig 4 Scour around pier

7 Based on the observations of scour in past years, following recommendations were made :-

- (a) The river water be made to flow in the both the channel which is not happening at present as maximum discharge is going in the right side channel. This requires dredging of the river to some extent for left side span to pass the atleast 30% to 40% of discharge.
- (b) There is need of repelling type spur on U/S right side to ensure that further water flow stay to left channel equally.
- (c) Temporary arrangement made by PCC blocks to arrest scour be made in such a manner that top of block should match with existing bed level so that unnecessary obstruction is not caused to the flow and further scour is arrested.
