## **Locally Concentrated Severe Beach Erosion on Seisho Coast Caused by Typhoon T0709**

# LOCALLY CONCENTRATED SEVERE BEACH EROSION ON SEISHO COAST CAUSED BY TYPHOON T0709

This paper studies severe beach erosions of Seisho coast caused by the typhoon No.9 in September 2007. Special focus is put on locally concentrated erosions and damages behind the Oiso-Spur, where the area with relatively shallow water depth,  $h < 100\text{m}$ , convexly extends toward the offshore. Field survey was first carried out to capture alongshore distributions of hydrodynamic forces that directly cause beach erosions and damages on the Seisho Bypass, the expressway along the coast. To quantitatively compare the intensity of hydrodynamic forces, inundation heights were measured at 28 locations along the coast. Measured inundation heights showed spatially periodic distributions along the coast and the peak of measured inundation heights was at Ninomiya Interchange, where the most severe damages were observed.

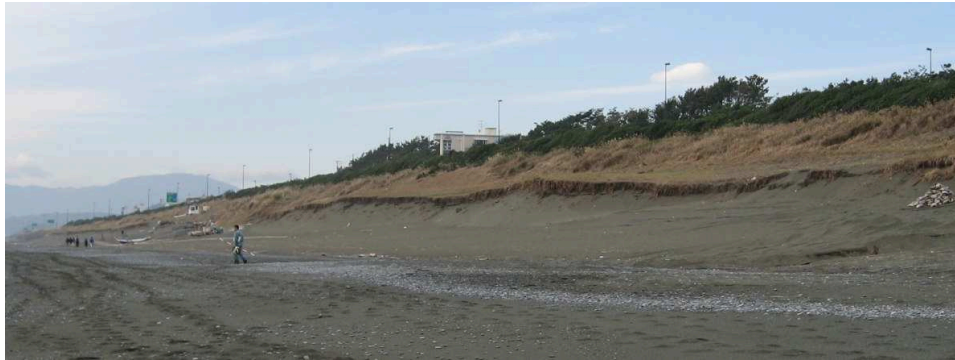
**Fig.3** Vegetation area eroded by storm waves (at **Fig.2**, #2)

km-long coastline from the east side of the Sagami River mouth to the Sakawa River mouth. **Fig.2** shows the geography of the surveyed area and alongshore distributions of measured elevations of wave run-up based on the datum of Tokyo Peil. A mark of washed vegetation area, as shown in **Fig.3**, was first used to detect the highest water marks. Especially near the most damaged area, i.e., around Ninomiya- Interchange as shown in **Fig.2**, the coast was covered by concrete seawall and thus there was no vegetation area. When water marks of vegetation area were not available, we looked for a water mark of flown debris or witness' information. At the most damaged site, as shown in **Fig.4**, splashing water overtopped the Seisho-Bypass and thus **Fig.2** just shows the elevation of the Seisho-bypass as a height of run-up wave. As seen in **Fig.2**, observed alongshore distributions of run-up heights had somewhat periodic undulation and the location of observed highest run-up area corresponded to the place where Seisho-Bypass was most severely damaged.

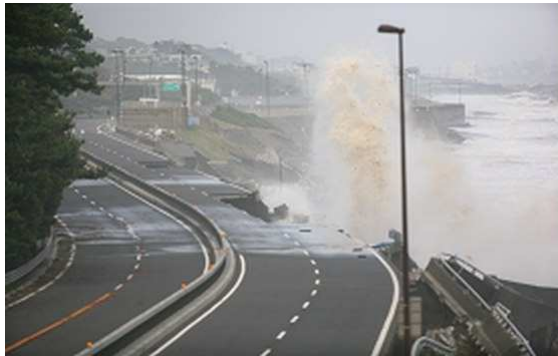
**Fig.4** Waves splashing on Seisho Bypass around Ninomiya Interchange.

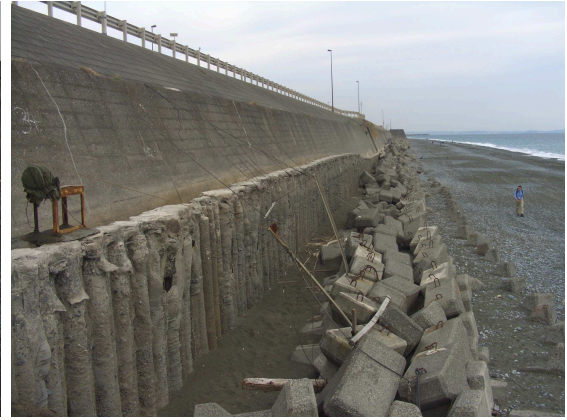
Fig.6 Damaged sea wall at Oiso (Fig.2, #3)

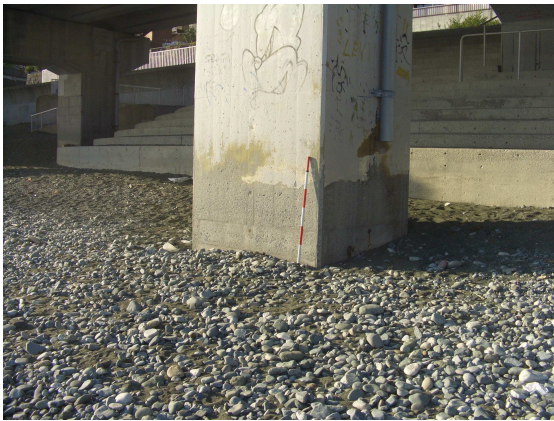
Fig.7 Eroded beach around Kozu (Fig. 2, #4).

waves, we also observed severe topography changes along the coast. **Fig.5** shows the photograph taken around the west-side of Oiso fishing port, indicated by number “1” in **Fig.2**. As seen in this picture, sandy beach was completely washed away and underneath rocks and gravels of relatively large grain sizes were exposed to the surface. Considering the fact that the other side of Oiso fishing port kept fine sandy beach even after the event, this observed severe erosion should be mainly due to unbalance of westward longshore sediment transports. **Fig.6** shows the collapsed seawalls near Ninomiya Interchange, where is indicated by number “3” in **Fig.2**. In front of the seawall, sandy beach was severely eroded during the storm and bed elevation subsided for about 4 meters in height. Eventually, subsidence of the sandy bed collapsed of the foundation of the seawall and the structure was finally collapsed. **Fig.7** shows the eroded beach observed around Kozu, indicated by number “4” in **Fig.2**. As seen in the figure, the pre-storm bed elevation was about 1m above the one shown in the figure.
