Conference Paper, Published Version

Rajabalinejad, M.; Baziar, M. H.; Vrijling, J. K. Erosion in the Foundation of Abshineh Dam (Iran)

Erosion in the Foundation of Abshineh Dam (Iran)

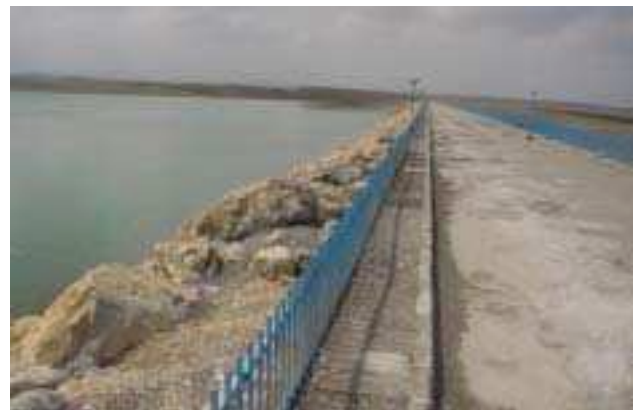
FIGURE 1. ABSHINEH DAM AND ITS RESERVOIR, HAMADAN, IRAN

The Abshineh dam is a clay core dam located in Hamadan, one of the provinces of Iran, on the Abshineh River and downstream from Ekbatan dam. A picture taken over the crest of Abshineh dam is presented in Fig 1. The Abshineh dam was constructed in 1996 to secure the water supply and irrigation needs of Hamadan city. Moreover, the discharged water of Ekbatan dam accumulates behind Abshineh dam. Table 1 presents the main characteristics of the Abshineh dam.

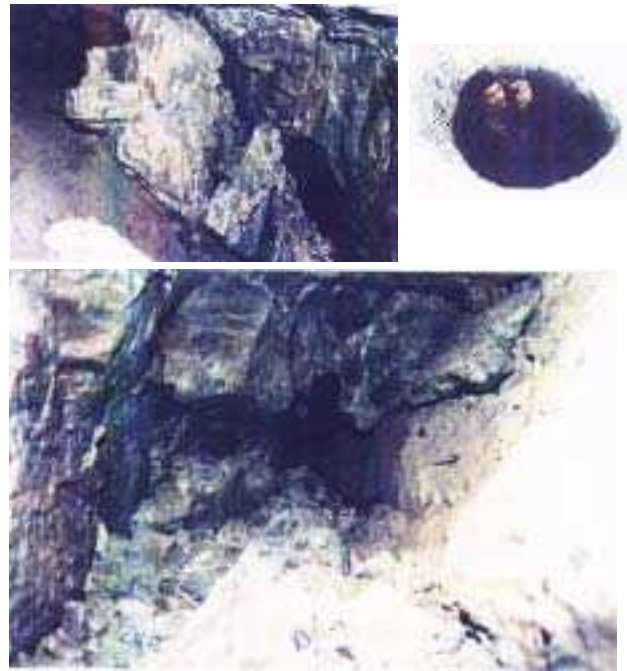
In this time, even grouting more than 7.5 tons mixed cement in C1, a borehole at the right abutment of dam, it did not fill, so was a shaft with diameter of 70 cm bored from the crest, and the excavation exposed a fault under the foundation. Fig 5 shows some pictures related to this borehole and fault. To close this fault, it was filled with concrete and rock in one-meter thickness, and then it was grouted with mixed cement.

FIGURE 5. BORING A MANHOLE OVER THE CREST, C1 CROSSED THE FAULT THROUGH THE FOUNDATION

In the fourth zone, half of the drilled boreholes had disclosed a permeability of 10^{-3} cm/s during insitu testing. In C27, one of the most permeable boreholes, a manhole was bored, and met an old Qanat. To close the Qanat flow path, it was filled with concrete and rock in one-meter thickness, and then it was grouted with mixed cement. This method is, also, was used to close C1 (see Fig. 5).
