Conference Paper, Published Version

## **Levee Failure Due to Piping: A Full-Scale Experiment**

## Levee Failure Due to Piping: A Full-Scale Experiment

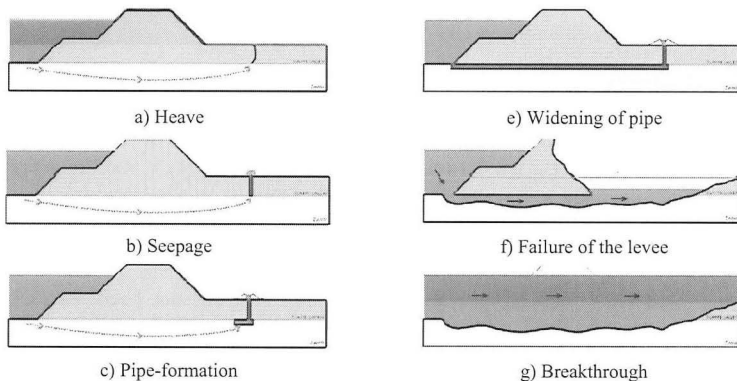
d) Retrograde erosion

**Figure 1a-g. Process of retrograde erosion**

Piping, the process of retrograde internal erosion in sandy layers underneath clay levees, is considered one of the most dominant failure mechanisms of levees in the Netherlands (VNK1, 2005). The process starts with heave and cracking of the soft soil top layer at the land side of the levee, caused by high water pressures which are easily transferred through the permeable sand layer (Figure 1a-b). The cracks in the top soft soil layer allow for seepage. In case the water level difference between river and land side (the hydraulic head) is large enough, sand grains may be transported along with the water flow, thereby creating a pipe underneath the levee (Figure 1c-d). Continuing erosion may finally lead to failure of the levee and breakthrough (Figure 1e-g).

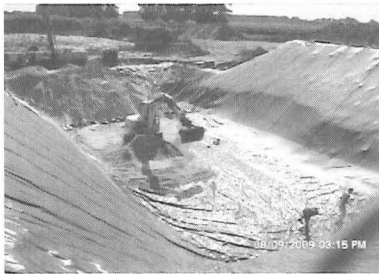
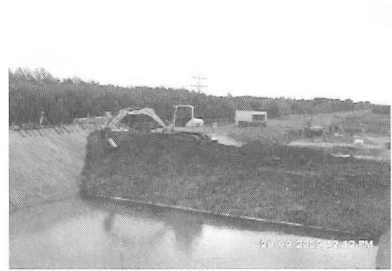
**Figure 4: Filling the basin with sand and build-up of the clay levee**

The full-scale experiment was performed at the location of the IJkdijk in the Northeast of the Netherlands. Two large basins were created (size 30x15 m), which were filled with two different sands. The sands had a  $d_{50}$  of 150  $\mu\text{m}$  and 200  $\mu\text{m}$  and are denoted in the following text as 'fine sand' and 'coarse sand' respectively. The dry sand was applied in layers and densified until a relative density of at least 50% was achieved. After densification, the sand layer was saturated. A clay levee with a height of 3.5 m and slopes of 1:2 was built on top of the sand by densification of smaller clay lumps. A levee with a seepage length of 15 m was obtained.

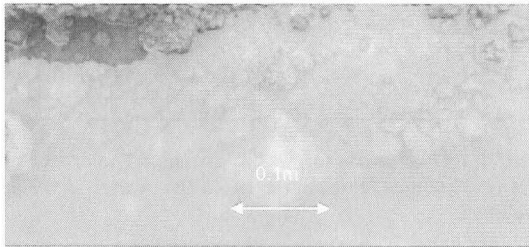
**Figure 5. A sand trace**

The retrograde erosion manifested itself in different forms. Sand traces occurred in an early stage of the experiment (first observed at hydraulic head of 0.10 m to 1.4 m depending on the experiment (gradients of 0.007 – 0.09)). Sand traces are spots of sand, which suddenly appear without any visual movement of sand. No boiling of sand or sand craters were observed. The amount of transported sand is limited (spots are generally around 0.1-0.3 m in diameter with barely any height). Although no sand transport is visible, the sand traces may slightly increase in size, and fines were found to be in suspension near these locations. The sand traces do not notably affect the water pressures and are present at various locations along the downstream toe.

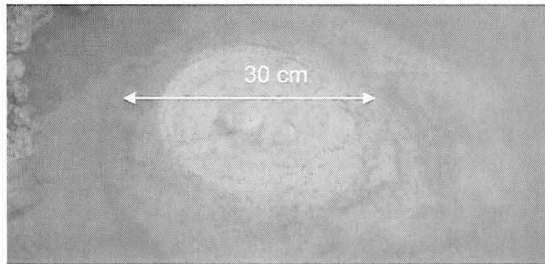
Figure 6. Sand transporting sand boil (sand crater)

After increase of hydraulic head until 1.6-2.1 m (gradients of 0.11-0.14), depending on the experiment, wells with boiling sand may occur. These wells do lift the sand grains in (small) sand craters, but sand grains are not deposited at or over the rim of the sand crater. A short channel must have been present as the pore pressure meters located near the downstream toe indicated a decrease of water pressure near these wells.

In some cases the wells with boiling sand started to deposit sand over the rim of the crater, after increase of hydraulic head. It also occurred that new wells were created that immediately started to transport sand. In experiment 1 and 3 several well locations were present along the toe of the levee, but in experiment 2 only one well transported sand. It is striking that sand transport at this stage does not cease. Although quantities were limited (approx 0.5 kg/hr) the transport of sand continued at a more or less stable pace.

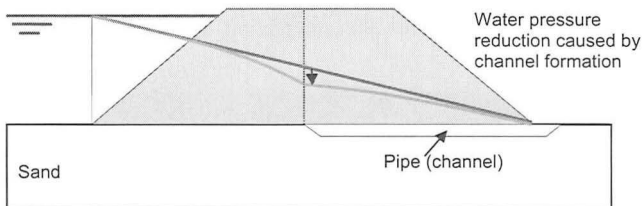
Figure 7. Sketch Local decrease of water pressure (pale blue line) caused by retrograde piping channels compared to initial water level before channel formation (blue line).

The channel formation was monitored by the water pressure measurements. A local decrease of water pressure is an indication for channel formation (Figure 7).

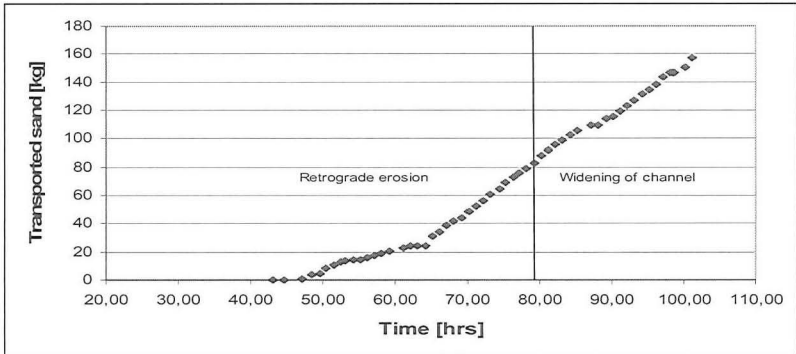
Figure 8: Cumulative amount of transported sand in experiment 3

The start of this process cannot be observed in the behavior of the sand boils, as the amount of transported sand does not change initially (Figure 8). The measurement data stops when the widening of the channel reaches the downstream side. It can be seen that no significant increase in transported sand occurs in the transition from retrograde erosion to widening of the channel.

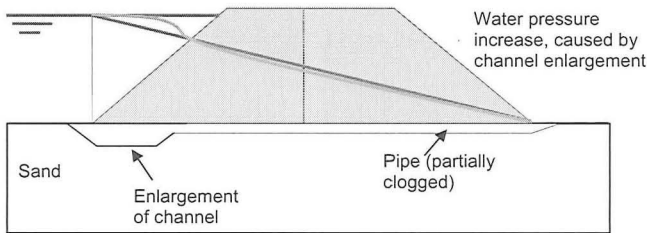
Figure 9: Sketch Change of water level in the sand as a result of channel enlargement (red line) compared to initial water level before channel formation (blue line)

However, the widening process can be observed in the water pressure measurements, as an increase of pressure is observed, caused by the low hydraulic resistance of the enlarged channel, spreading from the upstream side towards the downstream side (figure 9).

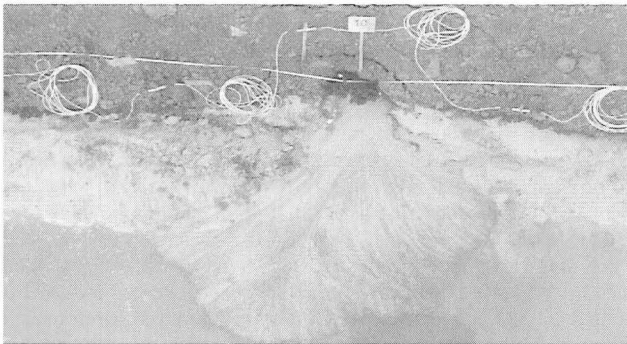
Figure 10: Widening of channel has reached the downstream side, resulting in an increase of sand transport, in this case followed by deformation

A change in the amount of sand transport is observed as soon as the widening process reaches the downstream side: a connection is created between the up- and downstream side of the levee. At this point two things may happen: either the flow and sand transport increase further until the levee fails (which happened in experiments 1 and 3), or the levee deforms (which happened in experiments 2 and 4), thereby partially closing the channel, causing the sand transport to decrease (figure 10). Cracks appear

in the levee. In the latter case, it is only a matter of time until the connection between the upstream and downstream side has re-established and sand transport and flow increase again. Several phases of reconnection and deformation may take place before the levee fails.

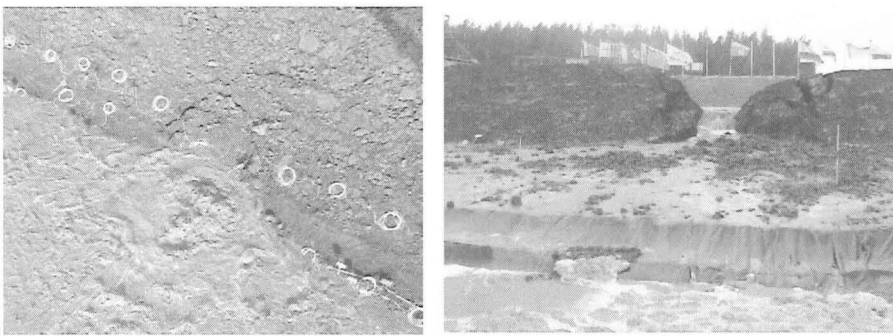
**Figure 11: Increase of sand and water transport (mud flow)(left) leading to failure and breakthrough of the levee (right)**

In all experiments failure of the levee took place. The process of failure starts with a large increase of turbulent flow and sand transport (mud flow), affecting a large area. Cracks appear in the levee and parts of the toe of the levee are eroded. Due to the large discharge, the water level at the upstream side could not be maintained, a drop of at least 0.60 m was observed in all experiments. In reality this drop of water level will not occur, thereby possibly even further increasing the damage to the levee.

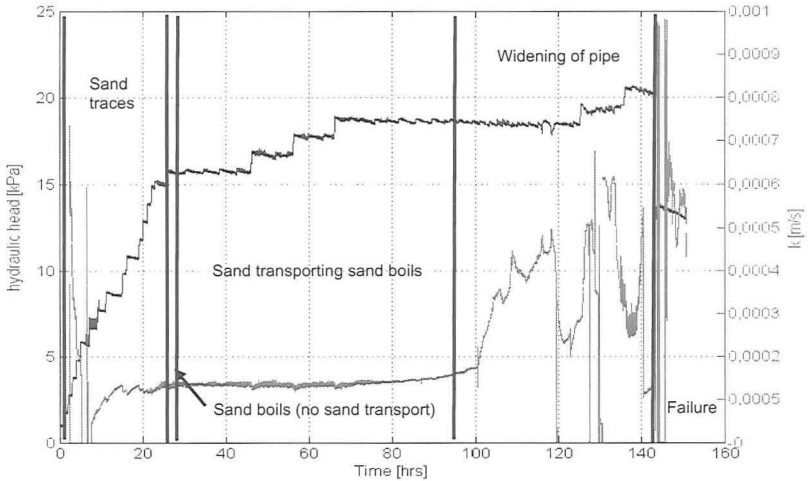
Figure 12. Experiment 2, Relation between processes, time, bulk permeability and hydraulic head

In figure 12 the named processes are related to the applied hydraulic head and the calculated bulk permeability for experiment 2. In table 3 the relation between observed processes, time and hydraulic head is given for test 1-3. An important finding, which results from both figure 12 and table 3, is the fact that the critical head is (almost) reached as soon as sand transporting wells appear. In the experiments the head is increased due to time constraints (after 45, 55 and 65 hours in the test shown in Figure 12), but it is expected that finally the channel would have reached the upstream side at the level at which the first sand transporting wells were observed. As this is uncertain, the critical head is expected to be somewhere between 1.6 and 1.9 m for experiment 2 (gradients 0.11-0.13). The critical head is therefore defined as the head at which it is expected that the channel will reach the upstream side. For the three tests the critical head is estimated to be 2.3, 1.75 and 2.1 m respectively.

It was expected that as soon as the channel reaches the upstream side, the flow and sand transport would increase significantly, quickly followed by failure of the levee. In figure 12 and table 3 it can be seen that the time necessary for the widening process can take up to a few days, which is longer than expected. The process can be well monitored using pore pressure transducers, but in a field situation, without any monitoring equipment, there may be little warning for the failure, as the situation may suddenly change from small sand boils to mud flows and failure. It would therefore be recommended to take immediate measures as soon as sand boils appear.
