## **Arizona State Government Bridge Scour Program - A Practitioner's Perspective**

# ARIZONA STATE GOVERNMENT BRIDGE SCOUR PROGRAM – A PRACTITIONER’S PERSPECTIVE

Keywords: Arizona; Scour; Countermeasure

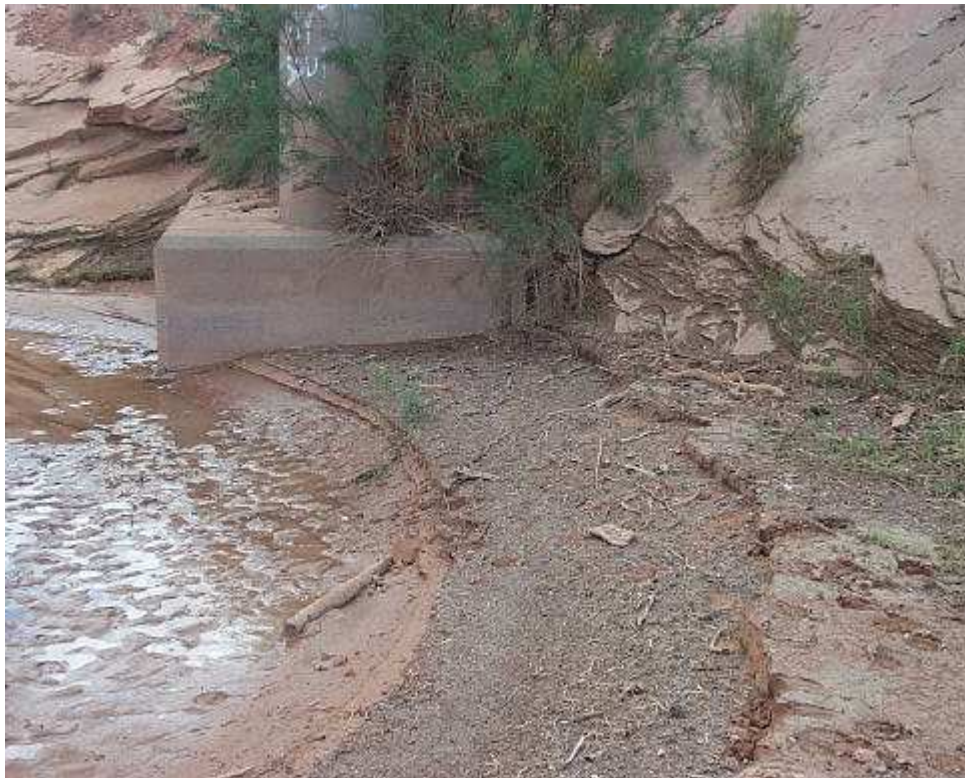
Figure 1 The scoured spread footing foundation prior to installing the countermeasure

This site is located towards the northeast part of the state. The spread footing foundation was initially thought to be on bedrock. However, Figure 1 illustrates that recent flash floods have caused the material under the footings to erode. There is a ten percent drop of the streambed across the bridge. A follow up geotechnical investigation indicated that the underlying Lukachukai Sandstone

formation is composed of sub-rounded, light brown clear quartz, very fine grained and well sorted. The formation can readily deteriorate under the following conditions:

1. Leaching of Calcium significantly reduces the inter-particle bonding strength of sandstone
2. Permeable sandstone is susceptible to degradation from volume changes of freezing water.

The trough type deposit is calcareous cemented, with an unconfined compressive strength ranging from 2800 to 4600 psi and the unit weight ranged from 118 to 121 pcf.

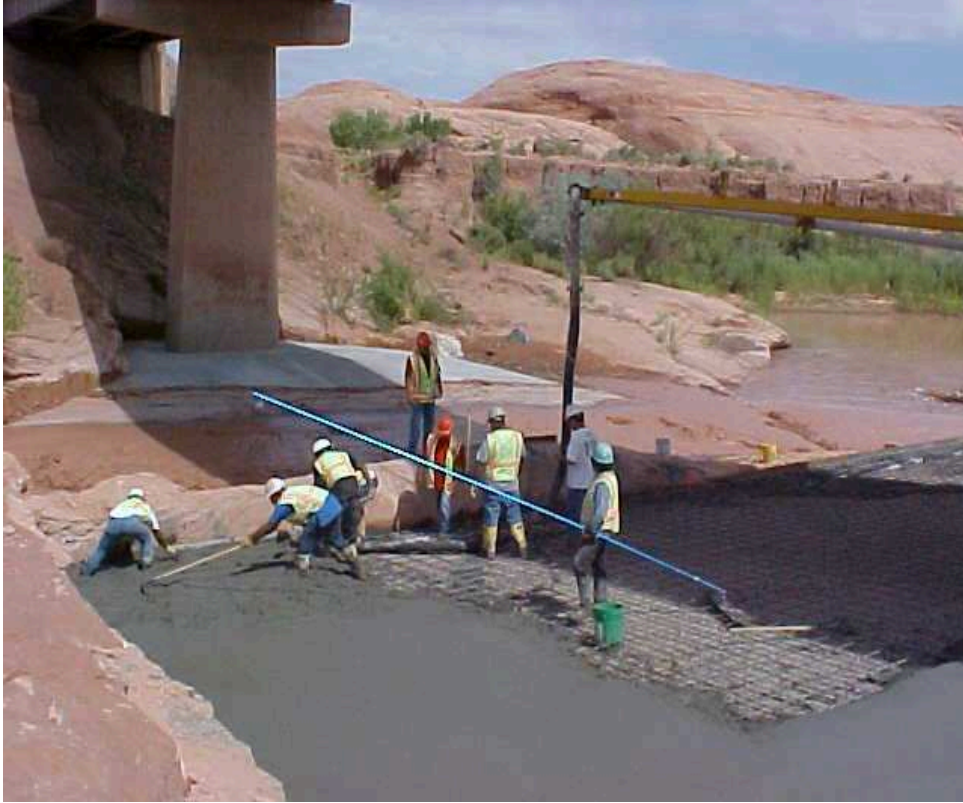
Figure 2 The spread footing foundation after during the installation of the countermeasure

Based on these considerations, a reinforced concrete apron with cut off walls was proposed around each spread footing as the countermeasure. The installation of the reinforced concrete armor around the pier is depicted in Figure 2. It may be noted that the raised armor is anchored to the existing sandstone formation with cut off walls embedded into the sandstone sufficiently away from the footings of the pier.
