### *The 2015 Chileno Valley glacial lake outburst flood, Patagonia*

*Published in:*  
Geomorphology

## The 2015 Chileno Valley glacial lake outburst flood, Patagonia

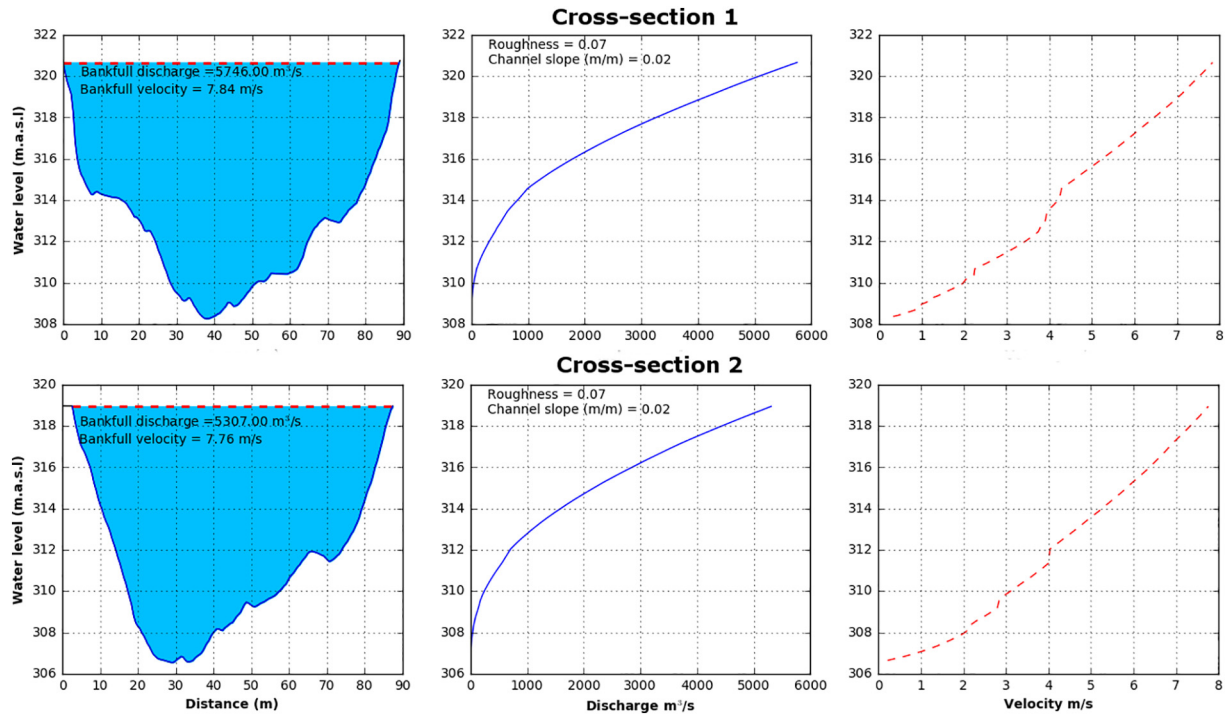
Fig. 3. Indirect measurements of GLOF discharge and velocity for two channel cross sections located in the Chileno Valley (see Fig. 6).

The indirect measurements of GLOF  $Q$  and  $V$  close to the location of the initial breach are shown in Fig. 3. Due to the close proximity of cross sections 1 and 2, estimations of bankfull  $Q$  and  $V$  are similar, ranging between  $5307$  and  $5746 \text{ m}^3 \text{ s}^{-1}$  and  $7.76$ – $7.84 \text{ m s}^{-1}$ , respectively. The accuracy of these estimations is difficult to assess primarily due to uncertainties related to the use of Manning's roughness coefficients. For example, in this case, we only accounted for flood energy losses in relation to cross-channel grain roughness. However, in reality, further energy losses would have occurred due to turbulence, sediment transport and channel expansion through erosion. This underestimation of total energy losses means that  $Q$  estimations using Manning's roughness coefficients are often overestimated (Cenderelli and Wohl, 2001; Lumbroso and Gaume, 2012). Furthermore, additional uncertainties arise related to the limitations of manual determination of roughness coefficients from photography and satellite imagery and the use of a static roughness value. In regards to the latter point, the river channel at cross sections 1 and 2 both widened and deepened during the GLOF event, altering the cross-channel grain roughness. As a consequence of the uncertainties discussed above, the indirect measurements of  $Q$  and  $V$  are seen as first order approximations.

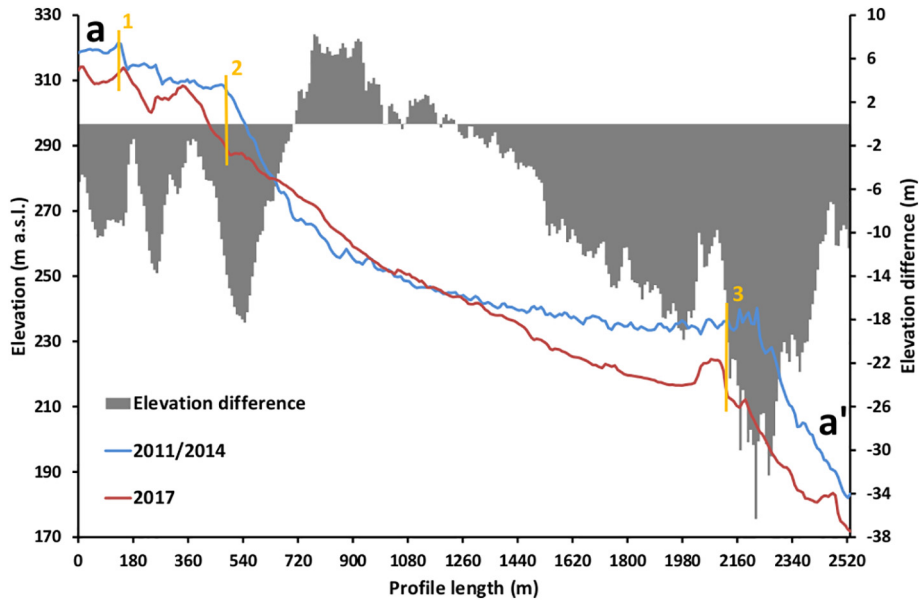
Fig. 5. Surface elevation changes along a longitudinal cross profile of the Chileno Valley (a-a' – see Fig. 4c).

The impacts of the Lake Chileno GLOF on the valley below are visually illustrated in Figs. 4–7. Impounded by the ridge of the overdeepened deglaciated basin of Chileno Glacier, Lake Chileno was initially drained via an overflow outlet located ~550 m upstream of an incised LIA moraine. Pre-GLOF, this overflow channel met two constraining points along the proximal channel (see Fig. 4a), where it dropped in elevation by ~6 m and ~48 m along reaches of 50 m and 230 m, respectively.

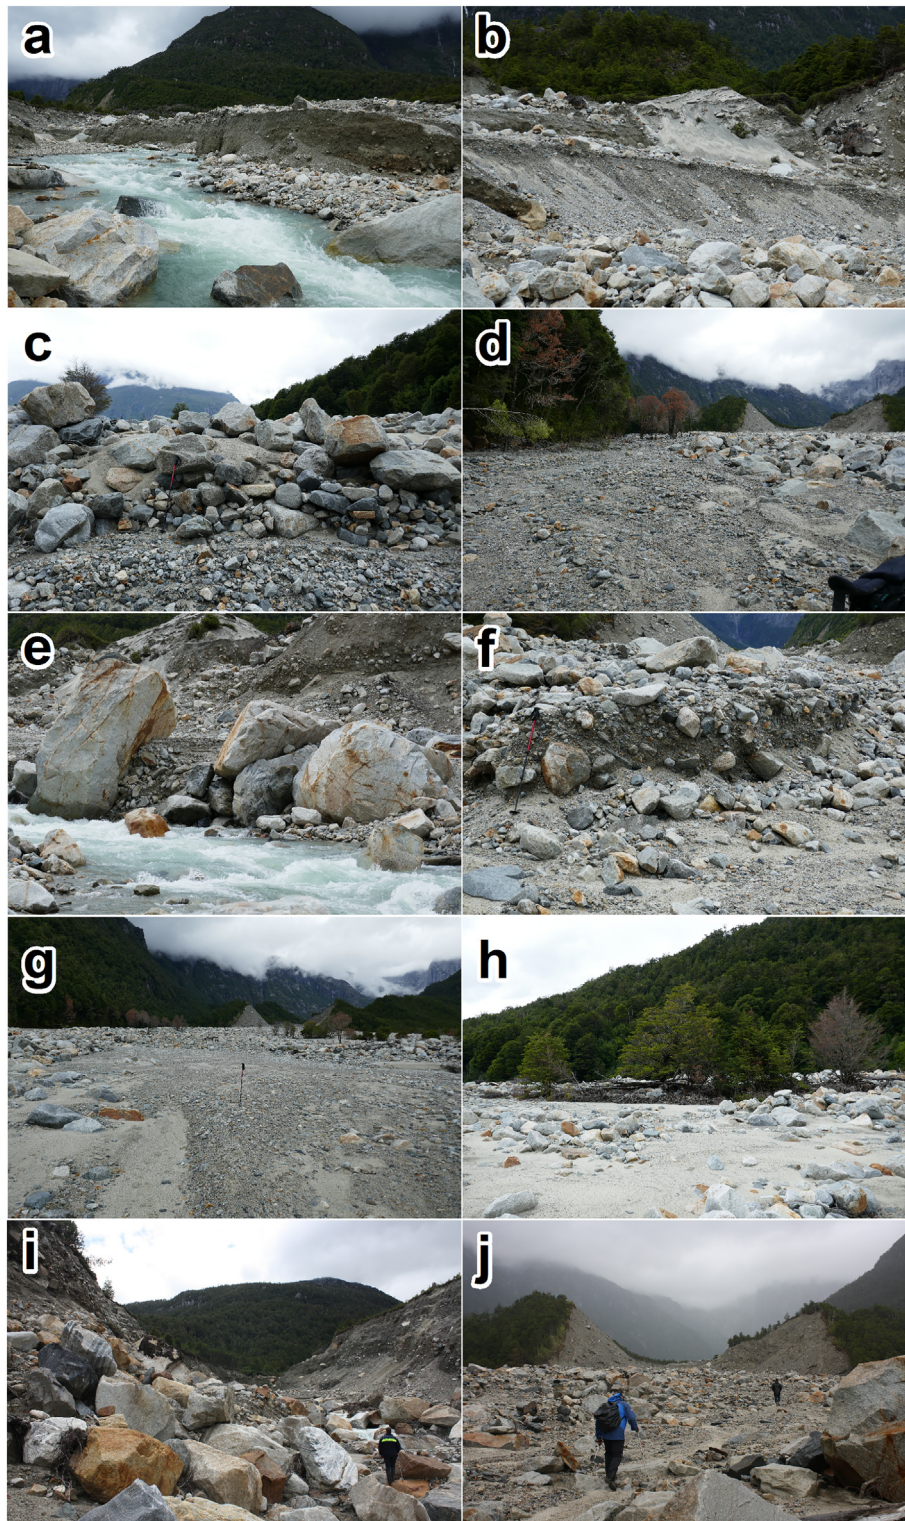
**Fig. 7.** Photographs taken during a field campaign in February 2017. Images illustrate the geomorphic impacts of the GLOF and the sedimentology of the floodplain. See [Table 3](#) for details.

6. Gravel splays (Fig. 7g)	Distal zone.	Units comprising large clasts up to 1.5 m b-axis, SR-SA. Form boulder runs. Units of small clasts form within-channel gravel splays; fine gravel matrix. Clasts up to 20 cm b-axis.	Clasts with little matrix. Imbricated.	Fluvial deposits. Form boulder berms.

7. Sand units (Fig. 7h)	Far distal zone.	Isolated clasts and clast runs.	sG. Found as sand/gravel sheets and also in lee of large boulders.	Associated with water floods during waning of GLOF flow.

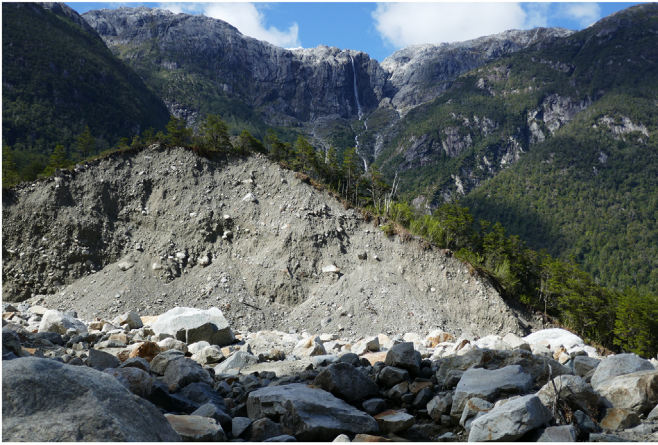
**Fig. 8.** Field photography captured in February 2017 illustrating the post-GLOF erosion of the LIA moraine crest (see Fig. 6 for location). The crest of the LIA moraine is up to 35 m high and composed of a series of stacked sedimentary units made of matrix-supported and poorly-sorted bouldery diamict. The units are from 1 to 2 m in thickness and dip downvalley at angles of up to 10°. Clasts are mainly subrounded to sub-angular and blocky, and up to 2 m in b-axis.
