Ireneusz Malik*, Małgorzata Wistuba*, Agnieszka Czajka*,
Katarzyna Łuszczczyńska*, Stanisław Czaja*

The destruction of natural river reaches due to improper land development - an example of the valleys of Czadeczka and Krężelka rivers (Beskid Śląski Mts)¹

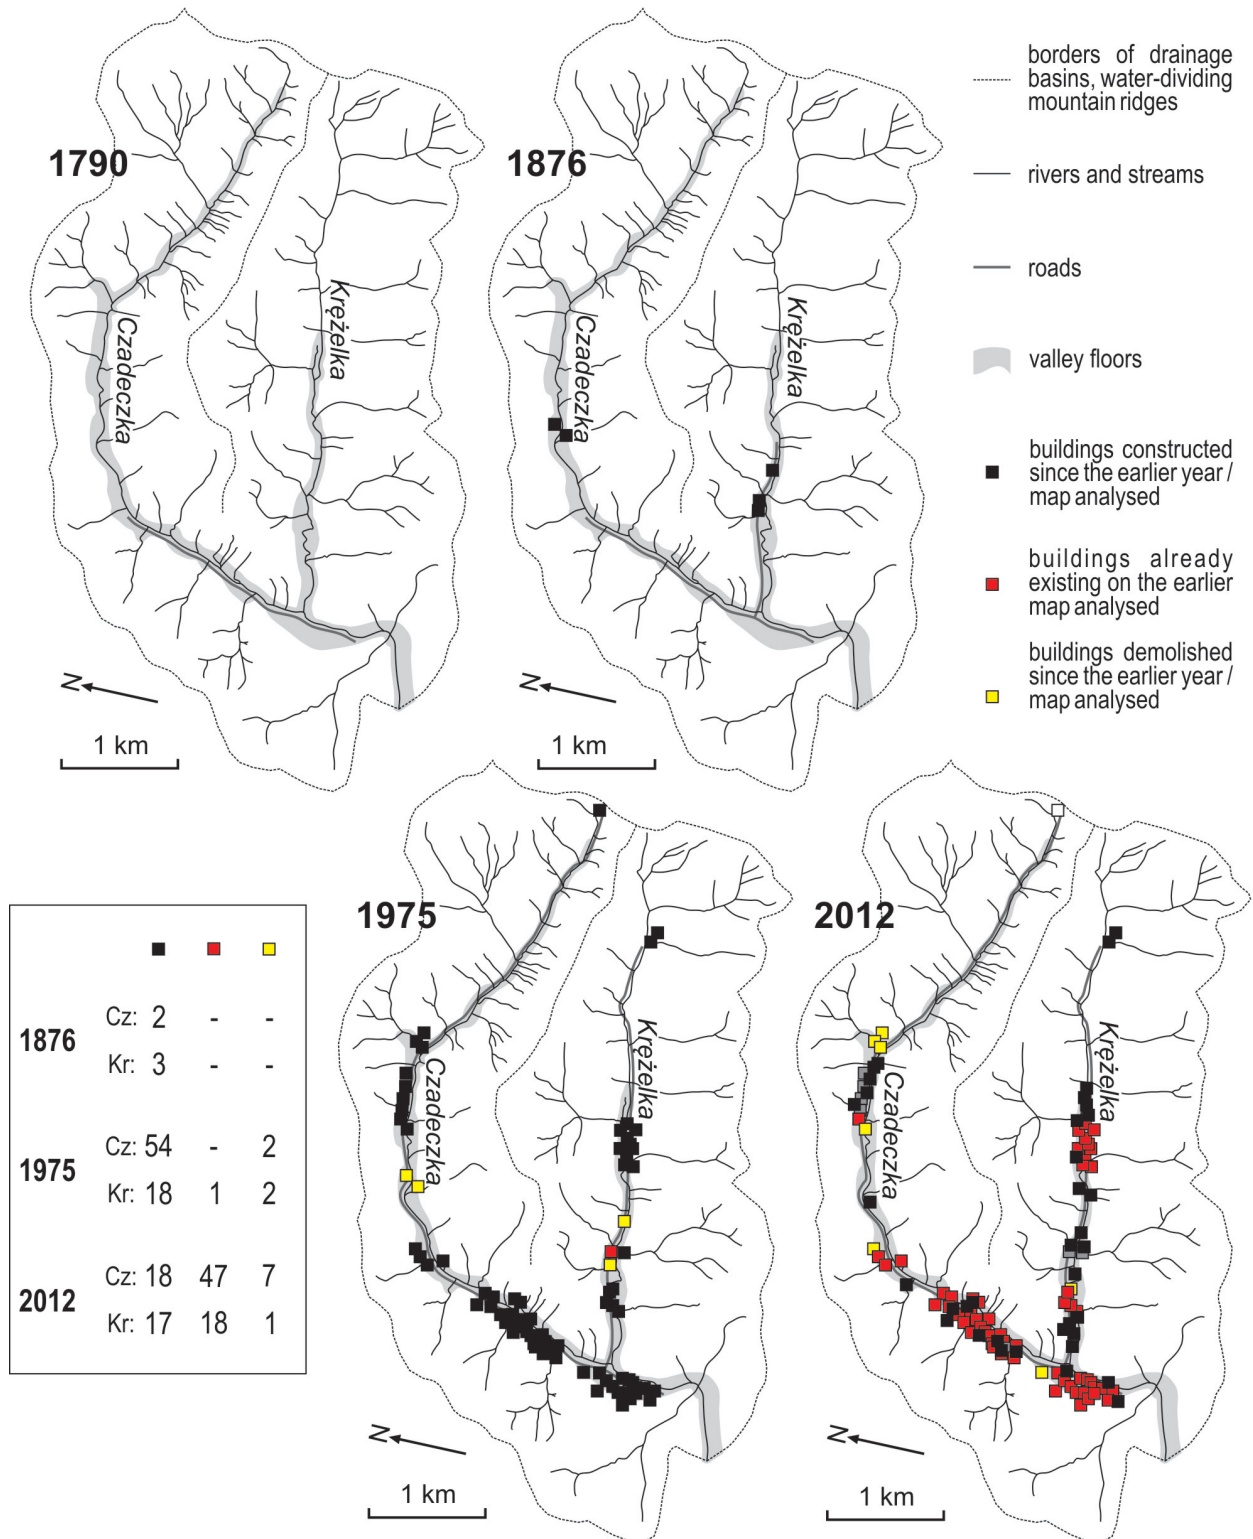
Fig. 1. Changes in the number of buildings located on the valley floors of the Czadeczka and the Krężelka (based on the analysis of maps from 1790, 1876, 1975, and 2012).

On the 1790 map, no buildings were found on the valley floors of the Czadeczka and Krężelka rivers. The analysis of a map from 1876 revealed that between 1790 and 1876, five buildings were constructed on valley floors (Fig. 1). Significant settlement of the studied valley floors occurred in 1876–1975. At this time, as many as 72 buildings were constructed on the studied valley floors, 54 of which were in the Czadeczka valley and 18 in the Krężelka valley. On the other hand, from the 2012 map, it is clear that since 1975, 35 more buildings were constructed on the valley floors of the studied rivers. During these 37 years, buildings were constructed mainly in areas formerly inhabited and developed (Fig. 1). Conducted analysis suggests that buildings on the valley floors of the Czadeczka and Krężelka were constructed mainly in the 20th century. The upper river reaches remained uninhabited. Houses were built in the middle and the lower sections of the valleys. Concrete and stone embankments are found along 780 m of the Czadeczka channel and 360 m of the Krężelka channel (Fig. 2). In the channel of the Czadeczka river, more check dams were found (25) than those found in the channel of Krężelka river (4 only) (Figs. 2, 3). Most of the artificial hydraulic structures were found in the Czadeczka valley. Check dams and concrete/stone embankments were found near building locations. This is particularly clear in the Czadeczka valley. In case of the Krężelka river, buildings are more dispersed along the valley floor. Check dams were found only in the outlet section of the channel. It is, however, clear that the components of channel regulation were found mostly in the areas where buildings were located.

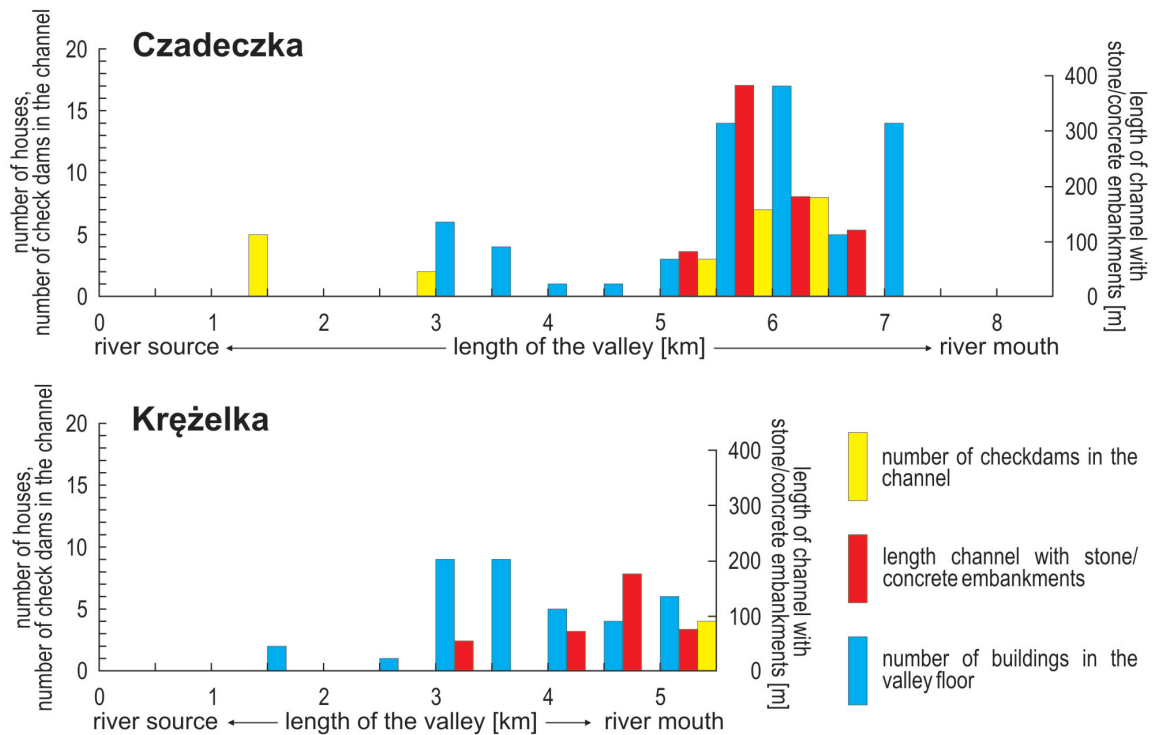
Fig. 2. Comparison of the number of buildings on the valley floors and the occurrence of concrete or stone embankments and check dams in the channels of the Czadeczka and Krężelka rivers divided into 500-m long sections (based on a field survey conducted in 2014).

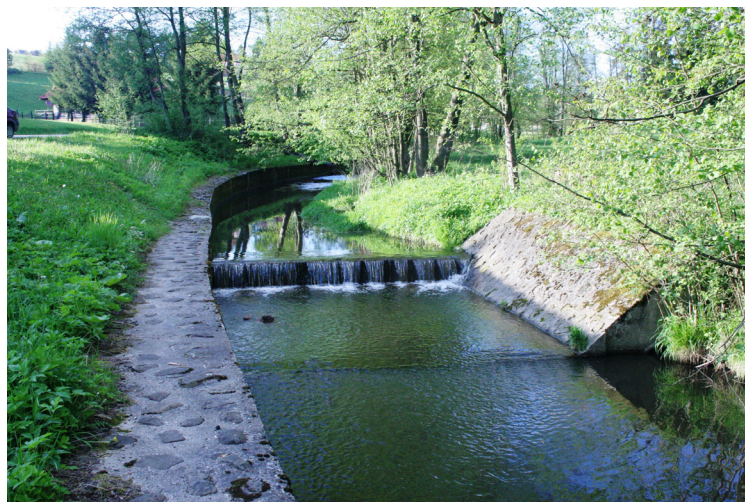
Fig. 3. Concrete embankment and concrete check dam in the Czadeczka channel.

Local inhabitants bring pressure to bear on the local authorities to regulate both rivers. First, channel banks are reinforced with stone blocks or concrete to prevent lateral erosion and then channelised. Next, after the channel is straightened, heavy bed erosion occurs. Thus, the channel bed is concreted over and check dams are constructed against the incision.

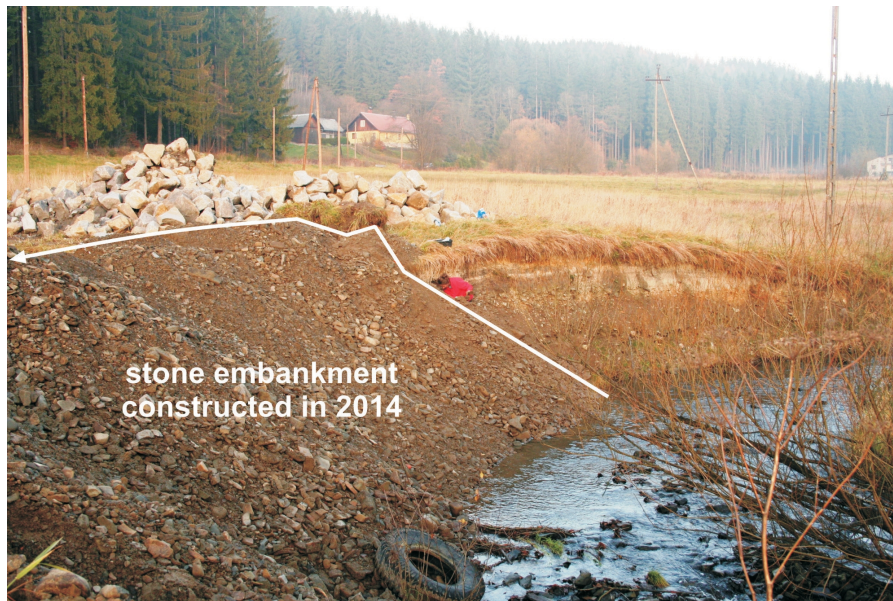
Fig. 4. Ongoing construction of stone embankment in the Krężelka channel in 2014.

The process of channel regulation and reinforcement is still being continued in the study area. In October 2014, we observed works conducted to prevent lateral erosion in the Krężelka channel. A stone embankment was constructed close to the area where a

house was going to be built (Fig. 4). Furthermore, gradual building development of the valleys will cause further regulation of the river channels. Results achieved indicate that the destruction of the natural river reaches results from the issuance of construction permits in the area of the Czadeczka and Krężelka valley floors
