Six-year Trial of an HV Overhead Line Wide-bodied Composite Insulator

ABSTRACT

Index Terms — composite insulators, wide-bodied, cross-arm, asset management, silicone rubber, NCI, field trial, leakage current, aging, algae

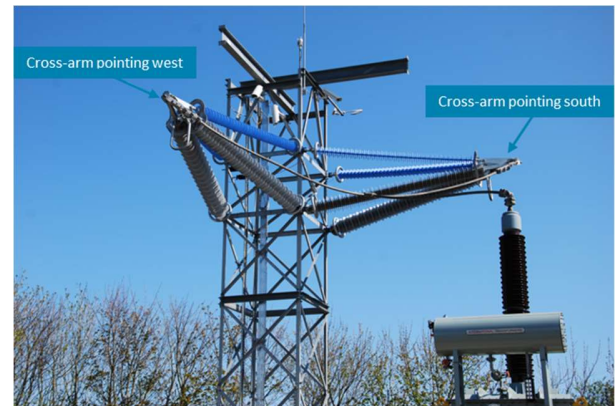
Figure 2. Photograph of the trial site, showing two cross-arms and the high voltage bushing. The cross-arm on the right points due south (along the coastline) and the other points west (away from the coastline).

The trial site was located 3 km from the coast in the east of Scotland. The cross-arms were installed on a bespoke lattice tower and oriented at 90° from each other (one pointing south, parallel to the coast, and one pointing west, away from the coast). They were installed perpendicular to each other to investigate the impact of orientation on their performance. A dedicated 230 kV single-phase test transformer energized the two cross-arms (voltage to ground of a 400 kV phase-to-phase system). Each of the four insulators comprising each cross-arm were electrically insulated from the tower so that leakage currents to ground could be continually monitored, to an accuracy better than 2%, through independent $20 \text{ k}\Omega$ resistors. Instrumentation also captured real-time weather conditions on the tower top to enable correlation of electrical behavior with ambient conditions. Solar radiation, rainfall, wind speed and direction, temperature, visibility and relative humidity (RH) were measured. Of the cameras overlooking the cross-arms: One gave a view of one entire cross-arm; another gave a continuous bird’s-eye view of a compression insulator’s top surface. The latter allowed surface moisture movement to be monitored. The system wirelessly transmitted a summary of data every five minutes for analysis in Manchester. Details of the test site instrumentation are given in [12, 13]. A photograph of the installation is shown in Figure 2, and a plan of the local arrangement in Figure 3. The nomenclature for each insulating member is given in Figure 4.

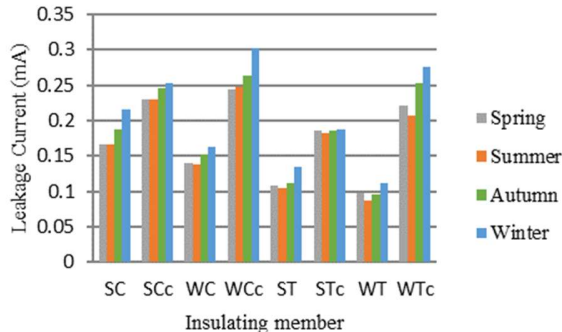
Figure 7. Seasonal variation in leakage currents averaged over three-month periods between 2013 and 2015. A restricted period of three years is compared so that the surface condition is not changed too much within the period considered.

Within each year there is a clear seasonal variation of leakage current, as would be expected in this north-European coastal climate, summarized in Figure 7. This is due to increased levels of moisture (rain and fog) in winter, and higher temperatures and increased solar radiation intensity and duration in summer. Averaged over all insulators, and taking spring as reference, summer currents are reduced by 5.7%, autumn increased by 5.1% and winter increased by 18.1%. Equation (1) can thus be modified so that:

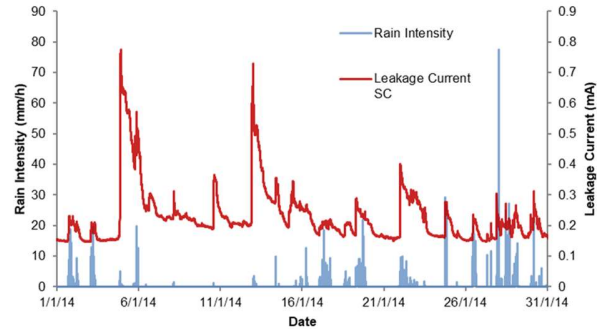
Figure 8. Wind roses showing how rainfall and current on tension member WC varied with wind direction in 2014, and a graph illustrating short-term variation of current and rainfall on SC in January 2014.

Figure 8 illustrates the variation of leakage current on one compression insulator, WC, with wind direction in 2014. Also shown is the leakage current on one insulator over one month with intermittent rain. This illustrates the importance of immediate weather, but also the difficulty in predicting response to rainfall. It is wind direction that controls rainfall in this coastal location; wind from the west, for example, implies no rainfall. The location has a latitude of 57.6° N and so solar radiation is weak, and there is only ~ 7 hours of daylight at the winter solstice. Nearby Aberdeen has an average monthly rainfall of 41 mm, 11 rain days each month, a monthly

The role of moisture on the surface of an insulator is critical in developing a resistive current, which adds to the capacitive ‘dry’ current. This is a complex picture, as illustrated in Figure 8. Laboratory measurements have verified that as the surface becomes conductive, the current magnitude increases and the phase difference to the voltage decreases from $\sim 90^\circ$. Whilst most of the eight insulators behave in a similar way in this trial, one of the commercial tension members showed anomalously high peak currents in wet conditions. No reason for this behavior has yet been identified.

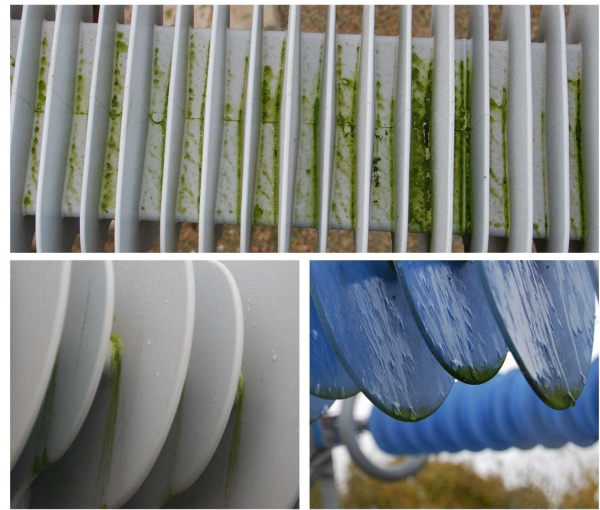
Figure 11. Top: Aerial photo of growth of algae in the central region of the compression element SCc after 35 months in service. Bottom left: the run-off of water from the top horizontal surface down the vertical shed led to a spread of algae. Bottom right: The tension insulator STc can be seen to have accumulated algae on the bottom of the sheds, and also to have lost much of its hydrophobicity.

facing surface (Figure 11). Once established, the growth intensified and spread (Figure 12). The undersides of the wide-bodied insulators remained free of organic pollution throughout, presumably because they remained dry. As time passed, the organic growth spread over a wider region of the top surface. However, organic growth never reached the high voltage end, which remained pristine throughout. Figure 13 shows how the algae spread on the top surface in time.

The insulator is designed so that water runs off the top surface. Figures 11 and 12 show that this leads to algae spreading along the drip-lines down the vertical faces of the wide-bodied insulator sheds. It is evident that the tension insulator above the compression element also has algae growing on the shed surfaces, as seen in Figure 11 after 35 months, and Figure 12 after 56 months.

The photograph of the wet tension element in Figure 11 also illustrates loss of hydrophobicity. The sides of the sheds of the ST insulator that face the sun completely lost hydrophobicity, and on the other side of the sheds, the hydrophobicity was reduced to between HC3 and HC4 on the STRI scale. Loss of hydrophobicity was also seen on WT and WTC. Pollution and algae are seen on these surfaces. The extremities of the lower parts of the insulator sheds can be seen as green in Figure 11.

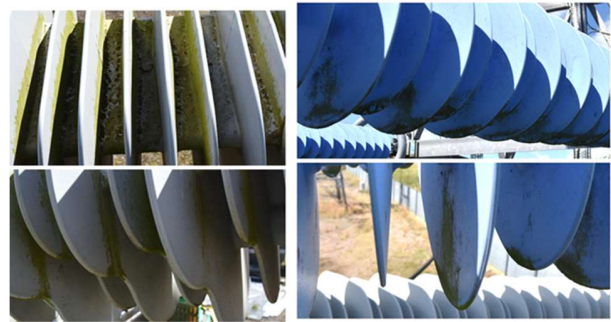
Figure 12. Biological growth after 56 months. Left: on top surface and on sheds of WC insulator. Right: on the WT insulators.
