## Scour Depth Estimation on Abutment With HEC RAS and Some Empirical Equation

*Toe Scour around abutment will be very dangerous and cause loss of stability on the bridge. The case of structure failure on Batang Kalu bridge in Korong Pasa Usang Nagari Kayu Tanam, Padang Pariaman Regency on Monday (10 December 2018) is a clear example of toe scouring. A case study of toe scour was on the Batang Kalu River bridge structure has been carried out. Rainfall data closest to the study location, Kandang Empat Station was used to minimize the errors in the calculation of flood discharge design. Numerical modeling with HEC RAS and scouring estimation with some empiric equation was conducted to predicting scour depth on abutment. Simulation results show scour depth results to an average of 2.731 m and close to the scour depth that occurred in the field (2.83 m). Results showed that the local scouring in the Batang Kalu River bridge structure can be suspected as the influence of the increasing river steepness. Discharge that is triggered by heavy rain with a long duration and increased river flow velocity due to steepness has the potential to create a very intense scouring. Increasing of steep

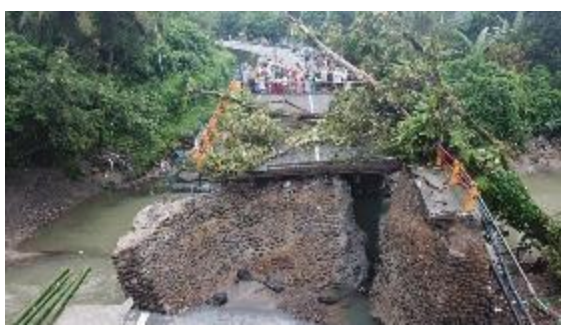
Figure 1. Condition of Batang Kalu Bridge damage caused by massive toe scouring occurred due to increasing flow at the bottom.

can experience scouring caused by flow, because its structure is always directly related to river flow. Abutment of bridges or other water structures can obstruct the flow of rivers causing changes in flow characteristics which in turn will cause local scouring around these buildings. Scouring around the bridge abutment will be very dangerous and cause loss of stability so that the collapse occurs on the bridge. Shear velocity as a component of the mechanism of sediment transport and scouring at the foot of the abutment is strongly influenced by the flow velocity that occurs in the river body, especially at locations near the abutment structure itself. The occurrence of changes in the speed around this location is actually a common thing to happen as a result of contraction of the flow due to narrowing of the channel by the reduced appearance of the river due to the existence of the structure. In general, this condition has been predicted beforehand by the bridge designer and is anticipated by efforts to protect the feet around the bridge abutment. However, changes in the character and pattern of flow due to changes in flow regime by the influence of changes in the river environment are different outside the planning which threatens the stability of the structure under the bridge. The case of the Padang - Bukittinggi transport line cut off due to failure of the structure under the Batang Kalu bridge in Korong Pasa Usang Nagari Kayu Tanam, Padang Pariaman Regency on Monday, December 10<sup>th</sup> 2018 is a clear example of structural failure due to scouring of the feet. (Figure 1).

One of the causes of this structural failure can be hypothesized as the impact of changes in flow character due to disturbance in the environment of the river body, as well as by an increase in flow velocity due to the amount of discharge that occurred at that time. This research will answer the problem formulation to find out how much influence the changes in flow patterns and characteristics of the river environment on the increase in transport and scour mechanism that occurs at the foot of the bridge abutment structure.

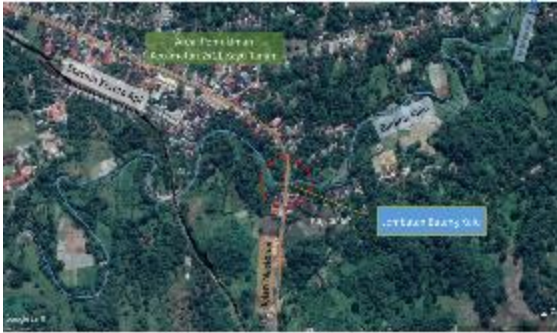
Figure 3. Resesearch Location

The research location is in the Batang Kalu river, Padang Pariaman Regency. At this location there is a bridge connecting Padang - Bukittinggi, as shown in Figure 3. Toe scour is caused by the acceleration of the flow that occurs due to contraction of the flow when passing through the bridge structure. The flow pattern that occurs is influenced by the characteristics of the river profile and discharge that occurs. Determination of discharge is calculated with using the Rational, Hasper and Weduwen methods. The results of the theoretical discharge are validated against field
