# Assessment of Degradations/Defects and Maintenance of Administrative Primary and Secondary School Buildings of the City of Bafoussam, Cameroon

## Abstract

This paper was aimed at assessing the degradations/defects and maintenance of administrative primary and secondary school buildings of the city of Bafoussam, Cameroon.

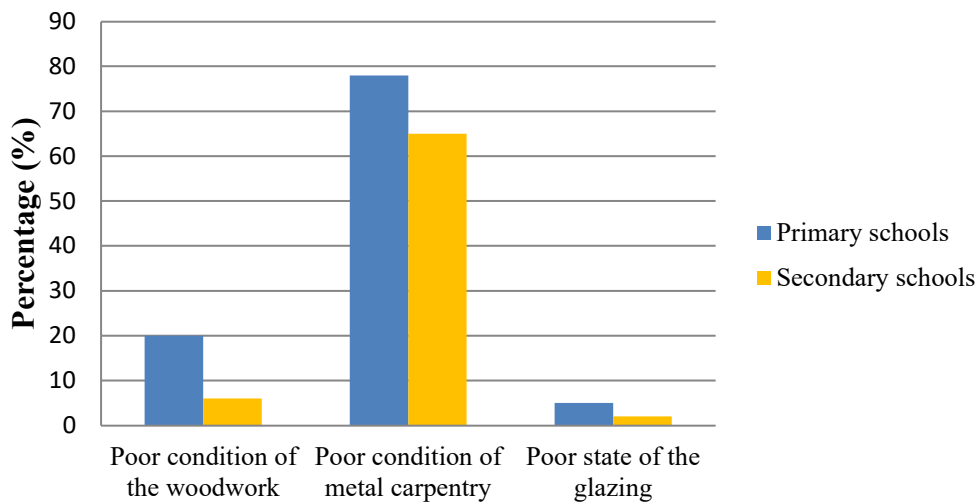
Table 1 and Figure 2 show the state of wood joinery, metal joinery and glazing of public primary and secondary school building in the city of Bafoussam. We observe the very poor condition of the metal carpentry, which is linked to the lack of paint, aging, student stinginess and acts of vandalism. In addition, the wood joinery and the glazing show just a few dilapidations, even if the glazing is rare and sometimes nonexistent. 78% of the primary school buildings of the city of Bafoussam present a very bad state in metallic joinery i.e. 102 of buildings, while 65 % of secondary school buildings are in poor condition with metallic carpentry i.e. 119 buildings. The school buildings of primary schools in the city of Bafoussam are more degraded than those of secondary schools in terms of carpentry (wood carpentry, metal carpentry and glazing).

Figure 2. Histogram of the state of the carpentry of public primary and secondary school buildings in the city of Bafoussam

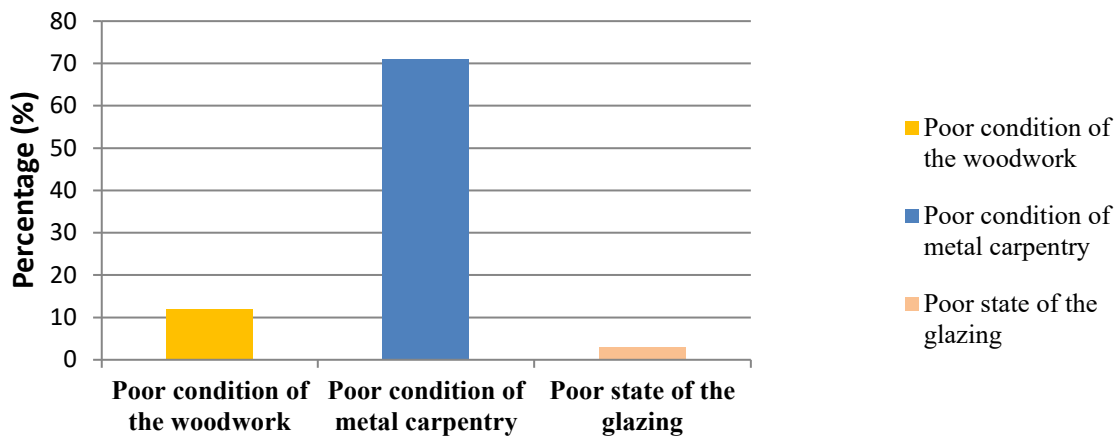
The combined degradations or defects on the wood joinery, the metallic joinery and the glazing of the administrative primary and secondary school buildings of the city of Bafoussam are given in figure 3. Figure 4 illustrates the poor condition of the doors of some school buildings.

Figure 3. Global histogram of the state of the carpentry of public primary and secondary school buildings in the city of Bafoussam

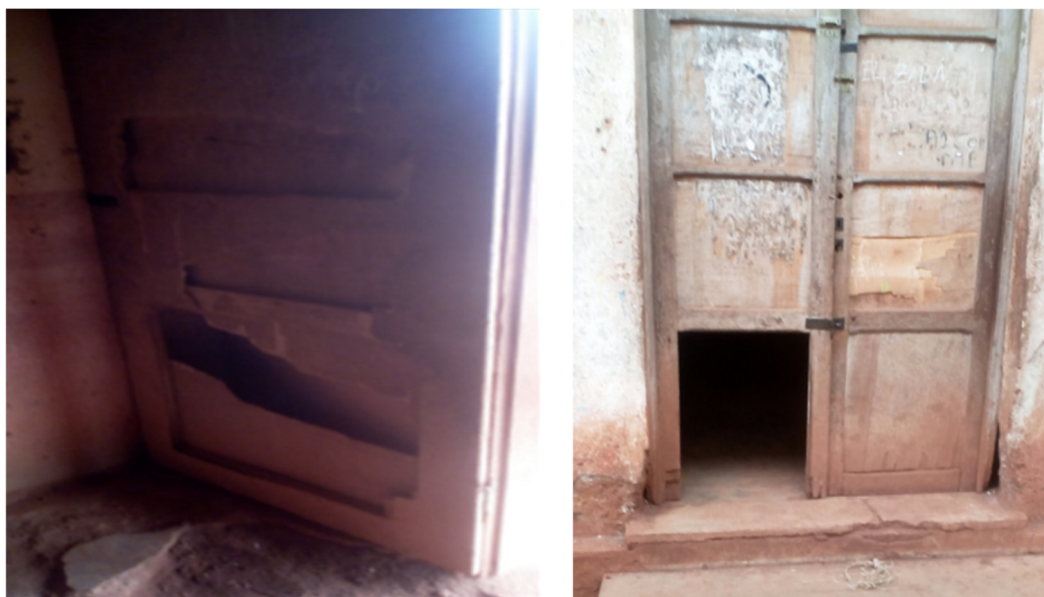
Figure 4. Poor condition of the doors of some school buildings

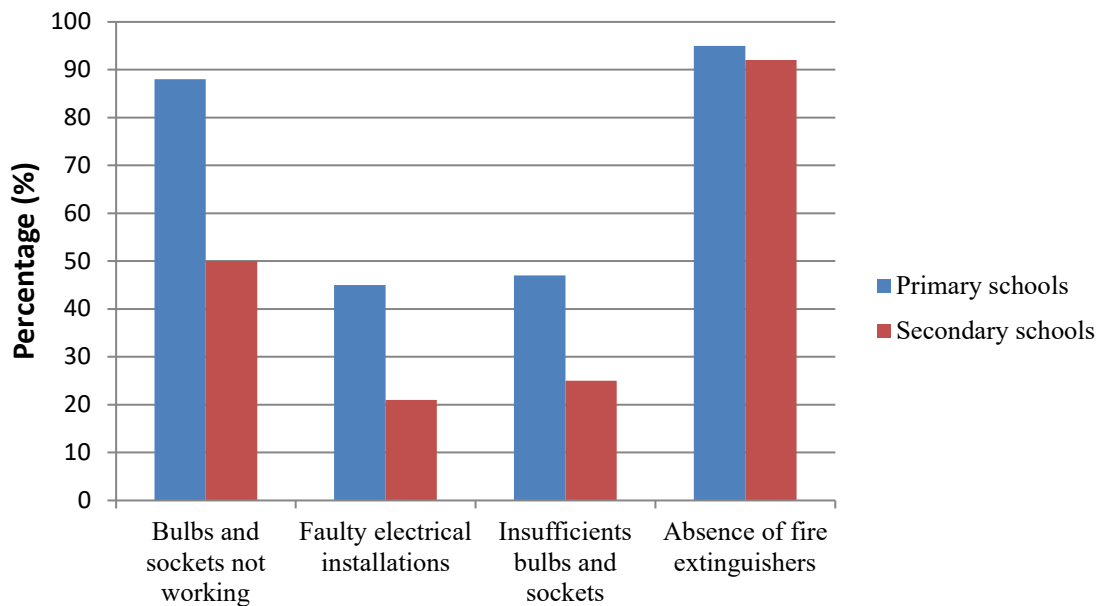
Figure 5. Histogram of the state of electricity and fire safety of public primary and secondary school buildings in the city of Bafoussam

The state of the electricity and fire safety of school buildings in the city of Bafoussam are given in Table 2 and in Figure 5. Figure 6 reports the combined degradations or defects on electricity and fire safety of the administrative buildings of the primary and secondary schools in the city of Bafoussam. In general, the electricity and fire safety of school buildings in the city of Bafoussam are in an deplorable condition. We observe that certain school buildings have non-functional light bulbs and sockets while other school buildings do not even have light bulbs and sockets, jeopardizing the smooth running of school activities, particularly in the specialized classrooms

(laboratories, multimedia rooms, workshops etc.). The often apparent and unprotected electrical installations jeopardize the safety of students and staff. We note the absence of fire extinguishers in the workshop rooms. The poor state of the electricity is due to the use of unskilled labor, the poor quality of the sockets, the poor quality of light bulbs and electrical equipment used and the students' bad behavior.

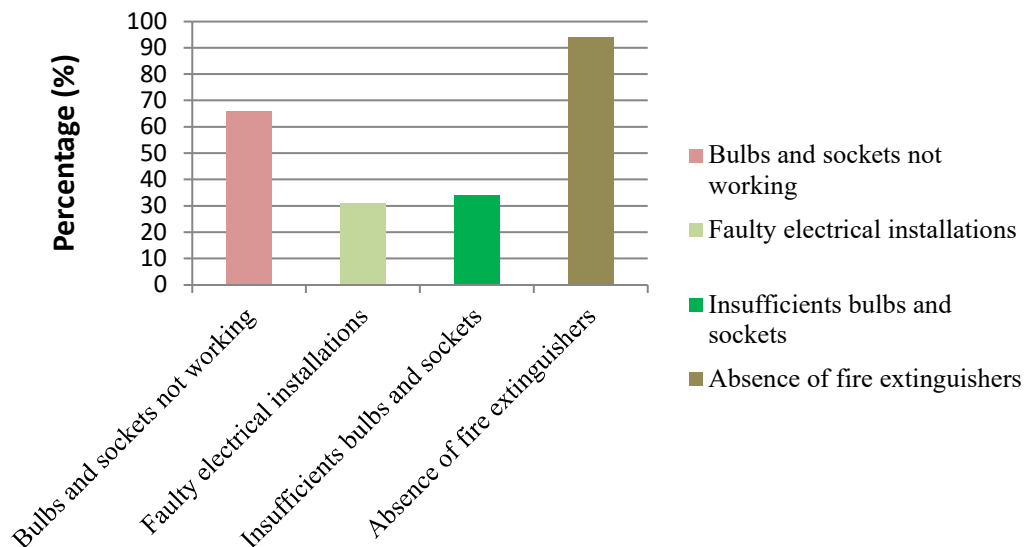
Figure 6.Global histogram of the state of electricity and fire safety of public primary and secondary school buildings in the city of Bafoussam

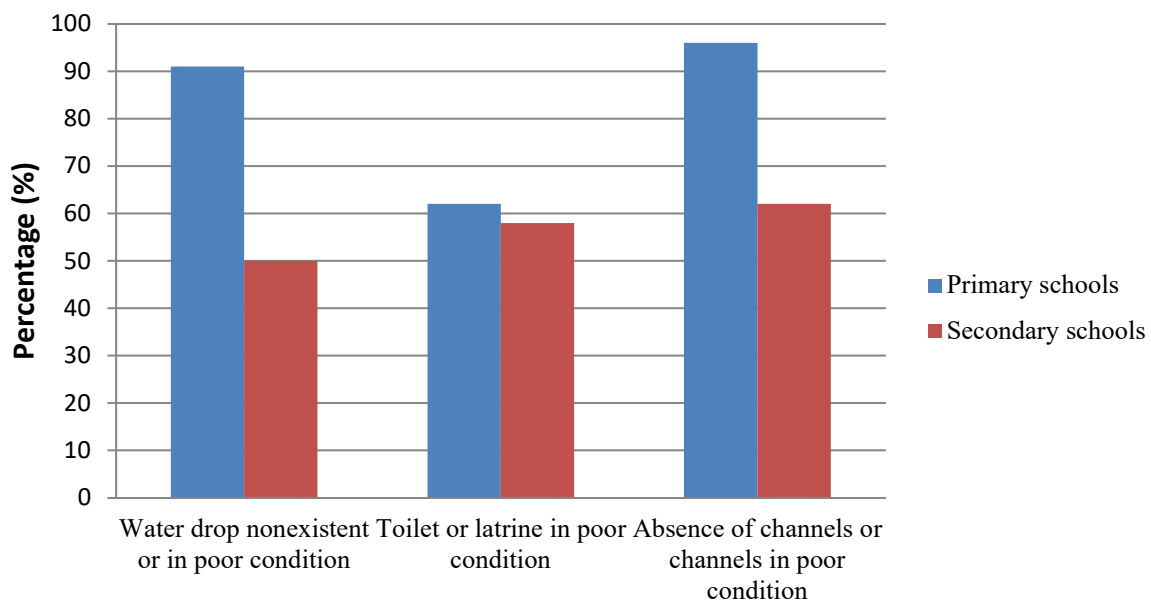
Figure 7. Histogram of the state of sanitation, plumbing and sanitary facilities of public primary and secondary school buildings in the city of Bafoussam

Figure 7 and Table 3 report the state of sanitation, plumbing and sanitation facilities. The combined degradations or defects in the field of sanitation, plumbing and sanitary facilities of administrative buildings of primary and secondary schools in the city of Bafoussam are listed in Figure 8.

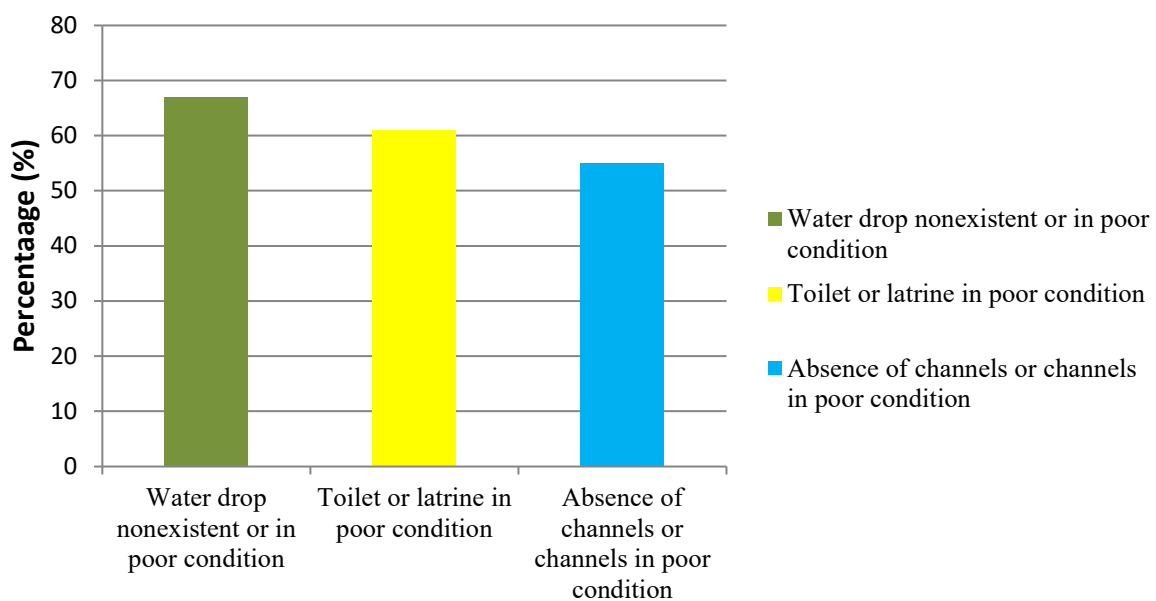
Figure 8. Global histogram of the state of sanitation, plumbing and sanitary facilities of public primary and secondary school buildings in the city of Bafoussam

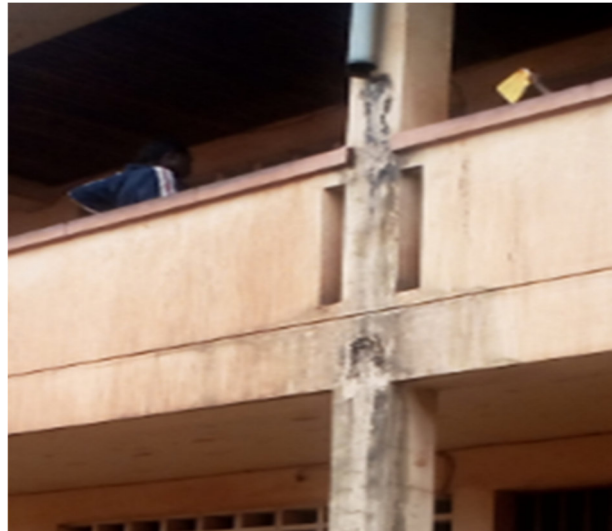
Figure 9. Defective water descent

The nonexistent or poor water downspouts (Figure 9) and the absence or poor condition of the channels (Figure 12) are respectively the cause of the deterioration of the paintwork of the building and the erosion which causes bare foundations and steps.

The state of sanitation is generally poor; the problem of non-functionality of the toilets is due to:

- A very aging water supply network
- Under sizing of the piping that does not take into account population growth
- Absence or low pressure of water
- Misuse of sanitation facilities by students and school staff
- The use of unskilled maintenance labor

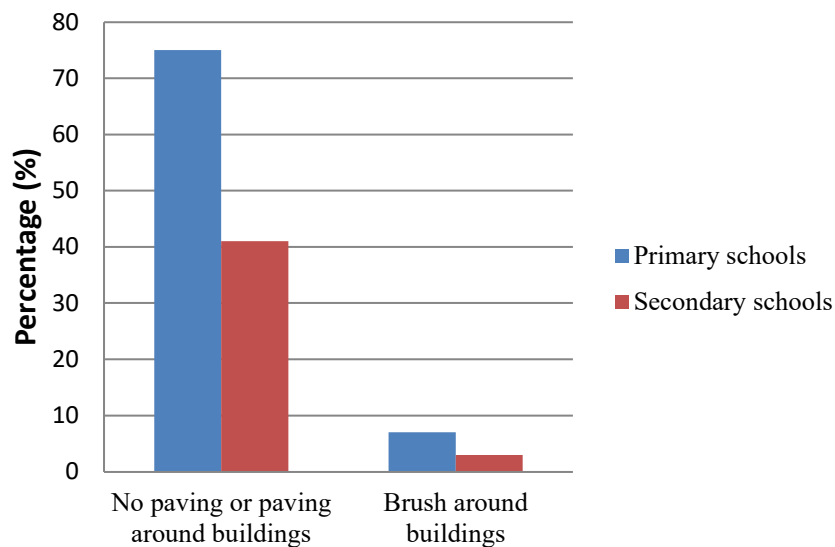
Figure 10. Histogram of the state of the exterior fittings of public primary and secondary school buildings in the city of Bafoussam

Figure 10 and Table 4 show the external appearance of public school buildings for primary and secondary schools in the city of Bafoussam. Figure 11 shows the overall external state.

One of the positive points here is the effectiveness of the cleaning work around the buildings by the students during manual work sessions. This is what explains the absence of brush around school buildings. Furthermore, the absence of paving or paving around the buildings promotes erosion and this is what is causing the bare foundations (Figure 15) of the buildings without channels. The school buildings of primary schools in the city of Bafoussam are more degraded than those of secondary schools in external appearance.

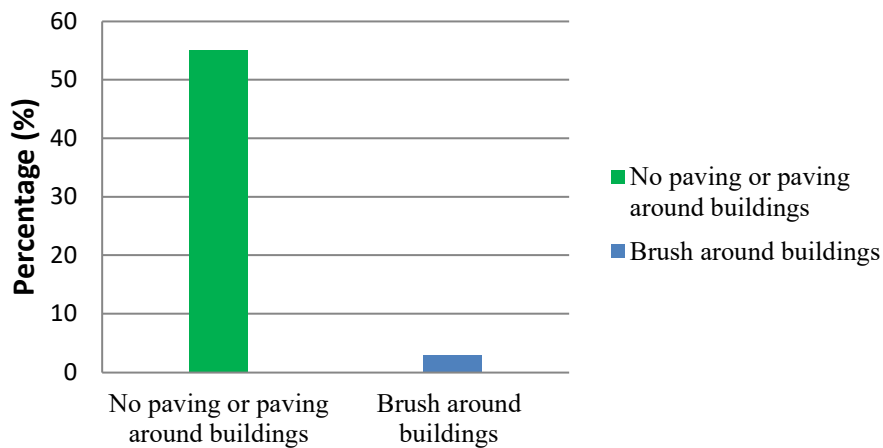
Figure 11. Global histogram of the state of the exterior fittings of public primary and secondary school buildings in the city of Bafoussam

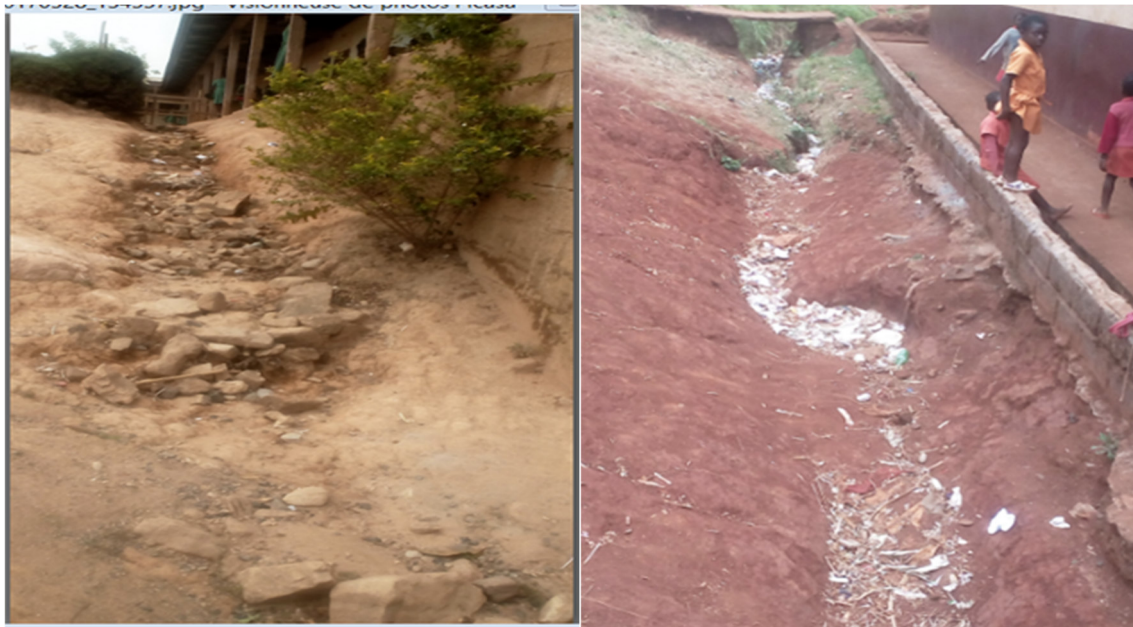
Figure 12. Absence or poor condition of the channels

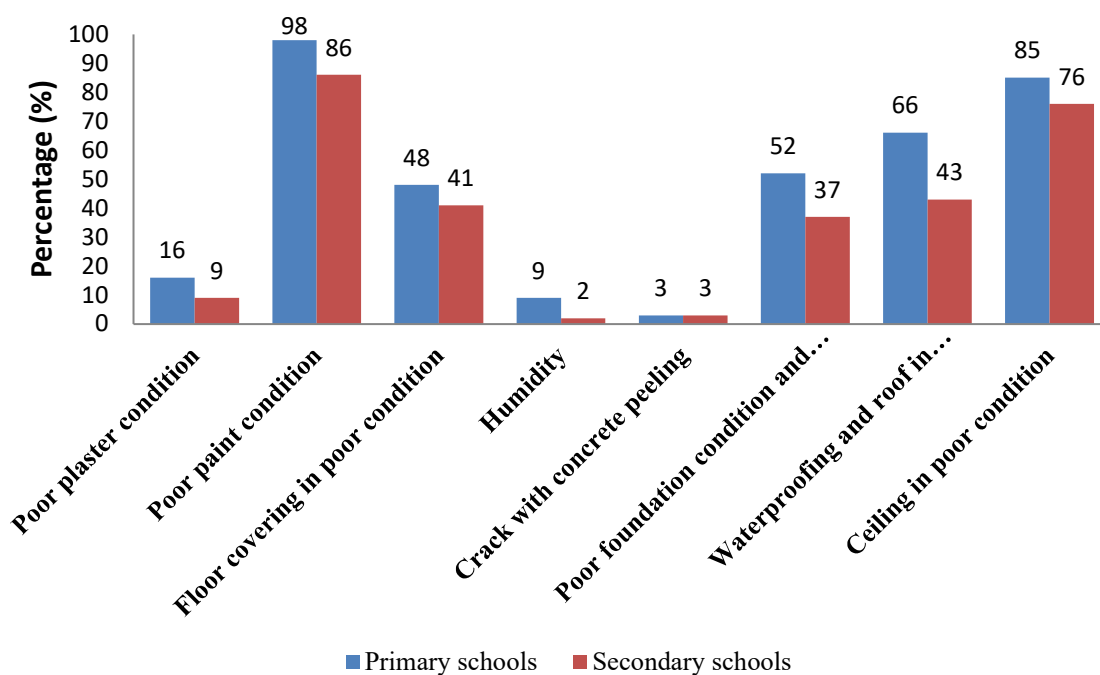
Figure 13. Histogram of the general aspect of public primary and secondary school buildings in the city of Bafoussam

Table 5 and Figure 13 show the state of the plaster, paint, floor, ceiling, roof terrace, etc. of administrative primary and secondary schools buildings in the city of Bafoussam visited. Figure 14 shows the combined degradations or defects due to poor condition of the plaster, paint, floor, ceiling, roof terrace etc. of administrative primary and secondary schools buildings in the city of Bafoussam. We observe that some buildings have an attractive general appearance; others on the other hand, and in majority, have a disastrous face. The defects cited above have their origin in the students' incivism, acts of vandalism, insecurity in the schools, the poor quality of the work carried out, the use of unskilled labor, the aging and poor quality of the materials used, the lack of a sewerage network, faults building design and non-compliance with architectural standards.

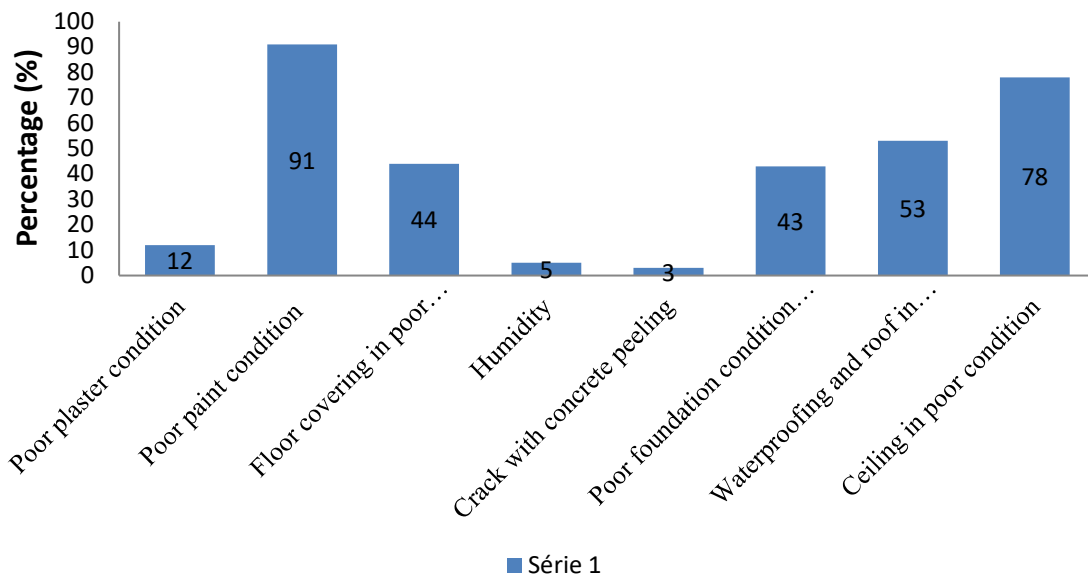
Figure 14. Global histogram of the general aspect of public primary and secondary school buildings in the city of Bafoussam

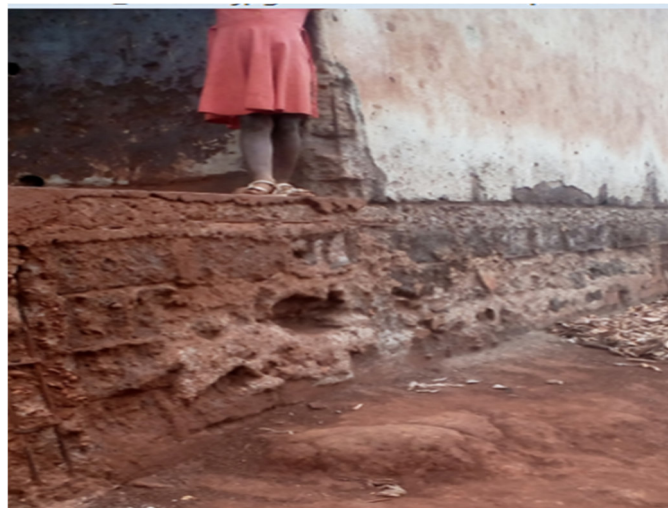
Figure 15. Foundation degradation

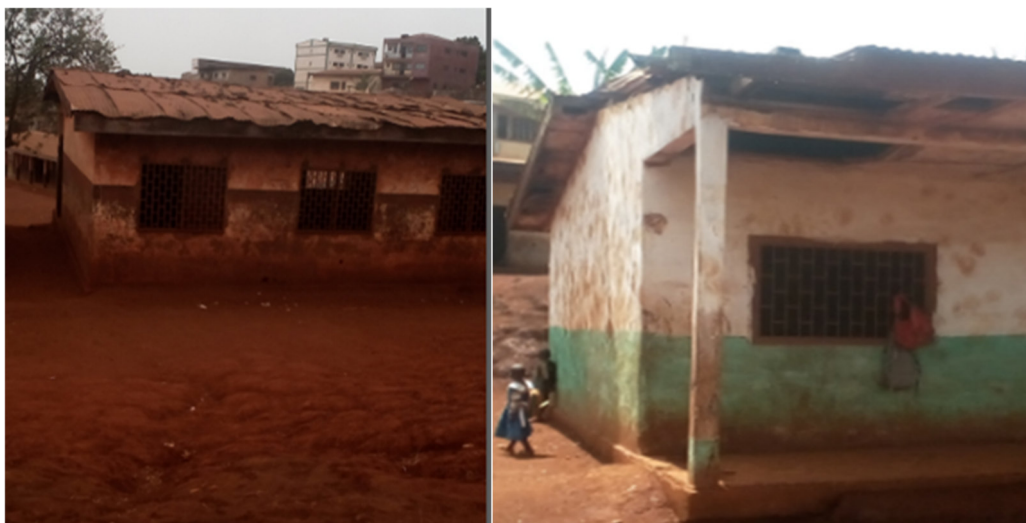
Figure 16. Poor paint condition / paint aging

98% of primary school buildings in the city of Bafoussam show an aging of the paint on the walls, i.e. 127 buildings, while those of secondary school buildings show 86% i.e. 157 buildings. 85% of primary school buildings in the city of Bafoussam have a ceiling in poor condition i.e. 111 buildings, while those of secondary schools buildings have 76% i.e. 132 buildings.

The primary school buildings in the city of Bafoussam are more degraded than those of secondary schools in general aspect. Figure 16 and Figure 17 respectively illustrate the poor condition of the paint on the walls and the defective ceiling of some school buildings.

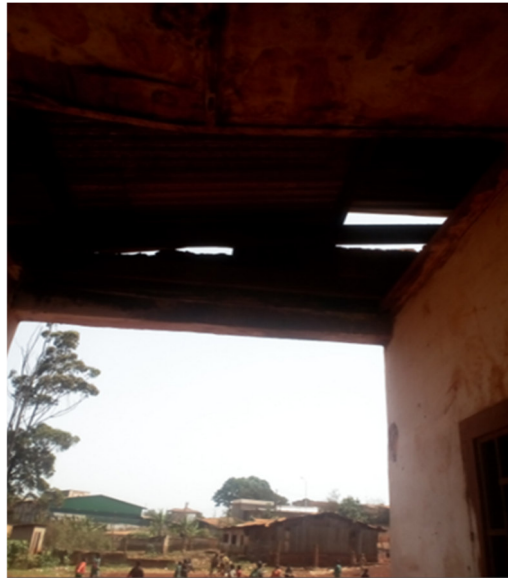
Figure 17. Defective ceiling

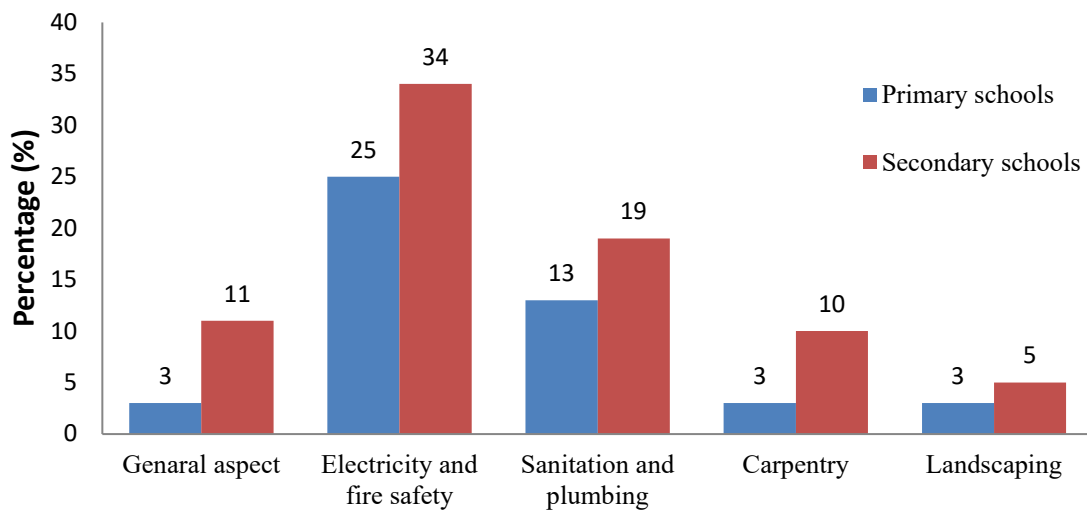
Figure 18. Histogram of maintenance activities of public school buildings in the city of Bafoussam

Figure 18 and Table 6 sufficiently show the scarcity of maintenance activities for administrative school

buildings in the city of Bafoussam; indeed, on average 8% of school buildings in general and only 3% of primary school buildings have been the subject of maintenance work relating to the general appearance during the last decade; that is to say a general annual average of 0.8%, we can easily understand why these buildings present a dilapidated face and particularly those of primary schools.

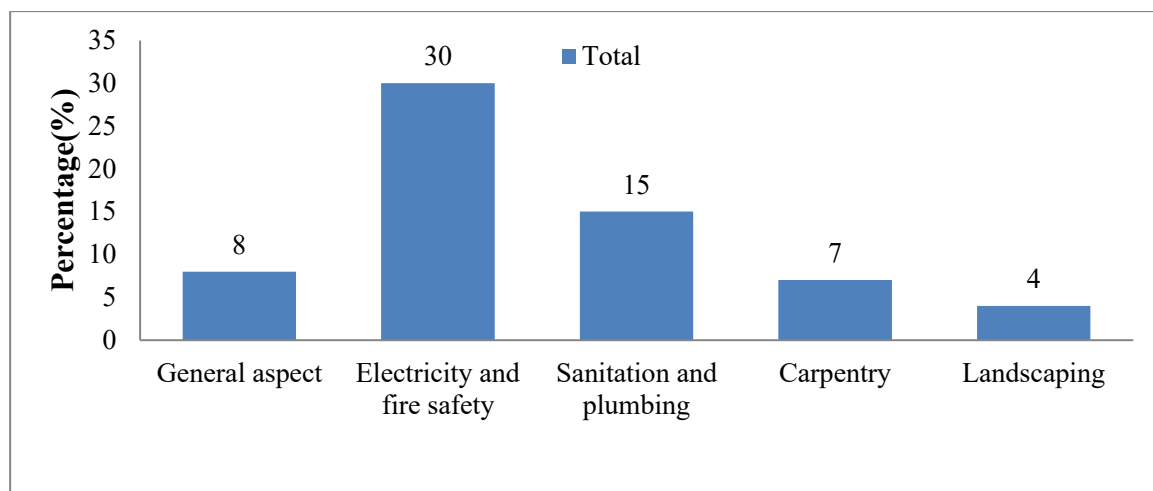
Table 6 presents the statistics of corrective maintenance activities undertaken on public school buildings in the city of Bafoussam over the past ten years. Combined corrective maintenance activities undertaken on electricity and fire safety, on plumbing and sanitary facilities etc. are shown in Figure 19.

Figure 19. Global histogram of maintenance activities of public school buildings in the city of Bafoussam over the past ten years
