1 **On the Status and Mechanisms of Coastal Erosion in Marawila Beach,**
2 **Sri Lanka**

33 **Abstract**

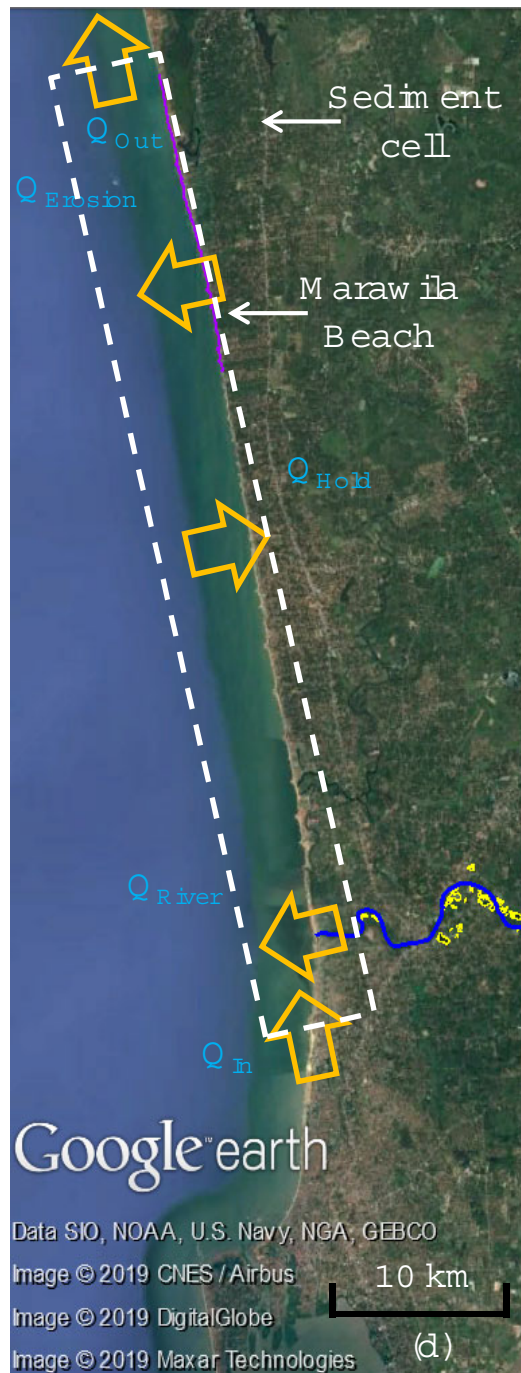
117 [Fig. 1. Spatial extent of \(a\) Maha River and Colombo City, \(b\) west coast, offshore sand mining areas, Colombo City,](#)
118 [Negombo Lagoon mouth, Kalani River mouth, Maha River mouth, Bambukiliya barrage, and clay mining areas in the](#)

119 Maha River riparian area and MB, (c) Maha River riparian area, excessive clay and illegal sand mining area, and (d)
120 sediment cell and sediment flux including MB and Maha River mouth (Source: Google Earth, Data SIO, NOAA, U.S.
121 Navy, NGA, GEBCO (Photograph was taken by CNES-Airbus/Digital Globe satellites in December 23, 2017)
122

124 Fig. 1 (d) shows the sediment cell within the Maha River mouth and MB. The sediment budget of the
125 investigated area (i.e., dashed rectangular area) in Fig. 1 (d), is estimated using sediment in from the
126 neighboring sediment cell (Q_{In}) and from river (Q_{River}), and sediment out to the neighboring sediment cell
127 (Q_{Out}), and the possible sediment exchange with the offshore area ($Q_{Offshore}$) and to the evolved tombolos
128 between the river mouth and MB (Q_{Hold}). The investigated area was divided into a southern cell covering
129 the protected beach and northern cell covering the unprotected beach. The sediment balance is derived from
130 the erosion (or accretion) of MB ($Q_{Erosion}$). Equation (1) shows the sediment flux of erosion in MB
131 ($Q_{Erosion}$).

254 The mined area was calculated by demarcating the mining pits [see Fig. 1 (c)] on Google Earth
255 Pro (the latest image was taken on February 4, 2017). The locations of sand/clay mining locations were
256 verified by traveling 14 km upstream from the river mouth in August 2017. The depths of the mining pits
257 were verified based on interviews (i.e., authors queried the depths from the inhabitants in the river
258 riparian area).

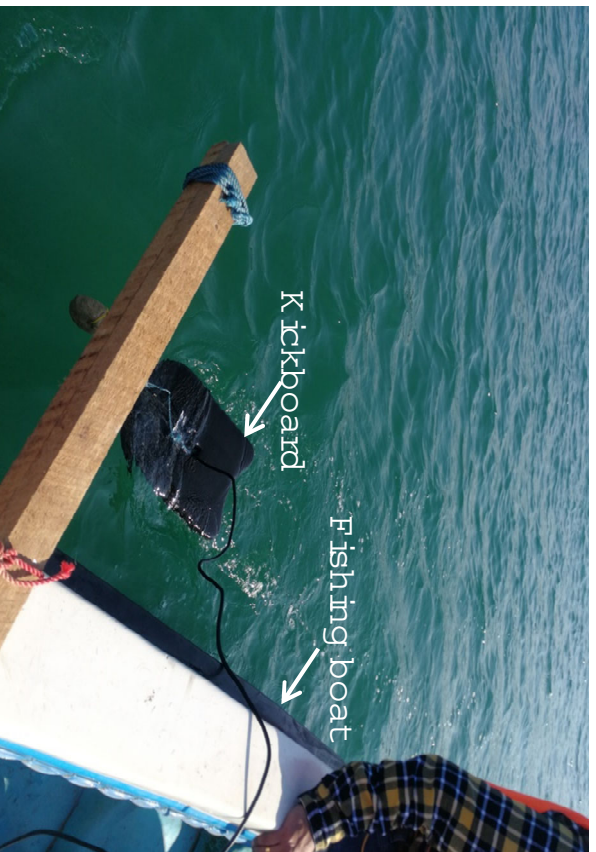
212 Fig. 2. (a) Photograph of kickboard (sonar was attached 6 cm below the downside-center of the kickboard); (b) maps
213 showing boat cruise lines of bathymetry surveys for 2017, 2018, and 2019; 500 m predetermined lines (L1, L2, and
214 L3) (Source: Esri, DigitalGlobe, GeoEye, Earthstar Geographics, CNES/Airbus DS, USDA, USGS, AEX,
215 Getmapping, Aerogrid, IGN, IGP, swisstopo, and the GIS User Community)

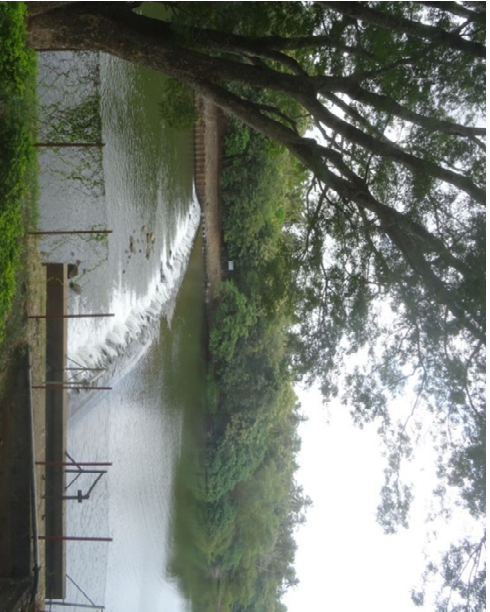
252 Fig. 4. (a) Barrage under overflowing conditions (photo was taken on August 8, 2018). (b) A schematic diagram of
253 barrage

242 The river discharge at the barrage was calculated using Equation (2), assuming that the barrage functioned
 243 as a weir (Hager 1987). Fig. 4 (a) shows a photograph of the barrage under flood conditions. Fig. 4 (b)
 244 shows a schematic diagram of the barrage.

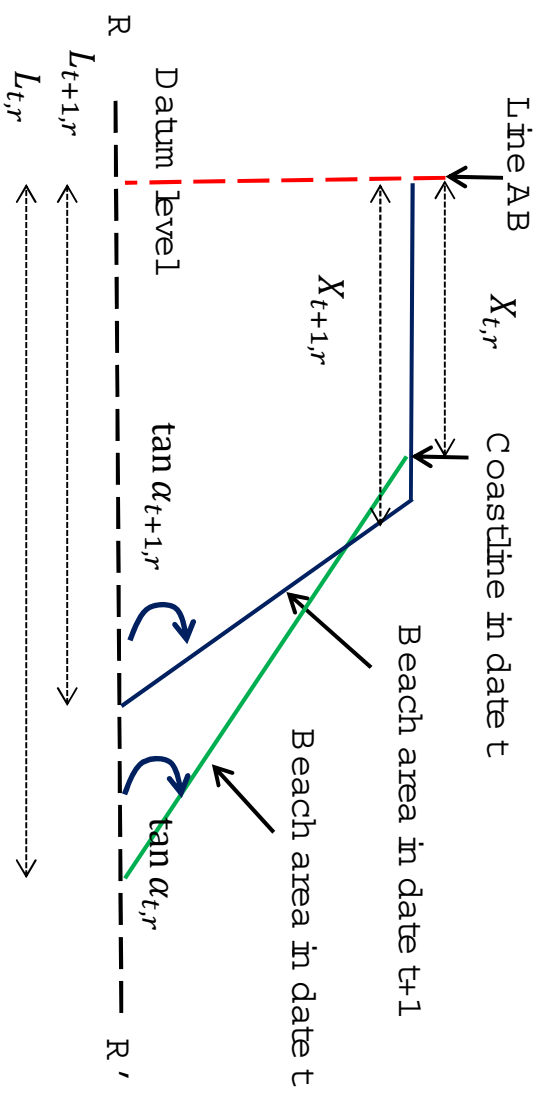
275 Fig. 5. (a) Schematic diagram of the coastline, shoreline, and beach area (plane view) showing the shoreline of day t
 276 and day t + 1, line AB, and lengths $L_{t,r}$, $L_{t,r+1}$, $L_{t+1,r}$, and $L_{t+1,r+1}$ (perpendicular distances to line AB from points
 277 $P_{t,r}$, $P_{t,r+1}$, $P_{t+1,r}$, and $P_{t+1,r+1}$, respectively). (b) Schematic diagram of cross-section (RR') showing beach area and
 278 beach slopes of days t and t + 1

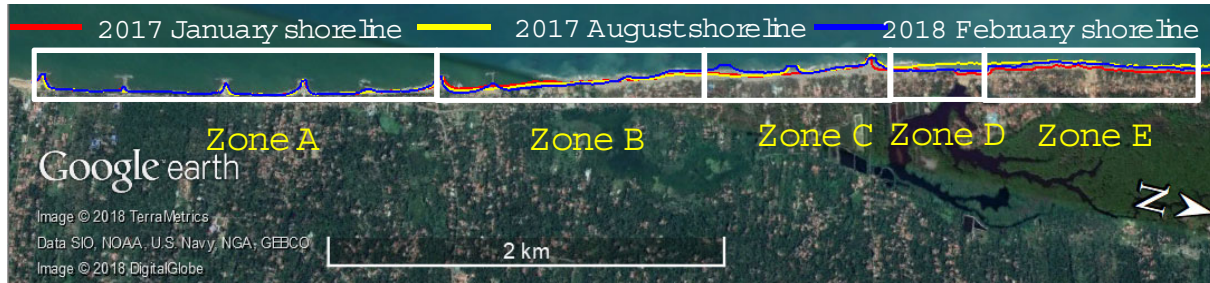
316 Fig. 6. (a) January 2017, August 2017, and February 2018 shorelines on a satellite image in December 2017 (Image
317 was taken on December 23, 2017) (Source: Google Earth, Data SIO, NOAA, U.S. Navy, NGA, GEBCO) (Image was
318 taken by DigitalGlobe). (b) Shoreline accretion rate from January 2017 to August 2017. (c) Shoreline accretion rate

319 from August 2017 to February 2018. (d) Shoreline accretion rate from January 2017 to February 2018. (e) Significant
320 management initiatives that took place in 2018

300 Fig. 6 shows (a) spatial extent of MB, (b) shoreline accretion (and erosion) rates between January
301 2017 and August 2017, (c) those between August 2017 and February 2018, (d) those between January 2017
302 and February 2018, and (e) management initiatives taking place after February 2017. Fig 6 (c) also includes
303 non-monsoon months (i.e. March and April). Beach accretion (and erosion) is small in Zone A as a result
304 of introduced detached breakwaters and revetments. Out of the four submerged breakwaters in Zone B, two
305 failed to maintain nourished sand. The construction of the submerged breakwater 500 m away from the
306 detached breakwater could account for ineffectiveness of beach restoration between 2100–3000 m. The
307 beach was accreted in Zone C in both the monsoon and non-monsoon season because of evolving tombolos.
308 The beach in Zone D was accreted from January 2017 to August 2017. This accretion was an overestimated

309 value because the beach nourishment had not occurred at the date of the satellite image (January 12, 2017).
310 The groin field interrupted a portion of the transported sediments towards the north and restored the beach
311 area in Zone E. The accreted beach in Zone E during the monsoon season was slightly eroded during the
312 non-monsoon period. Table 3 shows the accreted (or eroded) beach area for each zone. Interventions in
313 Zone A, Zone C, and Zone E successfully restored the respective beach areas. The shorelines in Zone B
314 and Zone C were eroded after beach nourishment in December 2016–February 2017.
