Probe geometry and surface roughness effects in microscale impact testing of WC-Co

Abstract

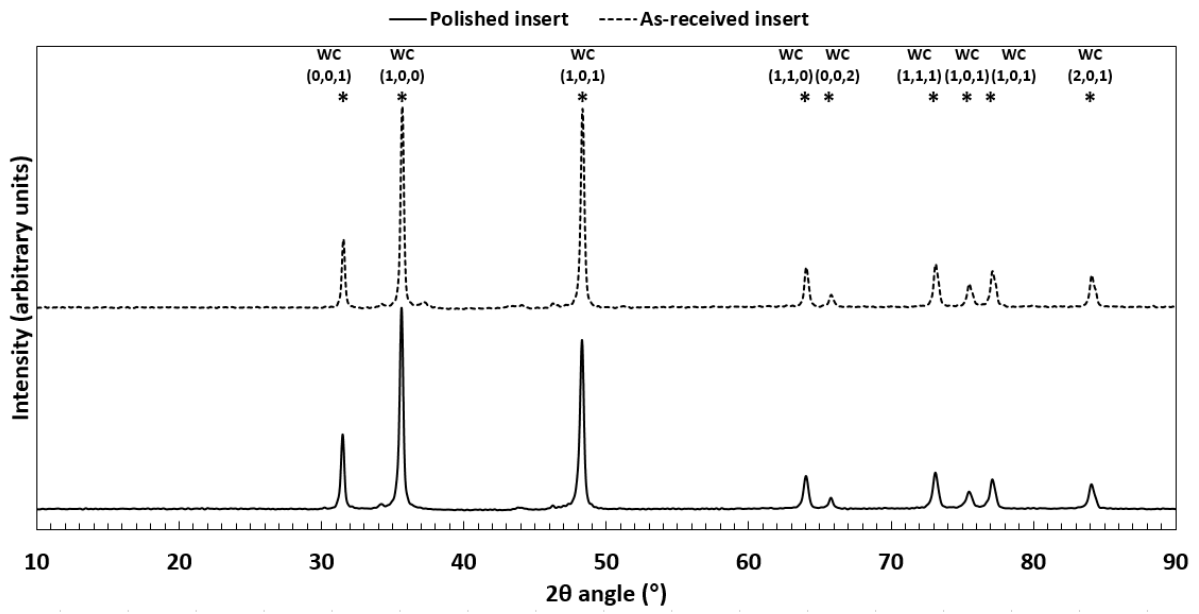
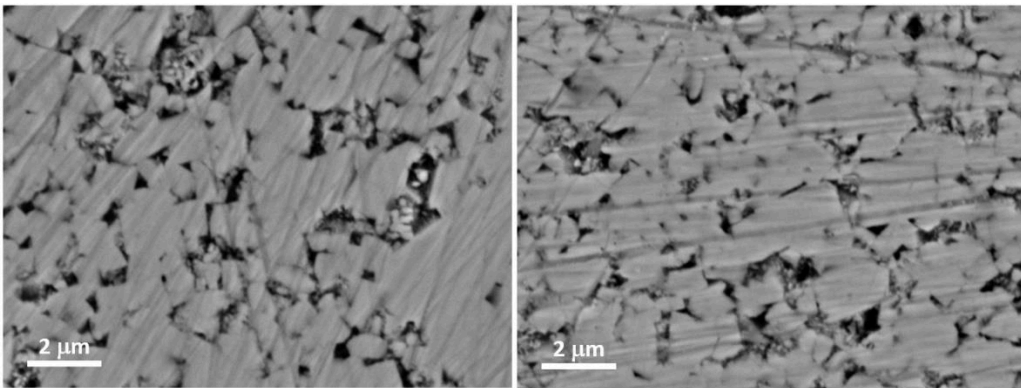
1. XRD spectra (a) and back-scattered mode SEM images of (b) as-received and (c) polished inserts at x25000 original magnification.
2. SEM images of impact craters with the 20 μm probe. (a-g) on the polished insert:- (a) 1 N; (b) 1.5 N; (c) 2 N; (d) 2.5 N; (e) 3 N. (a-e) at x4000 original magnification. (f) 1 N test at original magnification x15000 and (g) 3 N test at x10600 original magnification. (h-i) on the as-received insert:- (h) 2 N; (i) 3 N. (h-i) at x4000 original magnification.

XRD confirmed that the inserts were essentially the same (Fig. 1(a)), with dominant WC peaks, very minor Co/Co oxide peaks and no other refractory metals present (patterns compared with PDF-2 database of the ICDD). EDX compositions were WC-5 wt.% Co on both samples. No traces of any other metals apart from W and Co were found. Grain size and morphology are virtually the same as confirmed by SEM imaging, as shown in Figure 1 (b,c). AFM images showed the presence of many fine scratches on the as-received insert and several deeper scratches. There were less of the fine scratches on the polished sample although some deeper scratches were still present. The R_a surface roughness was (13.2 ± 0.8) nm on the as-received insert and (9.9 ± 0.7) nm on polished insert.

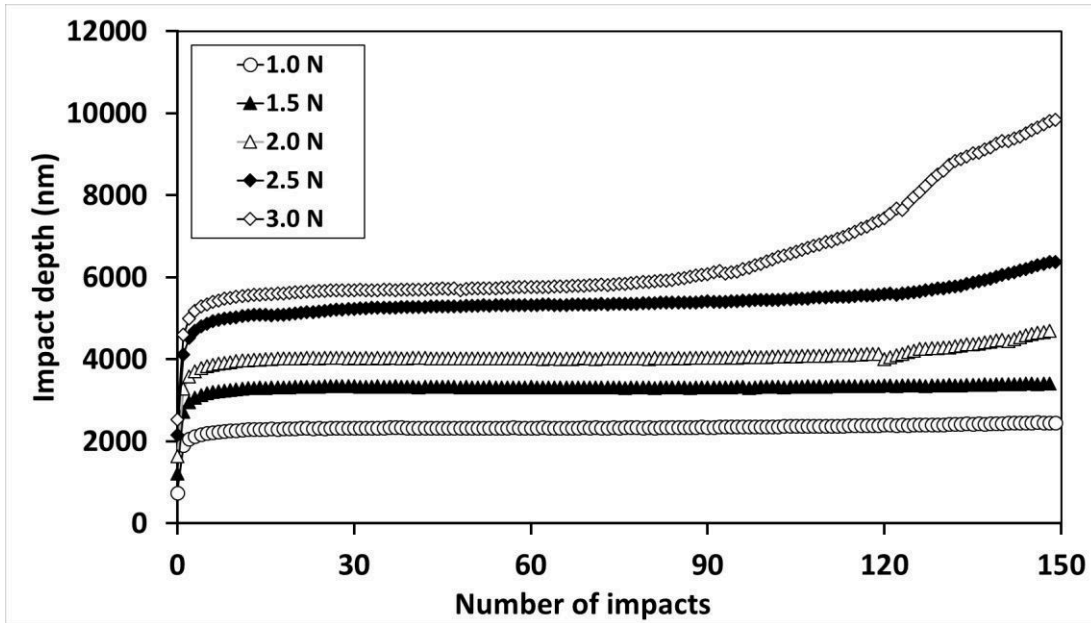
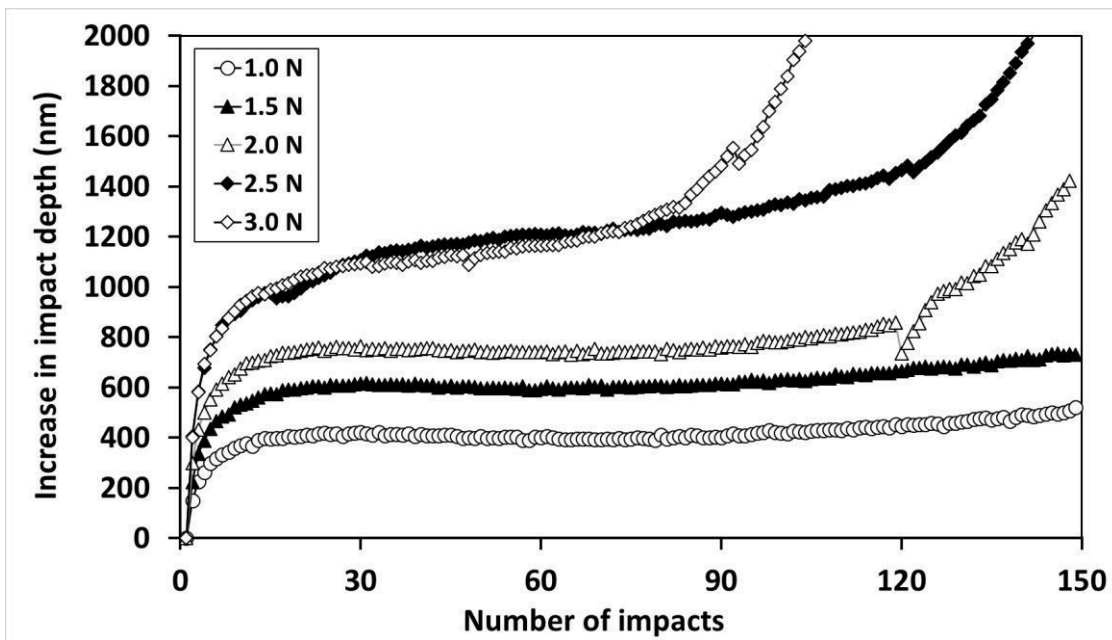
3. Evolution of (a) impact depth and (b) increase in impact depth, with number of impacts with 20 μm probe on the polished insert.
4. Load dependence of impact parameters in tests with the 20 μm probe on (a) the polished insert (b) the as-received insert (c) residual wear depth.

Illustrative graphs of impact depth vs. number of impacts at each impact load are shown for the polished insert in figure 3 (a). Corresponding impact depth increases (i.e. setting depth after the first impact to zero) are shown in figure 3 (b). In addition to a strong dependence on applied load it is clear that the impact damage rate varies as the test progresses, particularly at higher load, **which is discussed in more detail in section 3.5.**

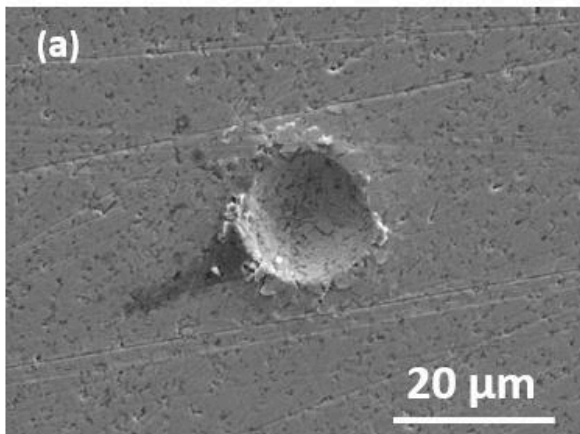
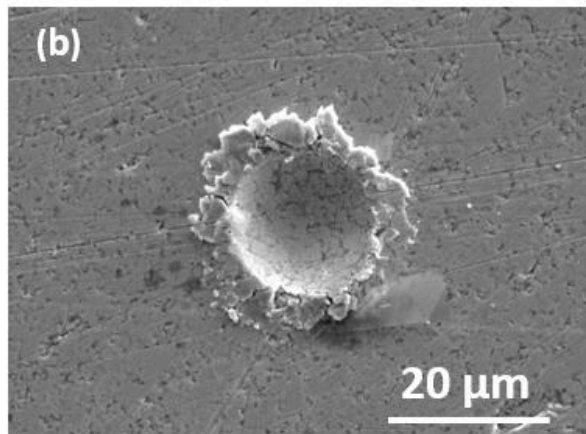
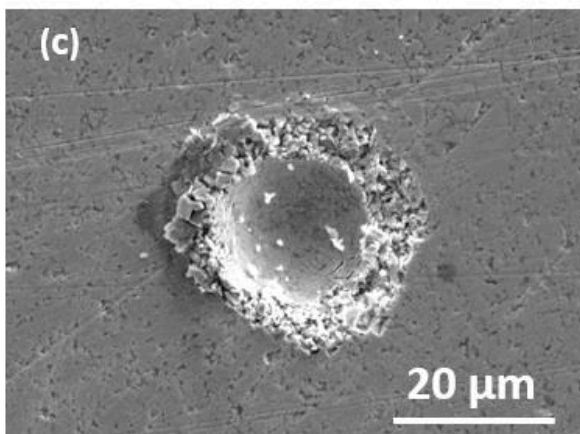
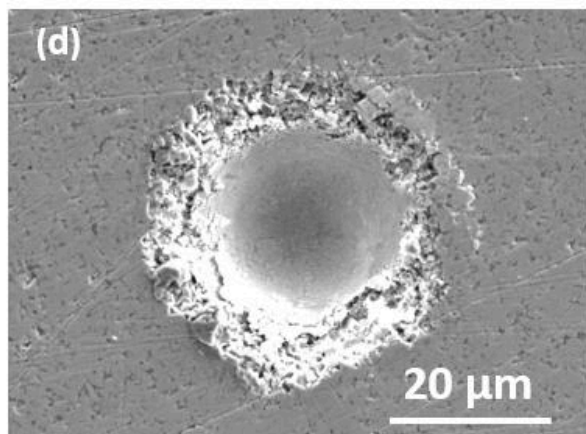
5. SEM images of impact craters with the 8 μm probe on the as-received insert at x4000 original magnification. (a) 0.2 N; (b) 0.3 N; (c) 0.5 N; (d) 1 N.

Illustrative SEM images of impact craters from tests at 0.2-1 N with the sharper 8 μm end radius probe on the as-received insert are shown in Figure 5. Pile-up around the impact site was observed at lowest load extending further from the crater at higher load. At 0.5 and 1.0 N the fragmentation at the periphery is much more extensive than at lower load. The impact depth data with the 8 μm probe confirm the strong load dependence seen in the SEM images (figure 6). At 0.5 and 1 N there is a transition to a faster damage rate and depths move from spherical to the conical part of the indenter. With the ~ 100 μm probe the impacts were close to elastic. Optical microscopy revealed some surface damage but there was no well-defined impact crater. Under these conditions it was not possible to produce dramatic failure within the range of impact loads used. Some tests were run over 20 min, these showed a very gradual fatigue process.

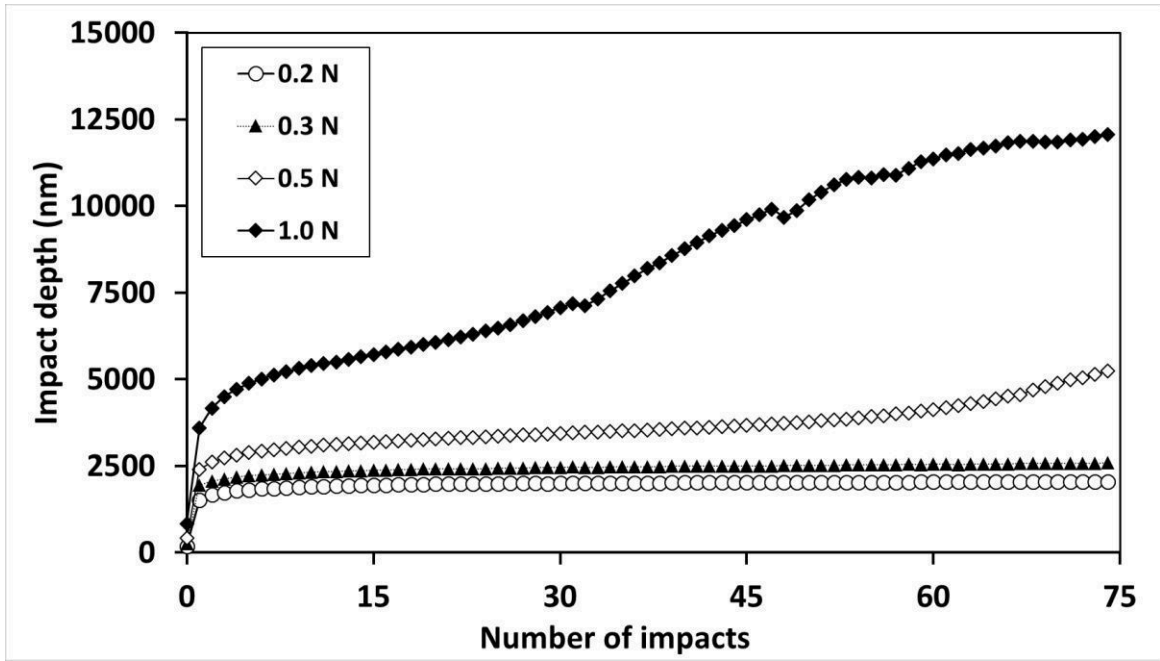
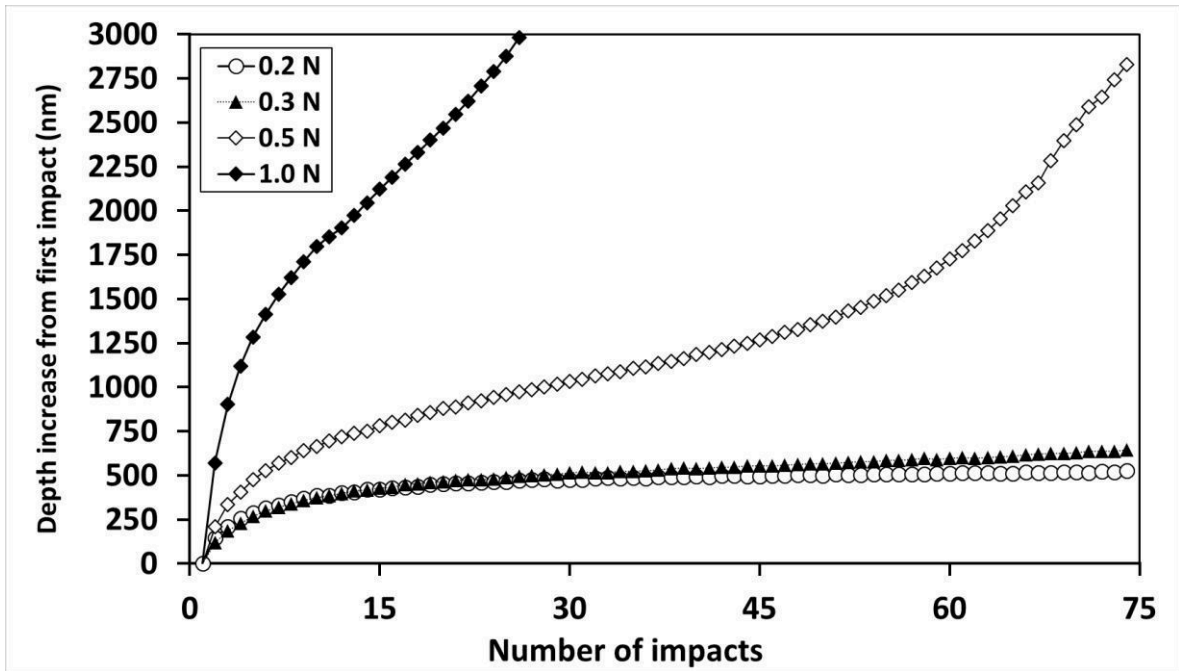
6. Evolution of (a) impact depth and (b) increase in impact depth with number of impacts with 8 μm probe on the as-received insert.
7. Evolution of impact depth with number of impacts with 20 μm probe in repeat tests at 3 N on (a) the polished insert (b) the as-received insert.
