# Cost-optimal restoration strategies under the aspect of energy efficiency for the built environment of the historic area of Fragomahalas in Thessaloniki

A thesis submitted for the degree of

*Master of Science (MSc) in Energy Building Design*

February 2019

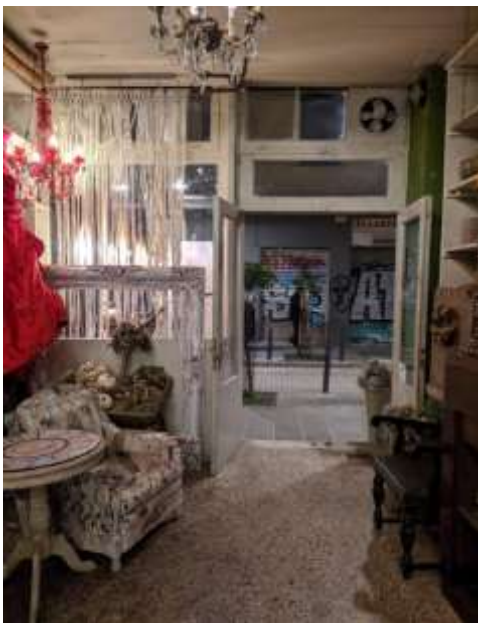
*Figure 5 Entrance to the building, author photo.*

The above photos show the attempt to restore the ground floor of the building. Apart from some abandonment points, such as some roof boards, the ground floor appears to be in good condition.

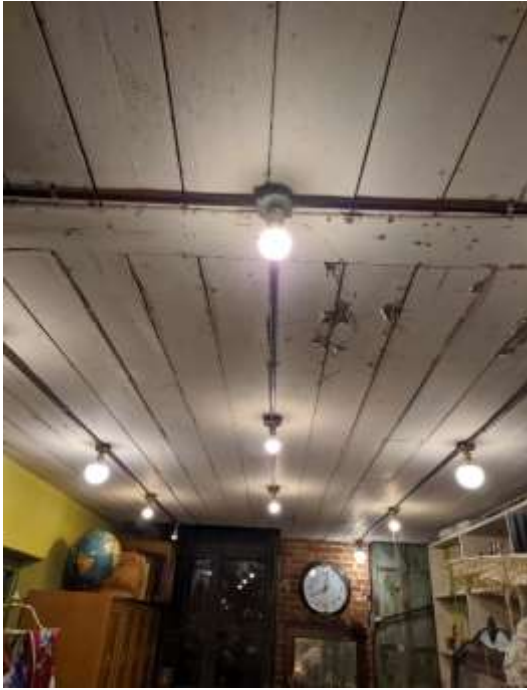
*Figure 6 Ground floor, author photo.*

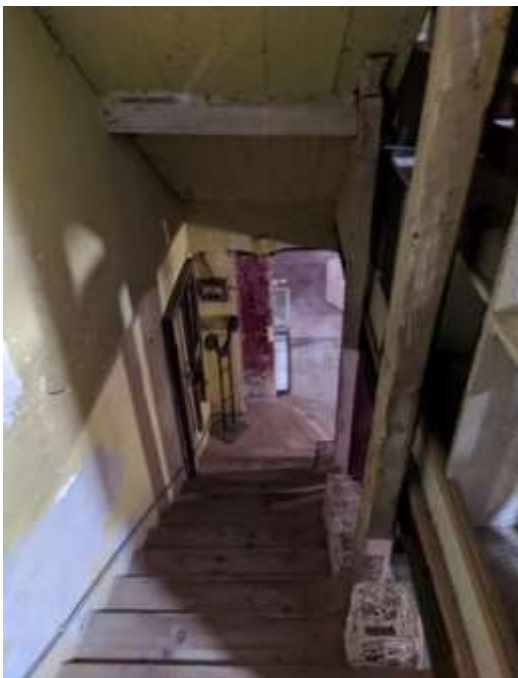
*Figure 8 Staircase leading to basement, author photo.*

The above two photographs show that a series of maintenance work has been carried out to restore the internal stairs leading to the attic and basement respectively. However, looking at the basement area there are significant omissions in the restoration of the space.

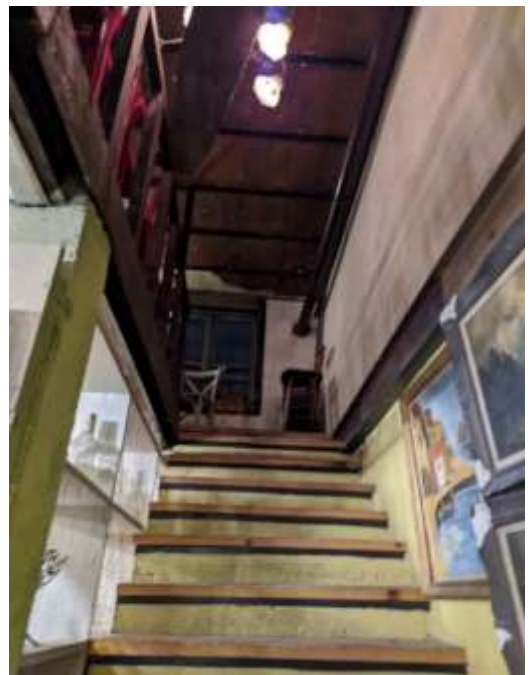
*Figure 7 Staircase leading to the loft, author photo.*

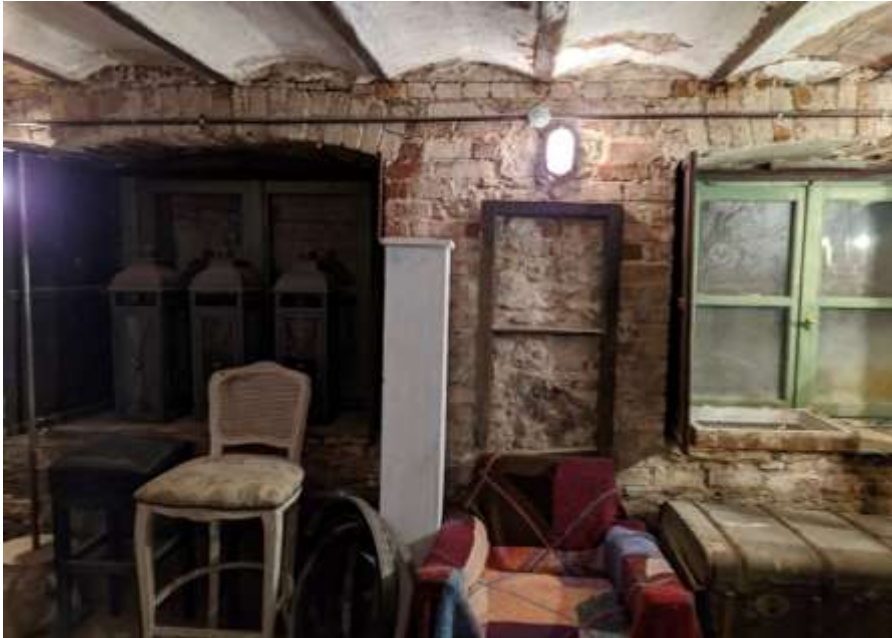
*Figure 9 Basement rear, author photo.*

In the above photo as well as in the following, the effects of moisture on the mortar and metal parts of the basement are evident, which makes it dangerous for ground floor patrons.

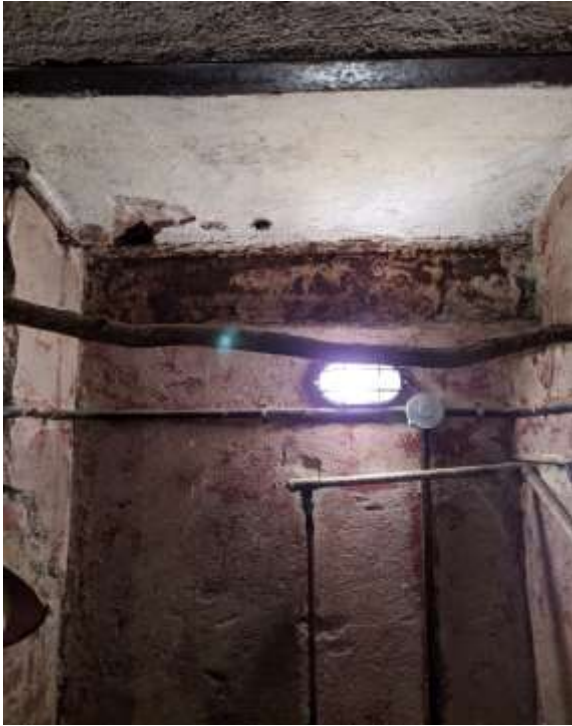
*Figure 10 Oxidation of metal supports, author photo.*

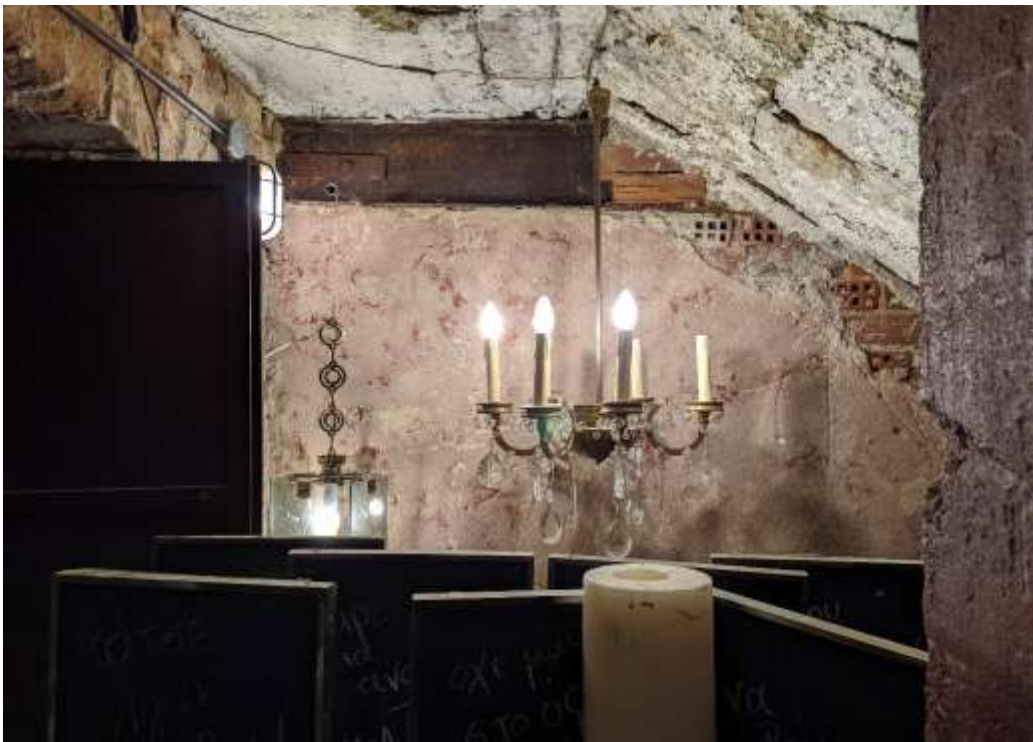
*Figure 11 Space below staircase leading from ground floor to basement, author photo.*

Problems can also be found inside the staircase, as the brickwork is exposed to moisture which makes it dangerous.

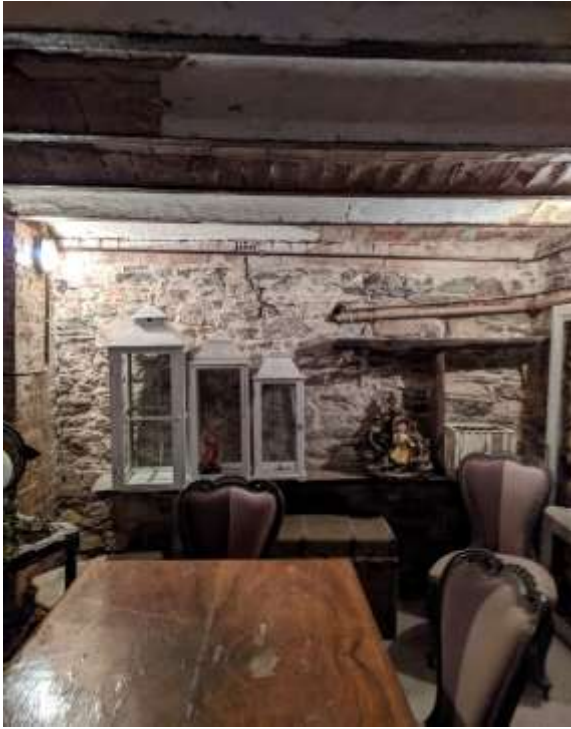
*Figure 12 Basement front view, author photo.*

Ground floor drainage pipes, along with a series of cracks, appear to be exposed on the walls, a problem that needs to be remedied immediately, as this section poses a threat to the health of the customers.

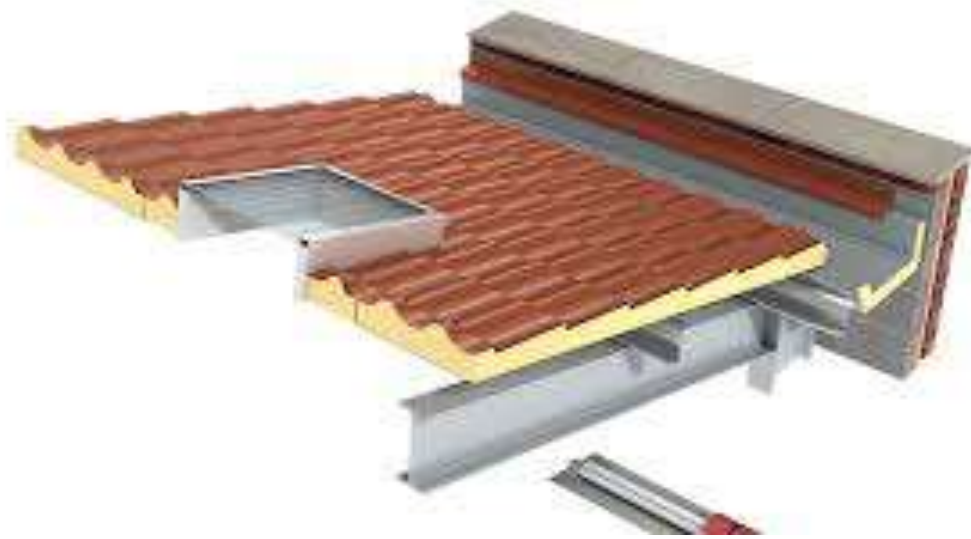
This material is placed in the form of boards on the ceiling frame, and a coat of adhesive is applied between the joints for better insulation and protection against rainfall leaks. In the inner part of the roof, the cement boards are painted in order to better protect them from corrosion (Theodosiou, 2003).

The paint applied consists of a special waterproof composition, with the aim of further sealing the joints between the cement boards, and protecting the base from moisture. Additionally, depending on the type of paint, additional properties such as improved thermal insulation can be given (Theodosiou, 2003).

At the top of the base are the tiles. Their shape and colour vary according to the will of the owner. However, in the case of a preserved one, the tiles should be of the same shape and colour as the preceding ones. For this reason, Byzantine type tiles were selected in their classical form. Welding of the tiles is carried out using the same coating applied to the cement boards (Dabaieh, Wanas, Hegazy, & Johansson, 2015).

*Figure 13 Example of passive roof protection implementation, source (Pisello, Cotana, Nicolini, & Brinchi, 2013).*

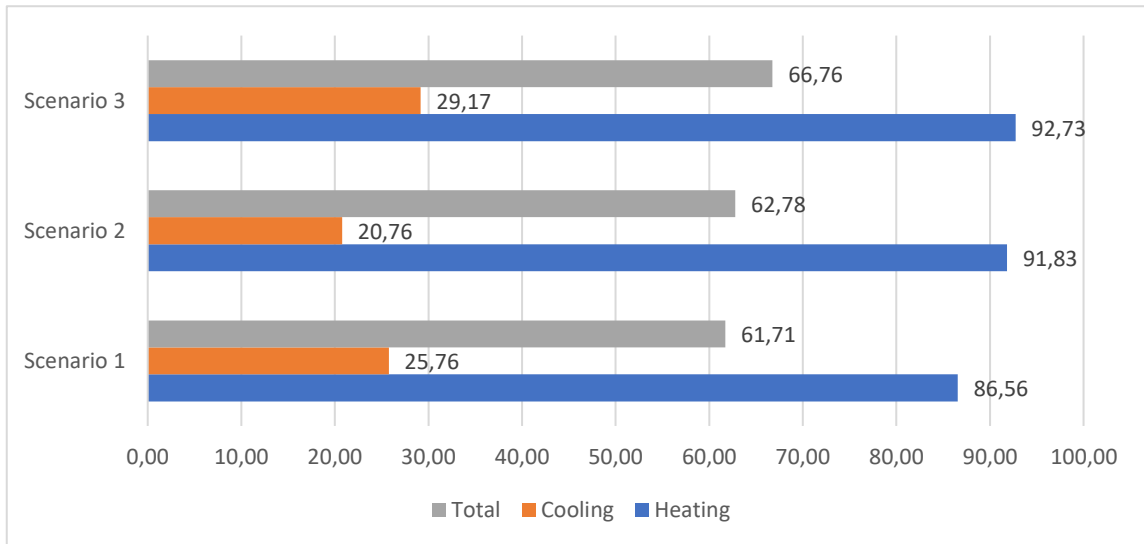
Figure 14 Percentile Reduction of the energy consumption per use.

The difference in consumption compared to the current state of the building is noticeable, with heating rates above 85%, while in cooling (for which there are no specific measures taken), the reduction varies from 20% to 30% in energy consumption. As a result, the fuel or electricity requirements for heating or cooling the building are also significantly reduced.

Based on the above results, energy consumption appears to have decreased significantly in all three scenarios compared to the existing condition of the building. In particular, the formulation of the percentage change in consumption is presented in the following diagram:
