# POST-OCCUPANCY EVALUATION STUDY: OCCUPANT'S PERCEPTION VS. OCCUPANCY SURVEY

This paper presents the results of an assessment of a higher education building located in the city of Puebla in Mexico. The research carried out is a post-occupancy evaluation study of a building built forty years ago but still very heavily used. The building is covered by four concrete shell structures joined together by a translucent dome. A focus group and a questionnaire provided us the views of the building users regarding environmental factors, aesthetics and functionality of the building. People's perceptions have been compared with the results of an occupancy survey, which has shown how people is using the building, peak usage times and space occupancy. Improvements to the building are suggested based on the data obtained. The main aim of this research is to improve the interior environment of the building while learning from it in order to design new good quality and sustainable education buildings.

This paper presents the results of a POE assessment of an educational building located in the city of Puebla in Mexico. The building is called La Monja Cultural Centre and is part of the Architectu

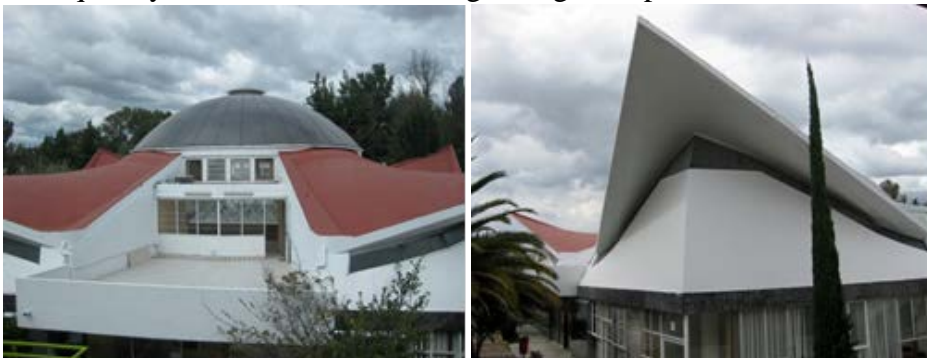
Figure 1 (left) Exterior view of the second floor of La Monja building. Figure 2 (right) Exterior view of one of the concrete shells.

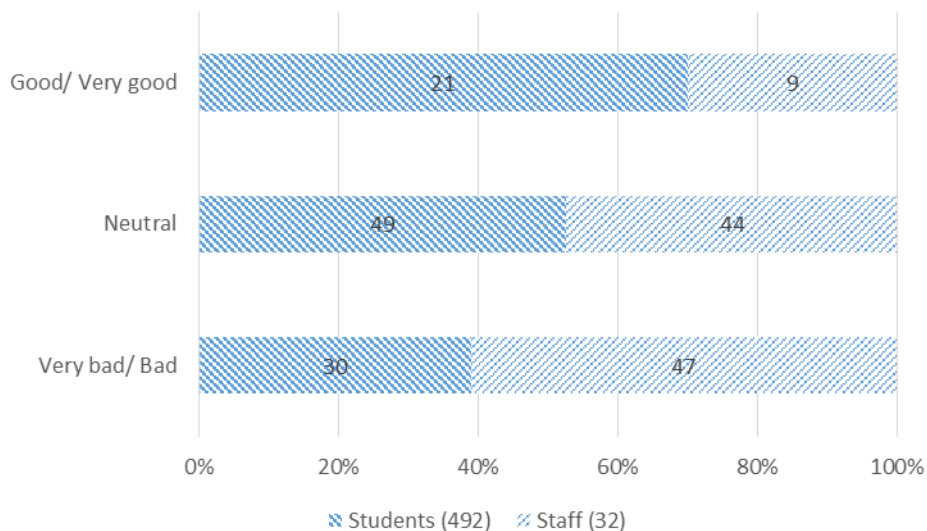
Occupants were asked to give their impressions regarding the interior environment of the building. Most students think it is neutral or bad, while most staff respondents were more critical saying that the environment of La Monja is bad and very bad (Figure 6) (Mundo-Hernández, et al, 2014). One third of the staff stated that the quality of daylight is bad/very bad for the activities they perform in the building. On the other hand, users believe the acoustics of the building is not too bad while others believe it is good/very good. Most of them think the shape of the concrete shells contribute to the quality of the acoustics of La Monja, particularly in the seminar rooms which are located underneath the concrete shells. However, some people reported bad acoustics on the multiple use area on the ground floor, regardless of the cork panels; particularly when it is divided into smaller rooms and all are used at the same time.

Finally, thermal control (temperature) and ventilation are the environmental aspects that were rated by most staff and students as being very bad and bad.

Figure 6. Users' perception of the interior environment  
(source: Mundo-Hernández, et al, 2014).

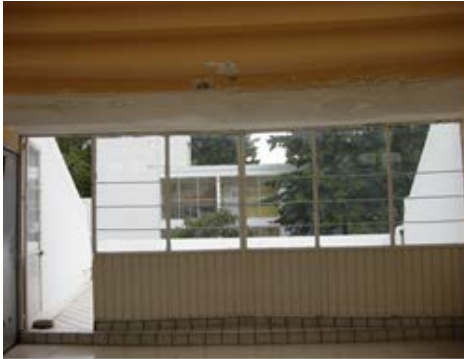
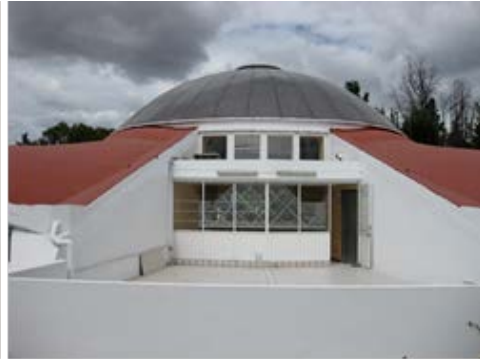
The least utilised areas according to this study are the three terraces located on the first floor (Figures 7 and 8), with only 1% occupancy. These terraces lack of proper exterior furniture, are not integrated into the main hall and corridor of that floor and the main problem is that the doors that communicate the hall with the terraces are most of the time locked. This problem was also raised by the focus group and through the questionnaire,

where people pointed out this as one of the reasons of having bad ventilation on that floor.

Figure 7 (left). Interior view of the door and windows that communicate to one of the terraces.

Figure 8 (right). Exterior view of one terrace, 1<sup>st</sup> floor of La Monja building.

- 4) Give users control over their environment.
- 5) Green roof for thermal control.
- 6) Use of terraces for cross ventilation and stack effect through central dome.

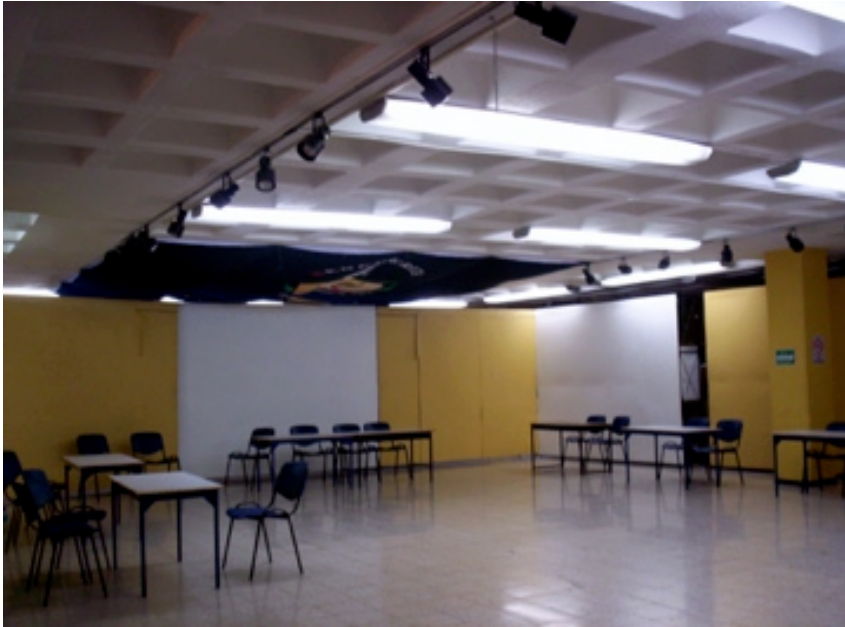
Moreover, the multipurpose area located on the ground floor (Figure 9) is also under-utilised with only 2% of its capacity. Originally, all the ground floor was a big open plan area for exhibitions. Currently, the floor has been divided to host the cafeteria, office space, storage space and one computer room. A central area with access through the main entrance of La Monja is considered to be a “flexible” space where special events take place, students work exhibitions, seminars and workshops. Furniture can be arranged to suit the event. However, there seems to be too few activities taking place in this area, or the activities that are held there are performed by only a few people. Hence, the space is not utilised to its full capacity.

Figure 9. Multipurpose room with movable partitions (ground floor).

- 5) Rearrangement of areas going back to its original open plan area on the ground floor but considering the use of: natural light, natural ventilation and outside views;
