Nondestructive Evaluation of Historic Hakka Rammed Earth Structures

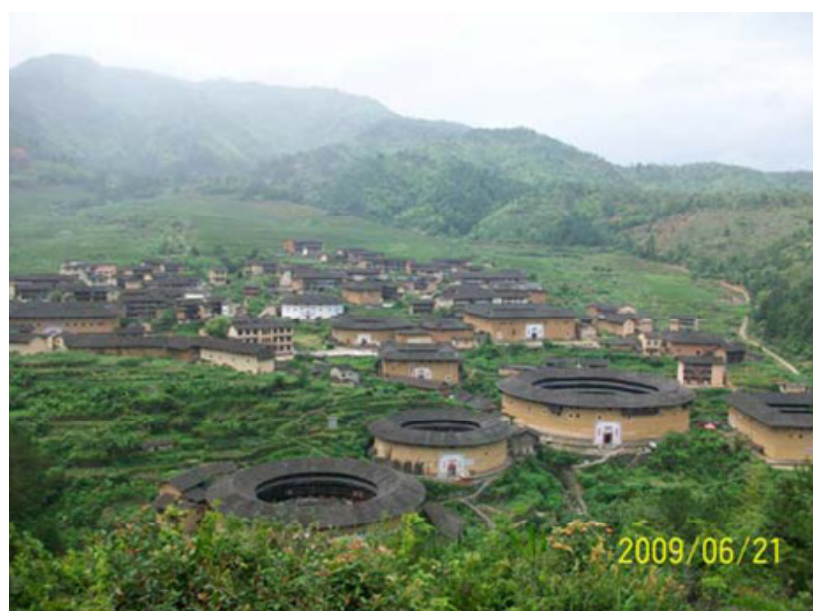
Figure 1. Hakka Tulou Village, Chuxi Tulou Group, Yongding, Fujian, China.

Hakka rammed earth buildings (also known as Fujian Tulou), in the Fujian Province of China, reflect the emergence of innovation, evolution and advancement in the engineering of rammed earth construction from the 8th to 20th centuries. Figure 1 shows a typical Hakka village of Yongding County living in Tulou buildings, while Figure 2 is a geographic location map of Fujian Tulou in China. These earth buildings have thick (~2 m) outer rammed earth walls and inner wooden structures that make up floors and rooms; they are three to five stories in height and round or square in shape; there are hundreds of rooms in each building housing up to 800 people. Since the 1980s, thousands of visitors (including professionals and scholars) have visited Hakka earth buildings, resulting in many illustrative photographs and travel logs about Tulou's characteristics and architectural features, including defense devices and fire walls. It is worth noting that Aaberg, a Danish architect, visited Hakka earth buildings in 1997 and reported the architectural marvel of those structures [4]. More recently, Ostrowski, a Canadian architect, has been researching the ecological footprint of Hakka earth buildings and discussed these buildings in terms of their planning, design, construction, lifestyle, resource management, renewable energy and modest ecological footprint [5]. However, people have underestimated the engineering values of these buildings in terms of low energy consumption for comfortable living, sustainability and durability [6].

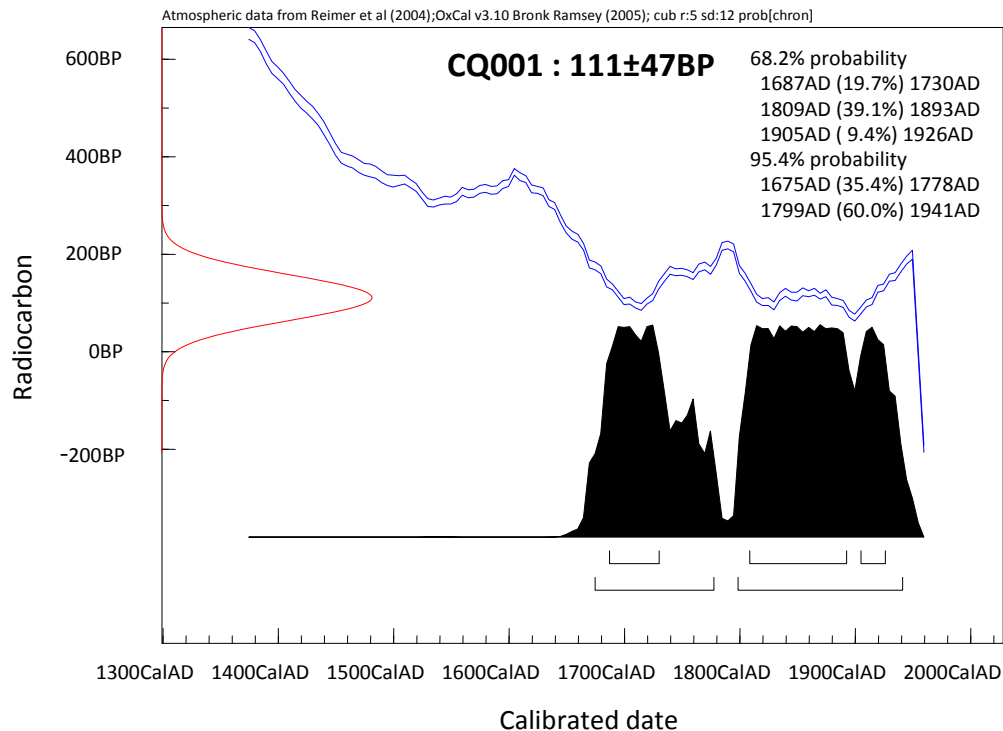
Figure 4. Carbon dating age of Chengqi Tulou.

To validate the ages of the Tulou buildings that were reported in the local official records, as a case study, a wooden sample from Chengqi Tulou was tested for its radiocarbon dating age. Chengqi Tulou was reportedly built from 1662–1709. This wooden sample was cut from a roof truss beam in the Chengqi Tulou and sent to the NSF-University of Arizona Accelerator Mass Spectrometry (AMS) Facility at the Department of Physics, University of Arizona, Tucson, AZ. The carbon dating measurement shows the sample at radiocarbon years 111 \pm 47 BP. Radiocarbon dates require calibration in order to transform them into calendar age ranges. The calibration plot for the sample tested is provided by the NSF-Arizona AMS team and shown in Figure 4. The result indicates that there is a 95.4% probability that the sample is aged between the two calendar age ranges 1675 AD–1778 AD and 1799 AD–1941 AD. This observation is consistent with the completion date of 1709 of Chengqi Tulou. Only the age of the wooden sample from Chengqi Tulou has been tested and verified, while the ages of all other Tulou buildings reported herein are collected from local government records.

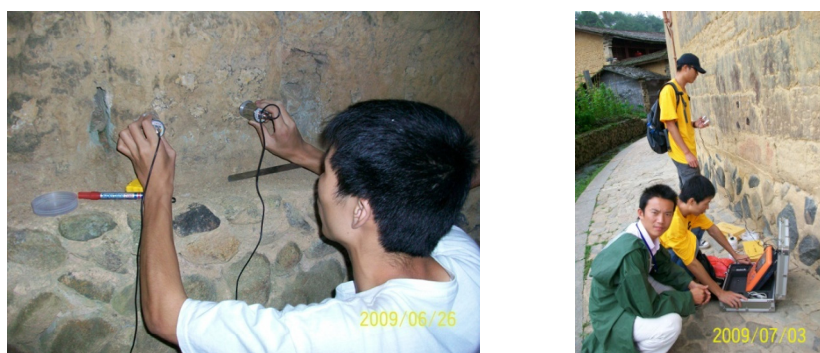
Figure 5. Ultrasonic testing heads and device.

The model NM-4B ultrasonic device that was used in the study was developed and manufactured by Beijing Zhongkelujian Instrument & Equipment Co., Ltd. This portable device can dynamically in real-time display the wave with automatic scaling of frequency and amplitude at high sensitivity. This device is designed to detect the strength or cracking depth of concrete or its uniformity or defects.

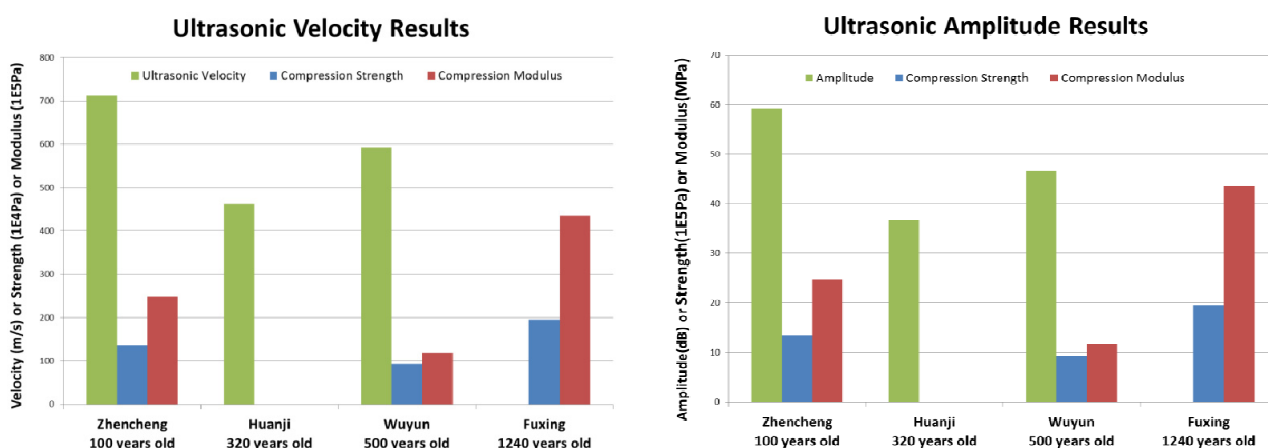
Figure 6. Ultrasonic testing results.

were conducted on the wet walls caused by rainy weather. Figure 6 shows both the ultrasonic velocity and amplitude results for the buildings tested. Note that each data point represents an average of 25 to 30 measurements. Both charts show a consistent trend. As can be seen in Figure 6, apparently, there is no direct correlation between the ages of the Tulou structures and the velocity/amplitude (the strength of the rammed earth walls) of the ultrasonic wave. Other than the age, there are many more parameters in the wall system varying from one building to another, including different earth constituents, with or without wall ribs and varying construction quality.

Even though there are limited ultrasonic data, a useful discussion can be made with reference to the compression properties of the rammed earth wall samples that were generated in the laboratory [8]. The compression strength and modulus data available for the buildings studied are also listed in Figure 6. Ultrasonic testing indicates that the Zhencheng earth wall is stronger than that of Wuyun. This observation agrees with the compression testing results. The ultrasonic result also shows that the Wuyun earth wall is stronger than that of Huanji. Unfortunately, the Huanji Tulou earth sample was too brittle and the researchers were not able to prepare any specimens of a regular shape. Thus, the Huanji Tulou earth sample would have the lowest strength among the buildings studied. The Fuxing Tulou earth sample has the highest compression strength and modulus, even though it was built 1,200 years ago. This is because its earth wall was made of a mix known as “sahetu” that contains a significant amount of lime [7]. Therefore, the limited ultrasonic testing results do appear to agree with the mechanical properties of the earth wall samples.

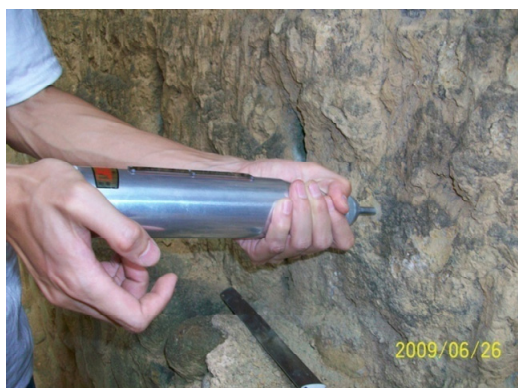
Figure 7. Rebound hammer being used to test the rammed earth wall.

As per ASTM C805, a rebound hammer works as follows: a steel hammer impacts, with a predetermined amount of energy, a steel plunger in contact with the surface of concrete, and the distance that the hammer rebounds is measured. This is shown in Figure 7 for the rammed earth wall instead of concrete. Note that the rebound hammer is not designated for a rammed earth wall, but it might offer a method to quantitatively evaluate the strength of Tulou earth walls. During the field study, two types of rebound hammer models, HT-75 and HT-20, were used, and both were manufactured by Tianjin Building Instrument & Testing Machine Company. The model HT-75 applies an impact energy of 0.075 kgf.m and is designated for red brick applications, while the model HT-20 applies an impact energy of 0.020kgf.m for mortar applications. Figure 8 shows the results of the rebound hammer tests using both HT-75 and HT-20. Each data point represents an average of 32 to 64 rebound hammer measurement readings. Again, all the measurements on the Fuxing building were conducted on wet walls because of rainy weather during the field study, and so the values were not representative.

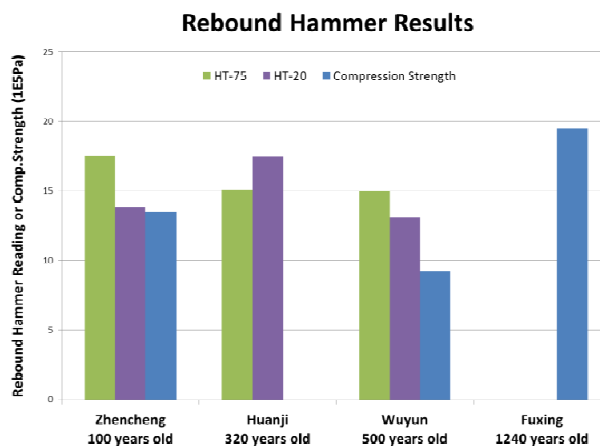
Figure 8. Rebound hammer results.

Similar to the ultrasonic data, the discussion on the rebound number can be drawn with reference to the strength data of the rammed earth wall samples reported in the paper by Liang *et al* [8]. As shown in Figure 8, apparently, the HT-75 brick rebound hammer readings correlated to the compression strength data of the earth walls better than the HT-20 mortar rebound hammer readings. It is interesting to note that the Wuyun and Huanji earth walls have had similar HT-75 hammer readings, and the HT-20 mortar rebound hammer average reading of the Huanji building earth wall was much higher than those of the Zhencheng and Wuyun buildings.

In this study, an ultrasonic device and rebound hammer were used with the intention of preliminarily comparing the strengths of the rammed earth walls of the different Tulou buildings tested. However, a calibration chart of the ultrasonic device/rebound hammer for the rammed earth wall should be developed in order to derive the earth wall strength values from such tests. Currently, a comparison of NDE data with experimentally determined strength data of the rammed earth walls would provide some trends for further use of such NDE techniques. The results indicate that ultrasonic testing appears to reflect the strength of the earth wall better than the rebound hammer. The nature of

rammed earth wall is more like red brick than mortar; hence the HT-75 rebound hammer instead of HT-20 should be used.

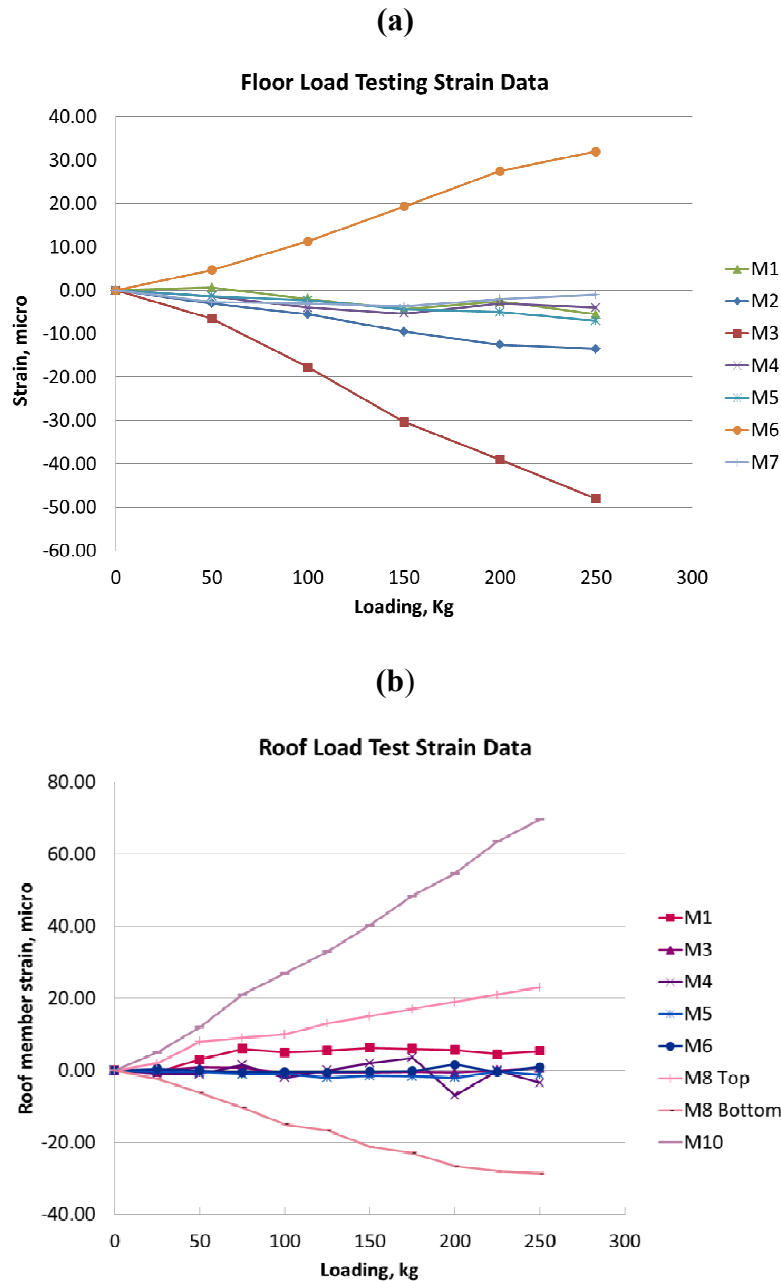
Figure 11. Strain data from load testing, (a) floor system member strain data and (b) roof truss member strain data.

The strain data generated from the floor testing are graphically shown in Figure 11a, in terms of the strain gage locations and corresponding structural members, as defined in Figure 10. The strain was recorded as a function of loadings for each member. Each strain value at a given loading was an average of three measurements from three separate runs. The load applying member M6 (gage #4) behaved as expected and gave a strain of 32 microstrains (parts per million) under maximal loading of 250 kg. All other members had small strain values, except the vertical member M3 (gage #5) that had unusually much higher values and gave a strain of 48 microstrains under 250 kg.

The strain data generated from the roof truss structure testing are graphically shown in Figure 11b, as per the strain gage locations and corresponding structural members defined in Figure 12. Similarly, the strain value was recorded as a function of loadings for each member mounted with a strain gage. Each strain value at a given loading was an average of three measurements from three separate runs, except that Member M4 (gage #8) had only two sets of data to average, while the third set of data were mostly positive, resulting in an uncertain trend for Member M4. Such uncertain trend may be attributed to potential disturbance during testing or imperfect connection of wires to the strain gage. Note that the

strain gages used were all 50 mm long gages to maximize the ability of detecting any small strains. All other members, except M4, behaved as expected. The load applying member M10 (gage #4) resulted in 70 microstrains under a maximal loading of 250 kg. For M8, the bottom side was subjected to compression (negative strain), and the strain values were closely matching those of the top tension side.

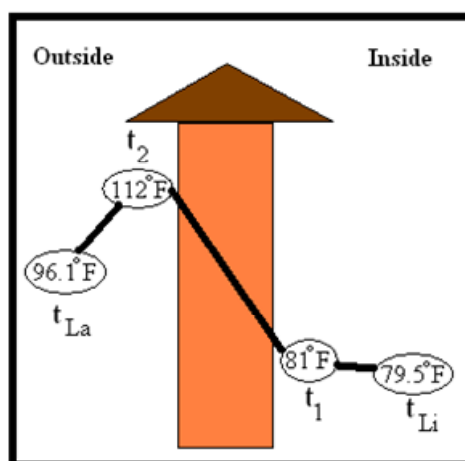
Figure 13. Chengqi Tulou temperature profile.

Table 3 shows temperatures recorded at different locations of the Chengqi Tulou, *i.e.*, outside the Tulou, the outer and inner rammed earth wall surfaces, inside an interior room, *etc.* As can be seen from Table 3, the hottest that the outer surface of the rammed earth wall ever reached was 112° F, with a temperature profile inside and outside the Tulou shown in Figure 13. Since this was the most extreme temperature difference, this set of temperatures at 15:20 was used to calculate the thermal resistivity *in situ*, giving a thermal resistivity of 1.0986 m.K/W [9].
