INVESTIGATION OF COPPER CONTAMINATION AND CORROSION SCALE
MINERALOGY IN AGING DRINKING WATER DISTRIBUTION SYSTEMS

Nadja Frank Turek, Captain, USAF

AFIT/GES/ENV/06M-05

THESIS

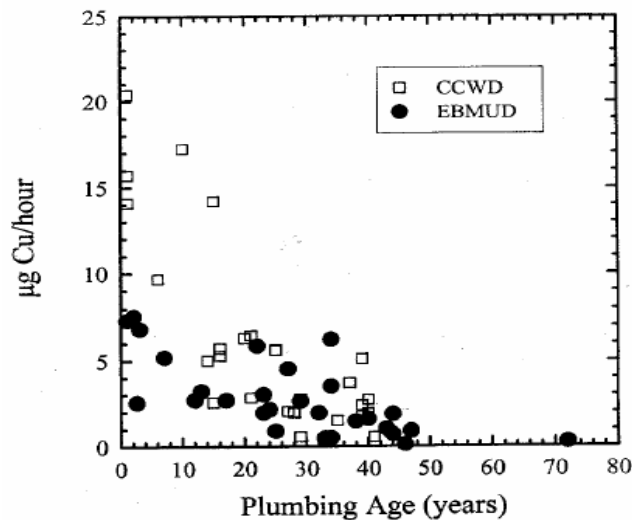
Figure 2.1 Distribution of adjusted copper leaching rates vs. age (Schock et al., 1995).

1995). These rates were then graphed, and an inverse relationship between rate and plumbing age was exhibited for plumbing ages less than 20 - 35 years. Above this age range, the data become more random. Figure 2.1 shows the rate vs. plumbing age data for two water systems, Contra Costa Water District (CCWD) and the East Bay Municipal Utility District (EBMUD), considered in the study (Brandenburg et al., 1993; Schock et al., 1995).

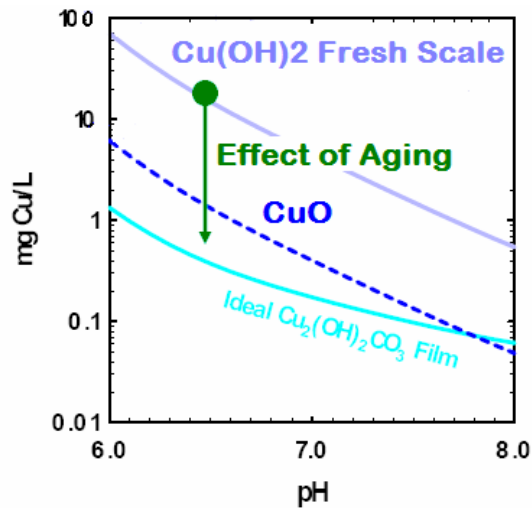
Figure 2.3 Effects of Aging on Dissolved Copper Concentration (Lytle, 2005)

It is believed that in drinking water systems where aqueous copper concentrations reach elevated levels, particularly when the systems are young, the dominant solid in the scale is $\text{Cu}(\text{OH})_2(\text{s})$. Equilibrium copper concentrations will begin to fall as copper precipitates to form more thermodynamically stable copper solids (Broo et al., 1997). Aqueous copper concentrations in equilibrium with tenorite (CuO) are predicted to be an order of magnitude lower than concentrations in equilibrium with cupric hydroxide, and concentrations in equilibrium with malachite [$\text{Cu}_2(\text{OH})_2(\text{CO}_3)$] are two orders of magnitude lower, as shown in Figure 2.3. An extensive explanation of the aqueous chemistry involved in both copper scale formation and dissolution is provided in the referenced work of Schock et al., (1995).

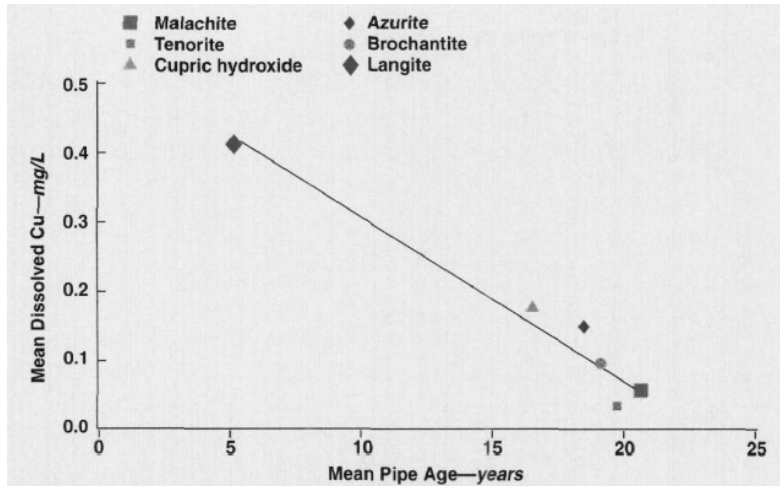
Figure 2.5 Plot of mean dissolved copper conc. vs. pipe age (Lagos et al., 2001), sorted by predicted copper solid

Having assigned each sample a predicted equilibrium solid, Lagos et al. (2001) then sorted the data by solid and found a mean copper concentration for each dominant solid. When copper concentration data were thus sorted, the average 8-hour stagnant copper concentration in drinking water decreased linearly with age, as Schock et al. (1995) had predicted (Lagos et al., 2001). Figure 2.5 shows the mean values and shows the downward trend of copper concentration with age.

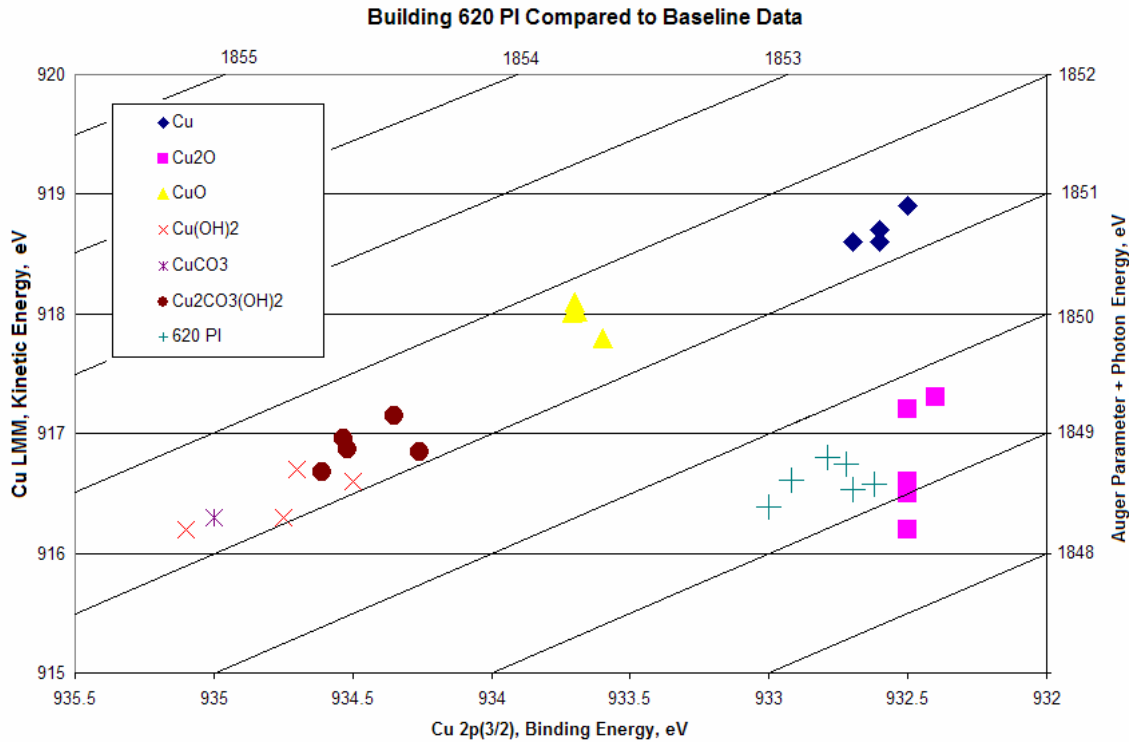
Figure 4.6 Chemical State Plot for Building 620 PI with Reference Data

Building 620 Phase I is a good example of the combination of chemical state and curve shape analysis necessary for scale identification. The chemical state plot for building 620 PI's six data points (three multiplexes on each of two pieces taken from the pipe) is shown in Figure 4.6. The FWHM determined peak locations for the Cu $2p_{3/2}$ peaks and Cu LMM Auger peaks place the samples in a neat cluster close to the reference values for Cu_2O .

Looking at this chemical state plot alone, one would ascertain that XPS identified Cu_2O on the samples from building 620 PI. However, a qualitative look at the peak shapes for the Cu 2p and Cu LMM peaks for these samples provides additional information about the solids present. Figure 4.6 shows the Cu 2p area of the XPS spectra for three multiplex scans taken on the same pipe sample in slightly different locations, one after the other.

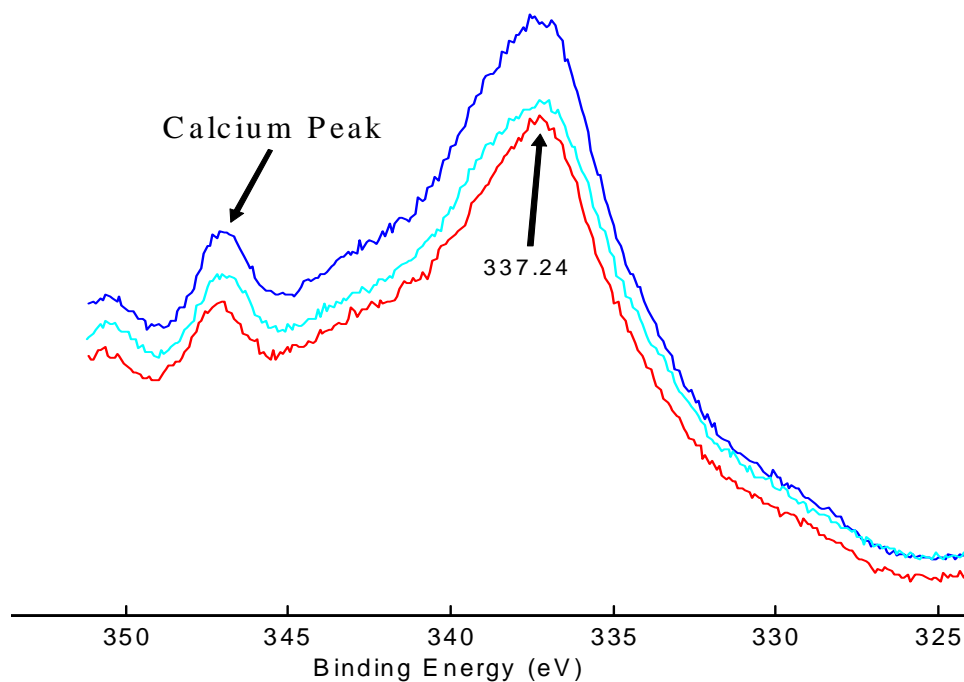
Figure 4.9 Cu LMM Peak Montage from Three Building 620 PI High Resolution Scans

Note that Figure 4.9 also identifies a characteristic calcium peak on the high binding energy side of the Cu LMM peak. The researcher was able to identify and analyze several other peaks in addition to copper to aid in species identification. Nitrogen, carbon, oxygen, zinc, iron, calcium, chlorine, silicon, and phosphorous were all recorded when identified. Often the location and shape of the carbon, oxygen and

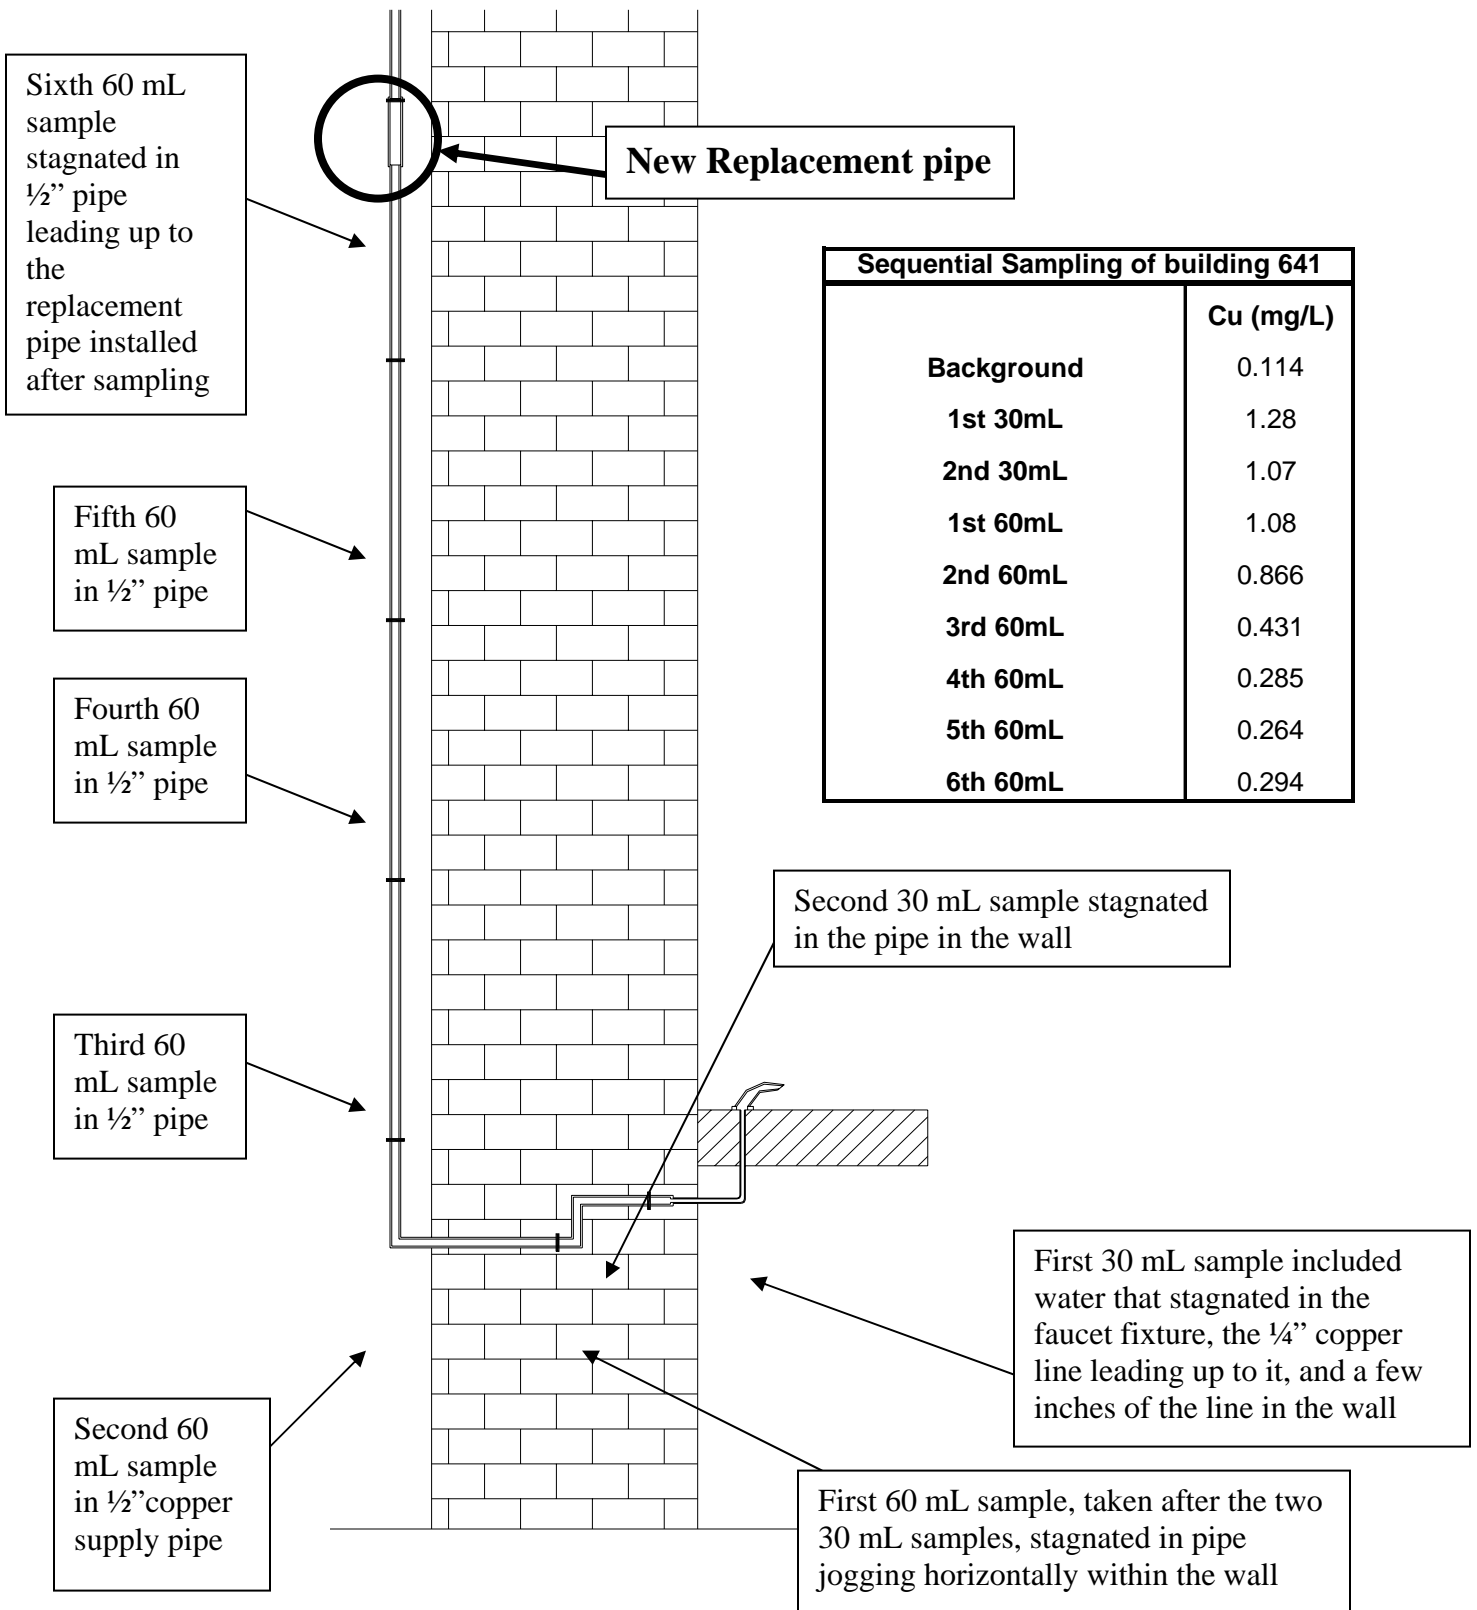
Diagram of Sequential Water Sampling Experiment
