Effect of Environment on Creep Behavior of an Oxide/Oxide CFCC with $\pm 45^\circ$ Fiber Orientation

THESIS

AFIT/GAE/ENY/06-J15

AIR FORCE INSTITUTE OF TECHNOLOGY

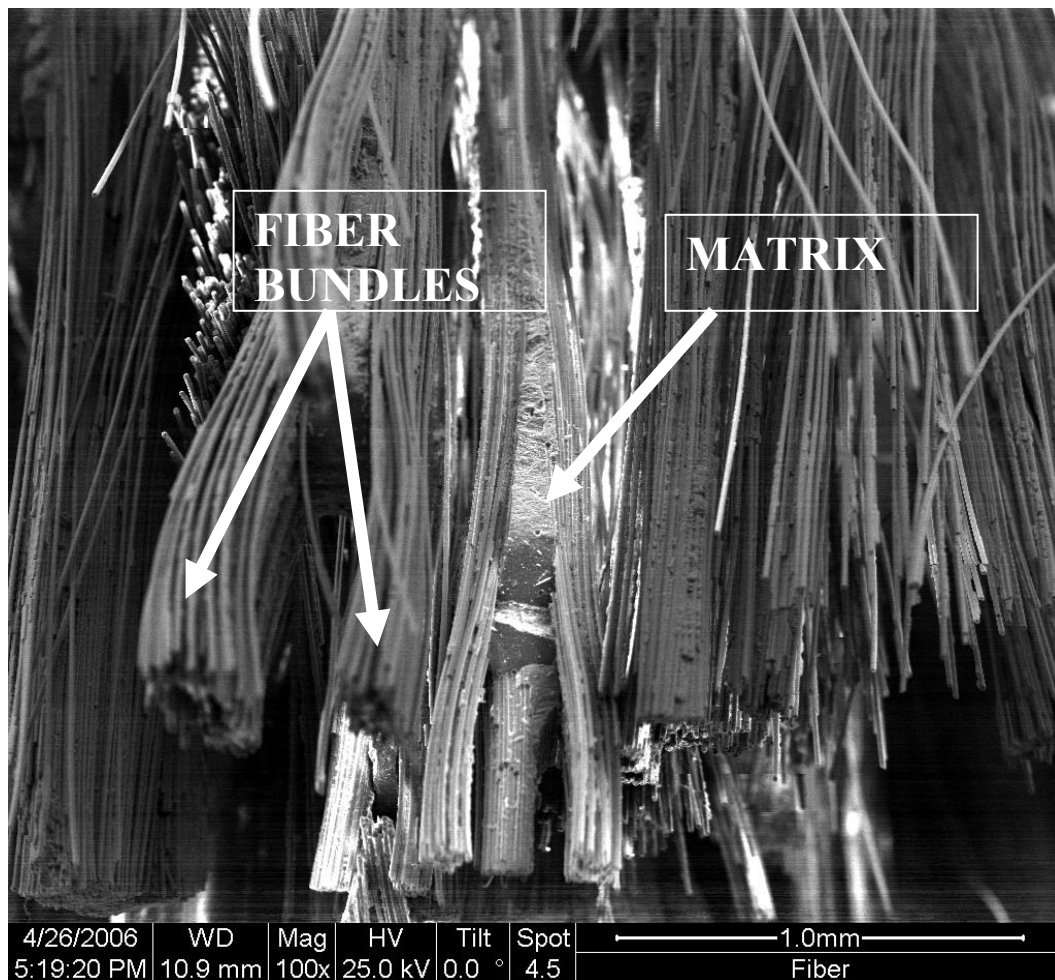
Figure 4. Micrograph of the N720/A specimen subjected to creep at 45 MPa in laboratory air. Fiber bundles and matrix are clearly seen.

(Al_2O_3) and/or mullite ($3\text{Al}_2\text{O}_3 \cdot 2\text{SiO}_2$) [11:12]. The fibers used in Nextel 720/A are oxide continuous monofilament fibers. In order to achieve high creep resistance, Nextel™ 720 fibers contain large mullite grains which minimize grain boundary sliding [17:2333]. The micrograph in Figure 4 shows fiber bundles from a Nextel 720/A specimen used in this research.

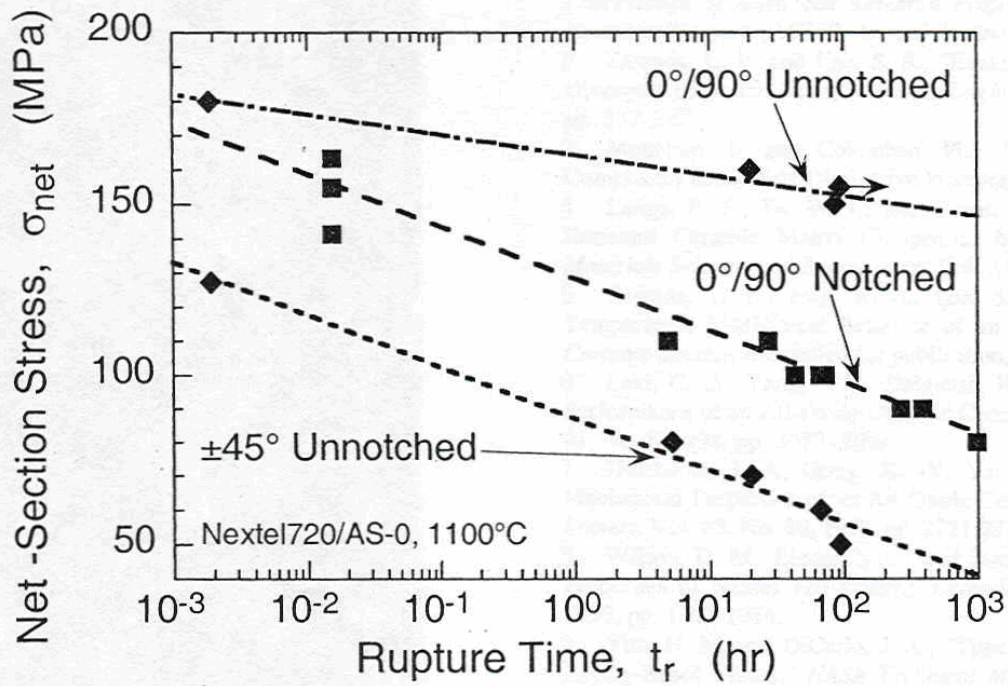
Figure 9. Creep rupture behavior of N720/AS in 0/90° and ±45° orientation at 1100°C. Shows that high creep rates generally correspond to a short creep life [8:457].

0/90° fiber orientation [8:457]. Figure 9 shows that regardless of fiber orientation, high creep rates generally correspond to a short creep life. However, Zawada et al [8:457] reported that the $\pm 45^\circ$ cross-ply exhibited higher secondary creep rates and shorter creep life compared to those obtained for the 0/90° cross-ply.

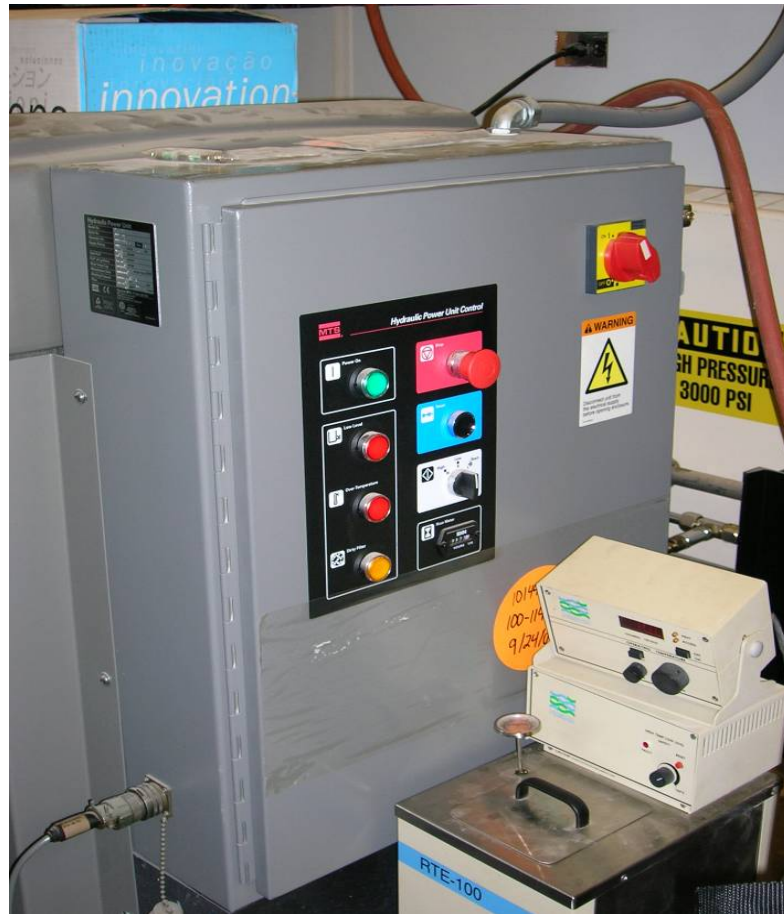
Figure 15. Hydraulic pump and chiller system.

The chiller for cooling the grips was the NESLAB model HX-75 chilled water system. This machine chilled the water in order to provide a safe operating temperature for the grips while the specimen operated in a 1200°C atmosphere. Using a water pressure regulator, the system chilled the distilled water to 10°C and re-circulated it through the wedge grips using 6.35 mm (1/4 in) diameter plastic tubing.

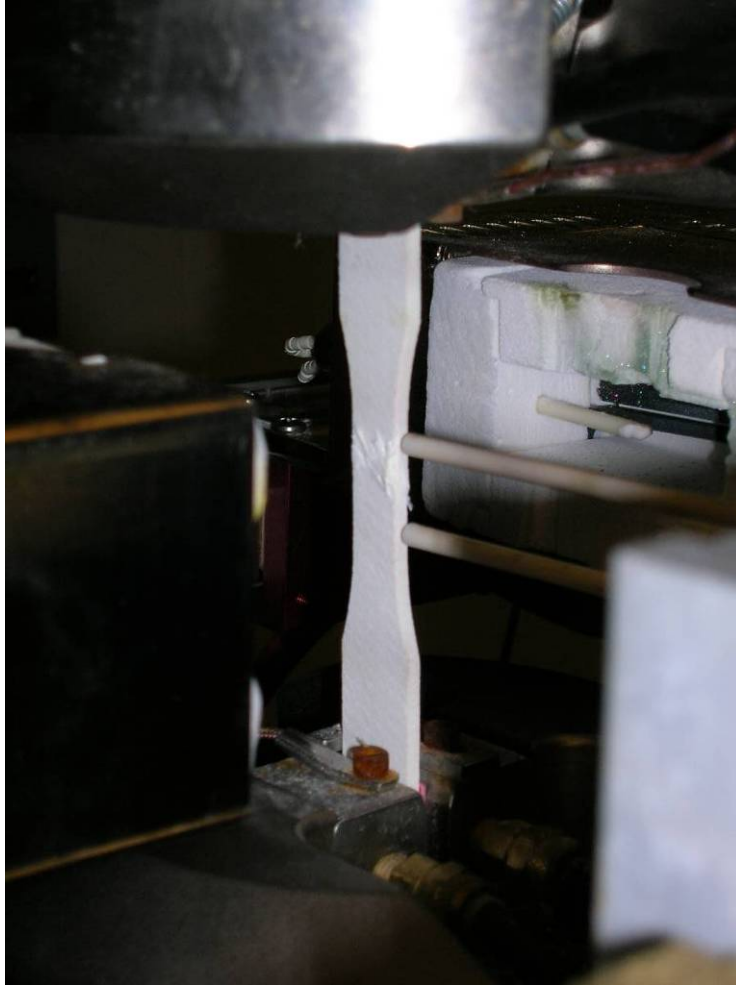
Figure 17. Extensometer on a fractured specimen.

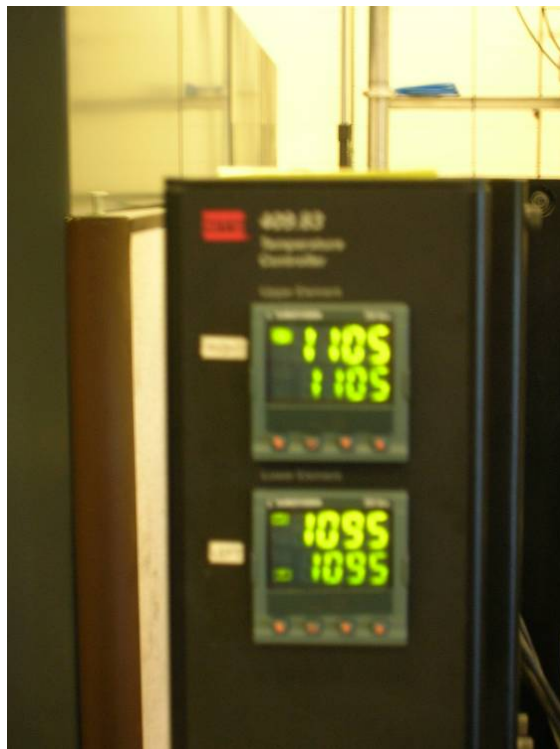
Figure 21. Temperature controller.

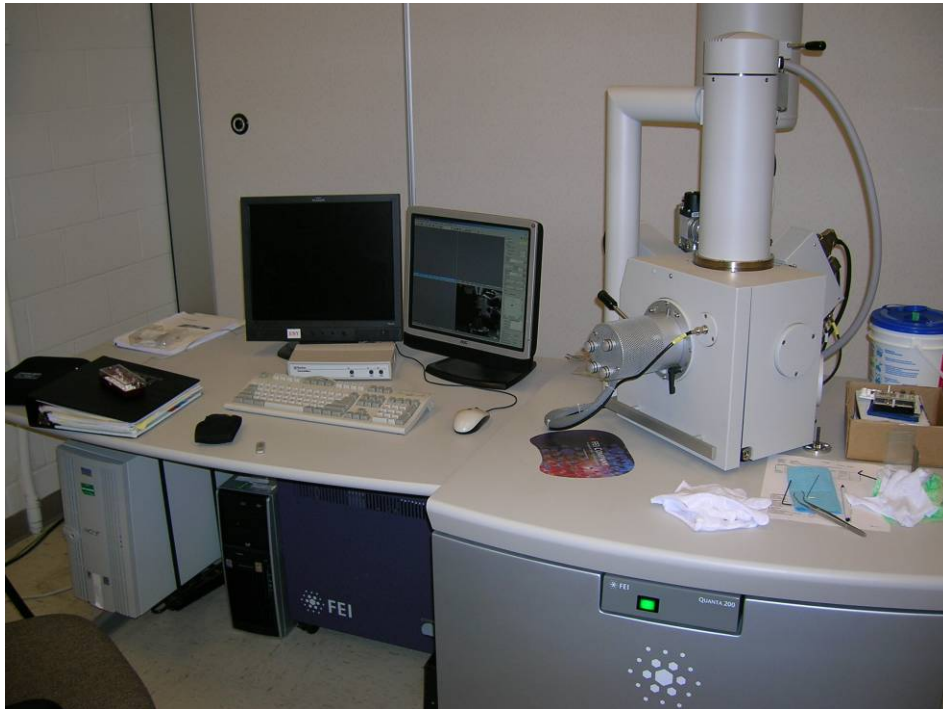
Figure 25. FEI FP 2011/11 Quanta 200 HV scanning electron microscope.

scanning electron microscopy (ESEM) mode. In the ESEM mode water vapor is present within the vacuum chamber enabling the non-conductive samples to become conductive. For observations at higher magnification, samples were coated with carbon paint using the SPI Module Carbon Coater. In addition, the SEM included an EDAX Genesis 4000 Energy Dispersive X-Ray Spectroscopy (EDS) system. This system permitted a detailed examination of fractured surfaces in order to determine what elements were present.

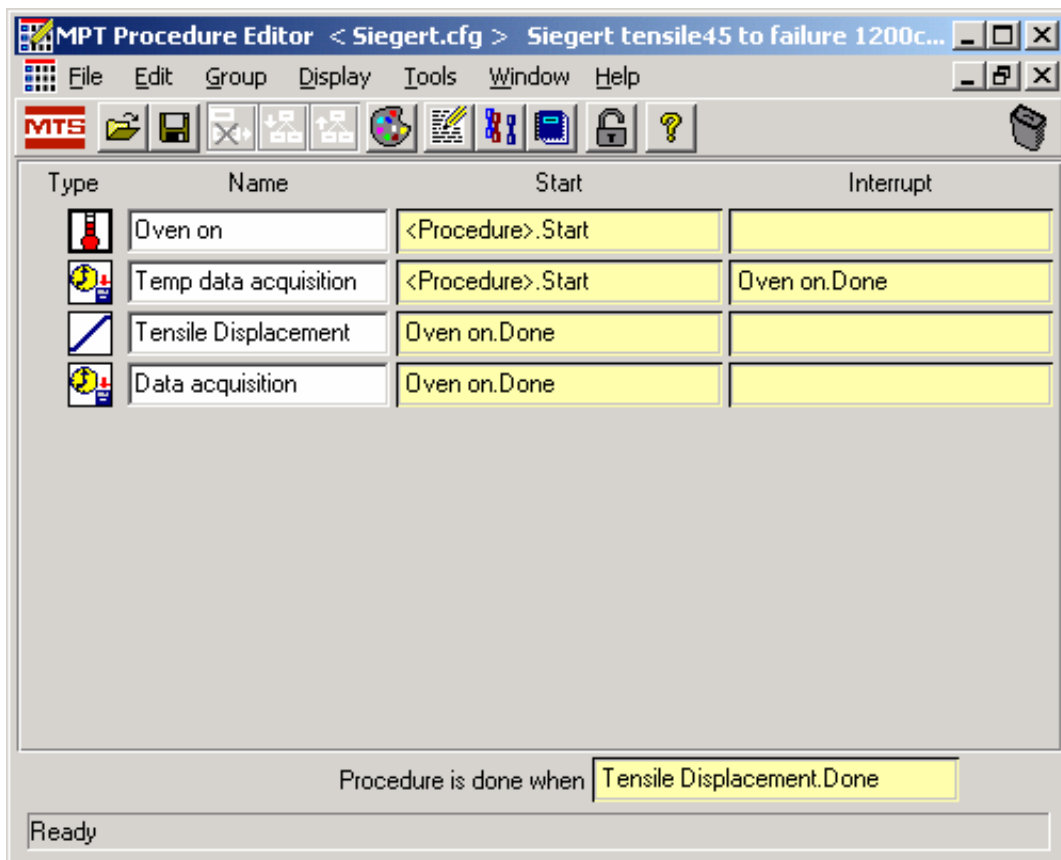
Figure 28. Monotonic tension test procedure.

Monotonic tension tests to failure were carried out to determine the ultimate tensile strength (UTS), modulus of elasticity (E), and coefficient of thermal expansion (α) of an as-processed specimen. Tensile tests were performed in displacement control with a constant tensile displacement of 0.05 mm/s at 1200°C in laboratory air. In all tests, the specimen was heated to 1200°C at a rate of 1°C/s and then allowed to dwell at 1200°C for at least 15 min. During tension tests time, furnace temperature, force, displacement, displacement command, and strain were recorded. An example of a monotonic tensile test procedure is shown in Figure 28.

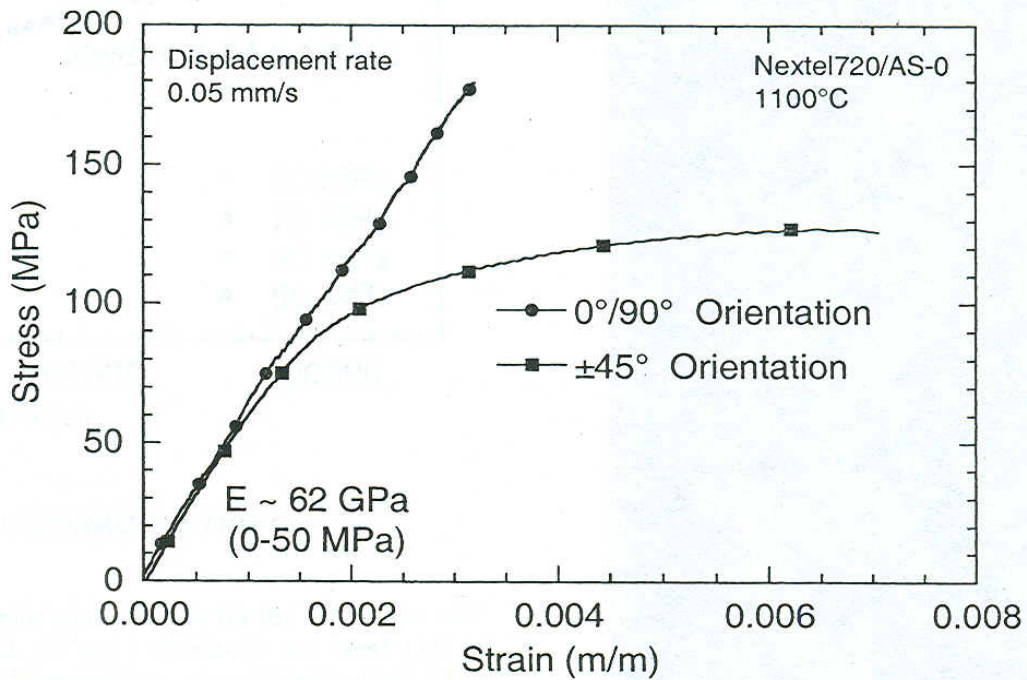
Figure 32. Tensile stress-strain curves for N720/AS at 1200°C [8].

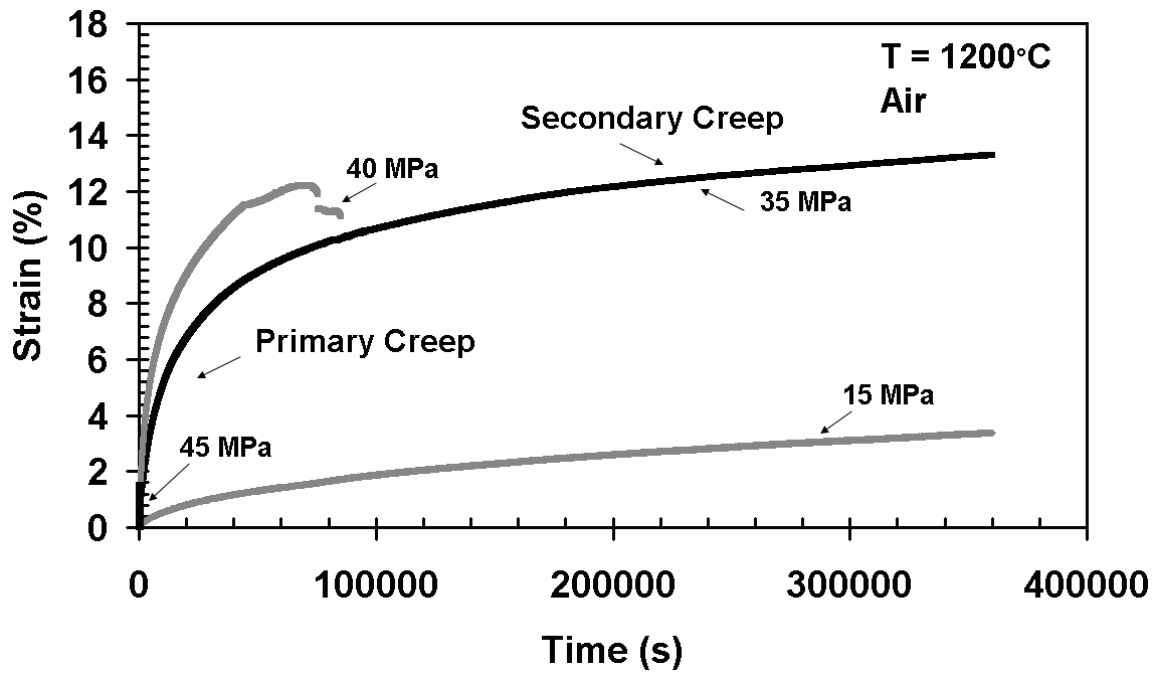
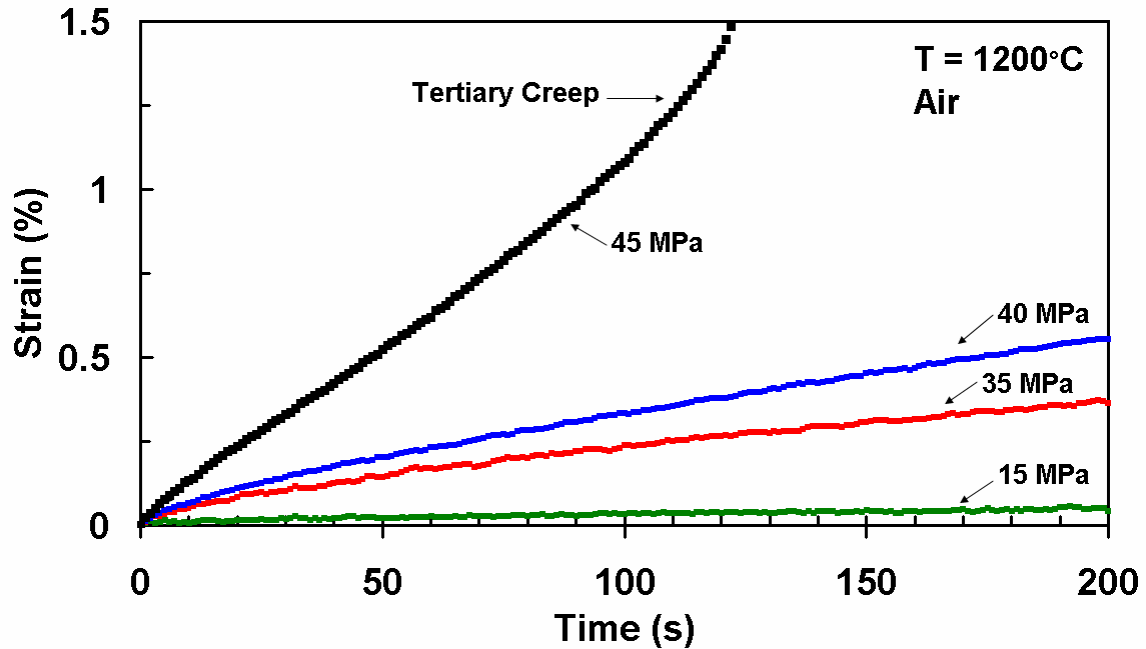
Figure 33. Creep-strain vs. time in air at 1200°C.

results were checked for any extensometer slippage and none was found. Creep curves obtained vs. time in seconds at 1200°C in air are shown in Figure 33. In all the tests in Figure 33, primary creep is seen and then rapidly transitions into secondary creep. In the case of the 45 MPa test, secondary creep rapidly transitions into tertiary creep, for the creep strain levels ≤ 40 MPa, secondary creep persists until failure or to run-out. Results in Table 7 indicate that in air the creep run-out stress is between 35 and 40 MPa.

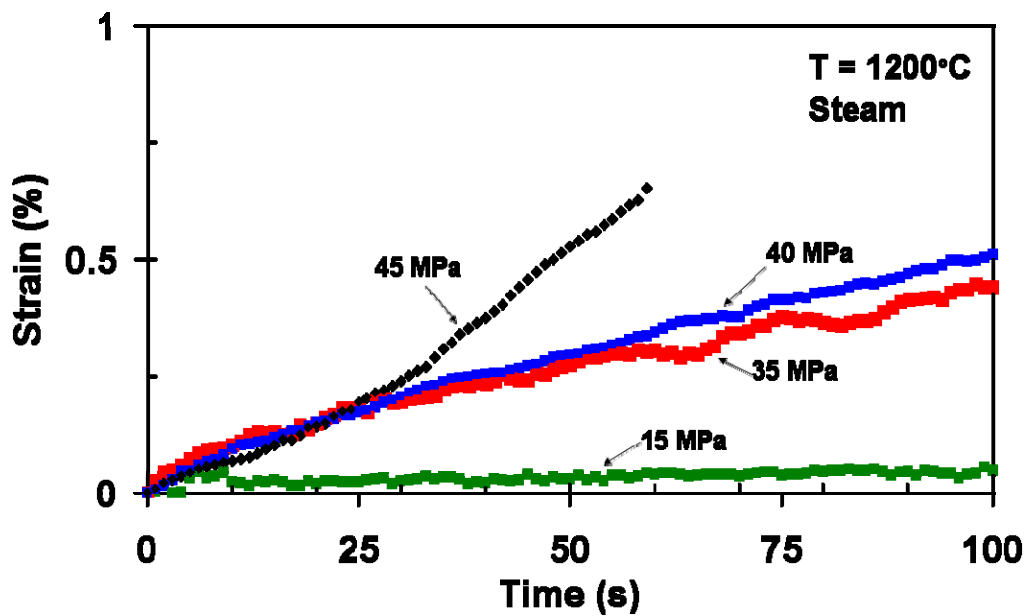
Figure 34. Creep-strain vs. time in 100% steam at 1200°C .

The creep curves obtained at 1200°C in steam are presented in Figure 34.

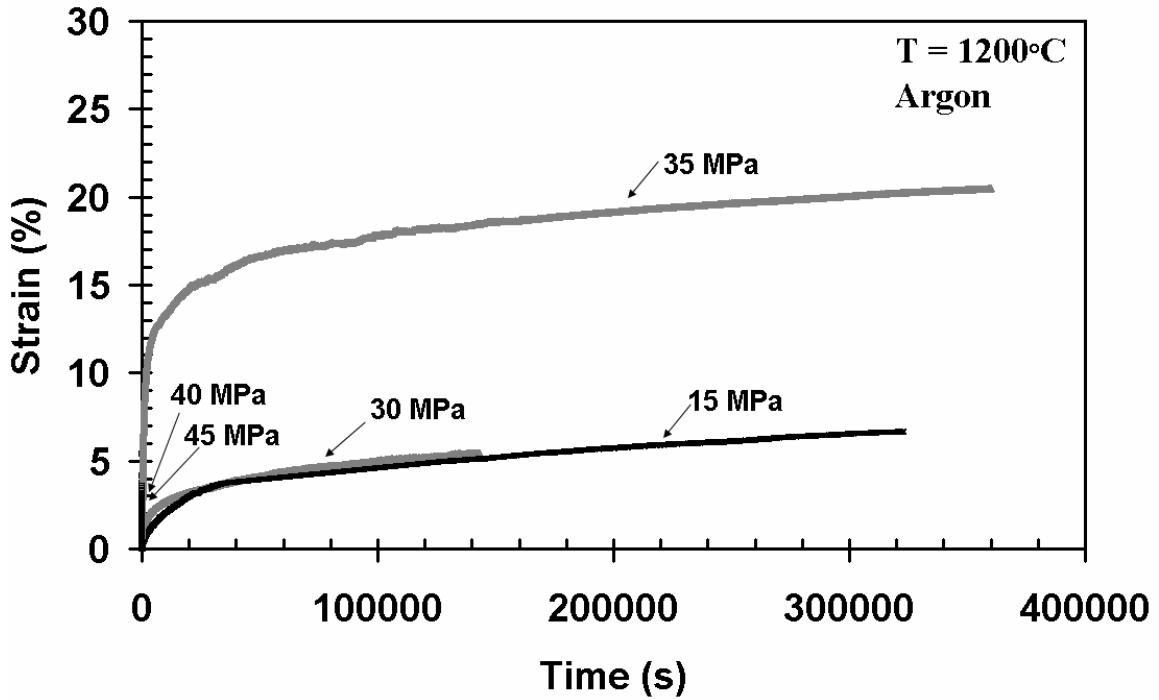
Figure 35. Creep-strain vs. time in 100% argon at 1200°C.

Specimen #	Creep Stress (MPa)	Time to Failure (h)	Accumulated Creep Strain (%)
C-12	45	0.006	3.72
C-13	30	NA	4.46
C-14	40	0.009	2.36
C-15	15	100	5.67
C-16	35	100	20.9
C-17	45	0.003	0.72
C-18	40	0.000	3.58

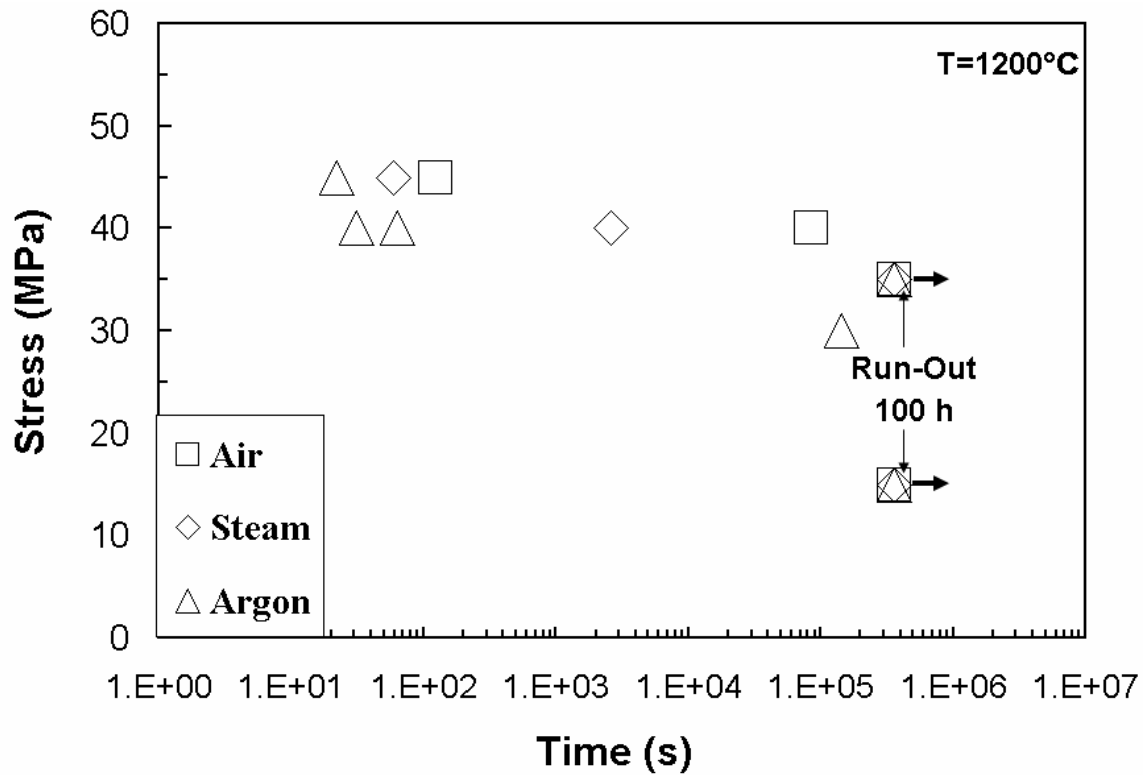
Figure 37. Creep strain rate vs. creep stress at $1200^{\circ}C$ in air, steam, and argon environments.

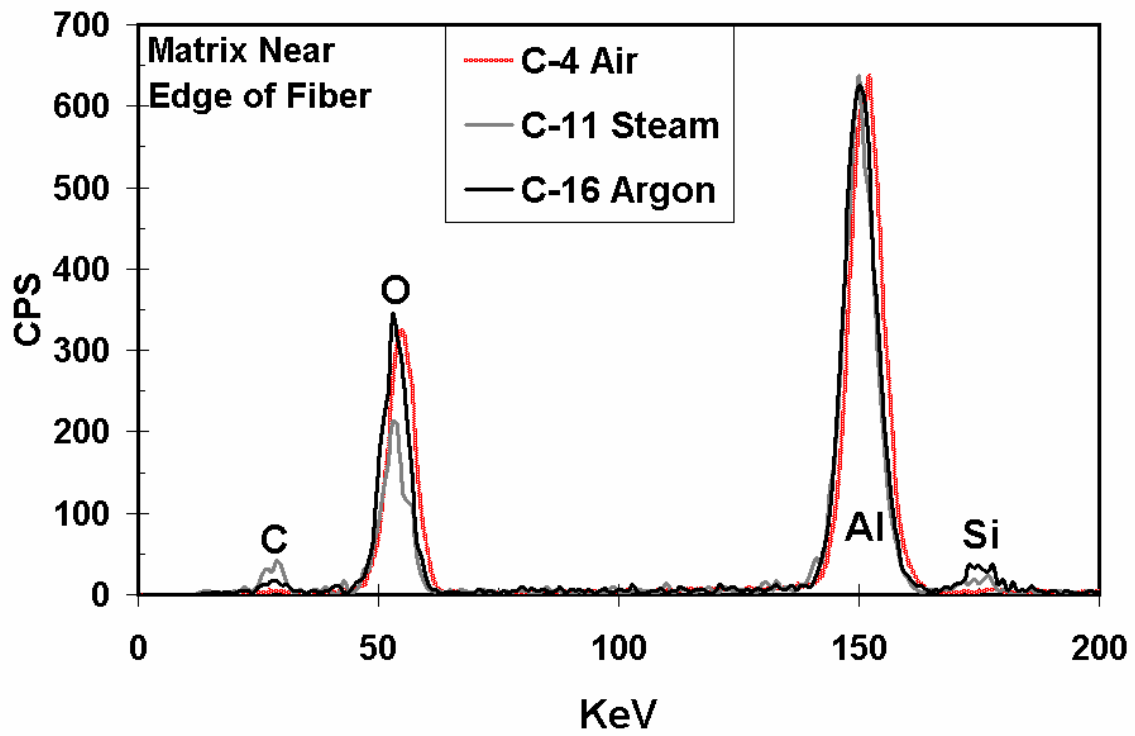
Figure 71. EDS spectra of the matrix near edge of fiber in all three environments.
