Creep-Rupture and Fatigue Behaviors of Notched Oxide/Oxide Ceramic Matrix Composite at Elevated Temperature

THESIS

Mark A. Sullivan, Captain, USAF
AFIT/GAE/ENY/06-M30

AIR FORCE INSTITUTE OF TECHNOLOGY

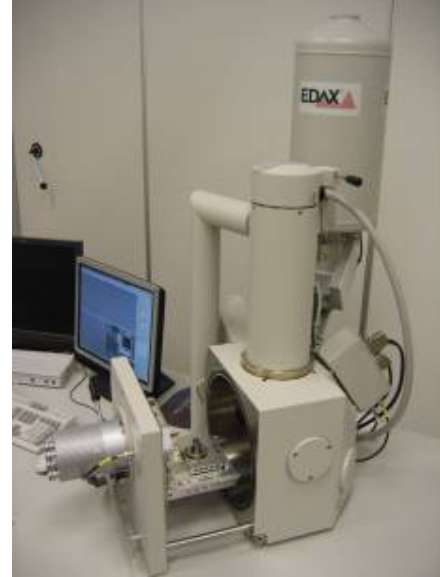
Figure 12. Quanta 200 SEM

Images of fracture surfaces were made using both an optical microscope and a scanning electron microscope (SEM). The optical microscope was a Zeiss Discovery.V12 with a Zeiss AxioCam HRc to capture images and the SEM used was a FEI Quanta 200, shown respectively in Figure 11 and Figure 12.

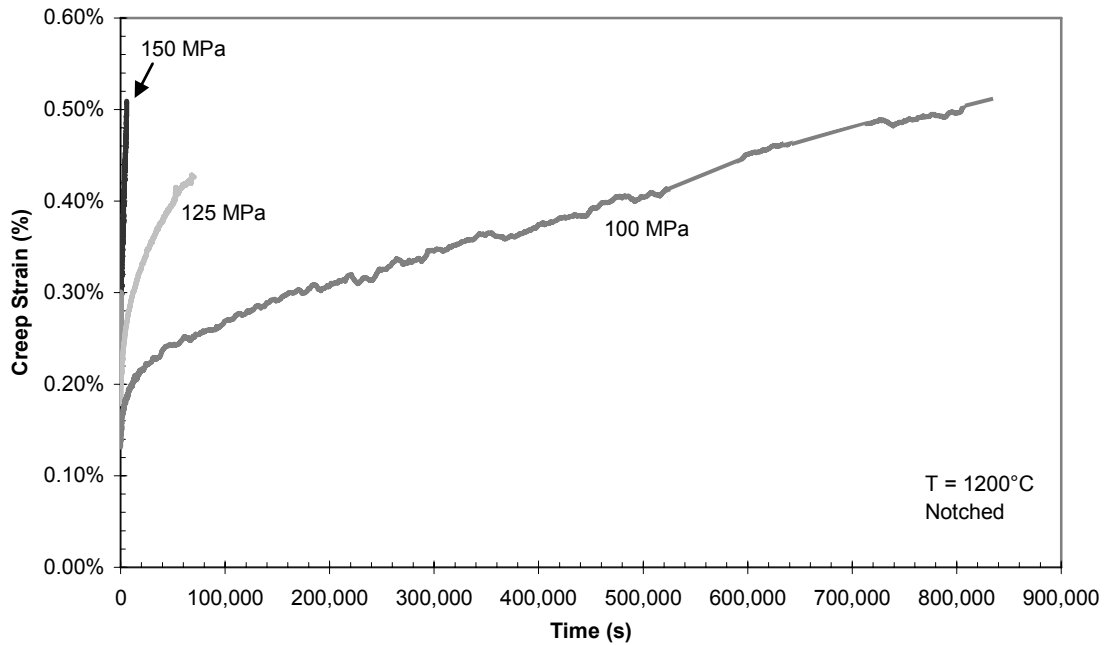
Figure 17. Creep strain vs. time for notched N720/A at 1200°C

strain gage exhibited slipping during the latter half of the test. Despite this slipping, it is apparent the secondary region extends to 800,000 s. However, it is impossible to determine whether or not tertiary strain growth occurred during the last period of the test.

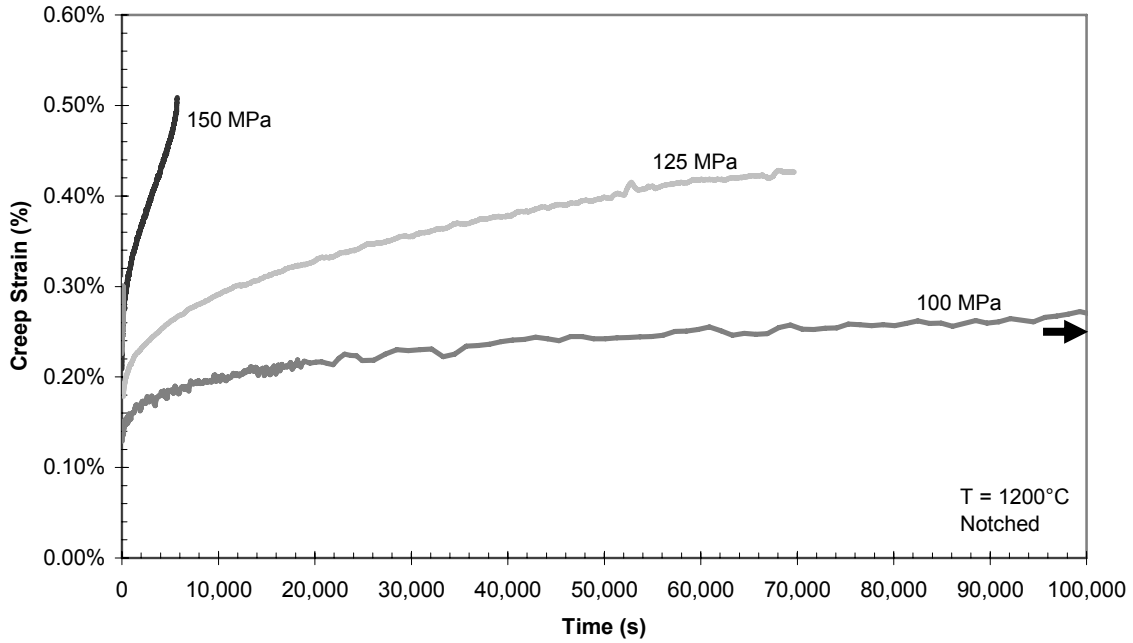
Figure 18. Creep strain vs. time for notched N720/A at 1200°C (truncated time scale)

The strain-time plot for 125 MPa is shown in Figure 18. In this case the curve appears to remain concave down up to failure, suggesting the specimen remained in the region of primary strain growth for the entire test. Calculation of creep rate was based on a linear curve fit of the last 10,000 seconds.

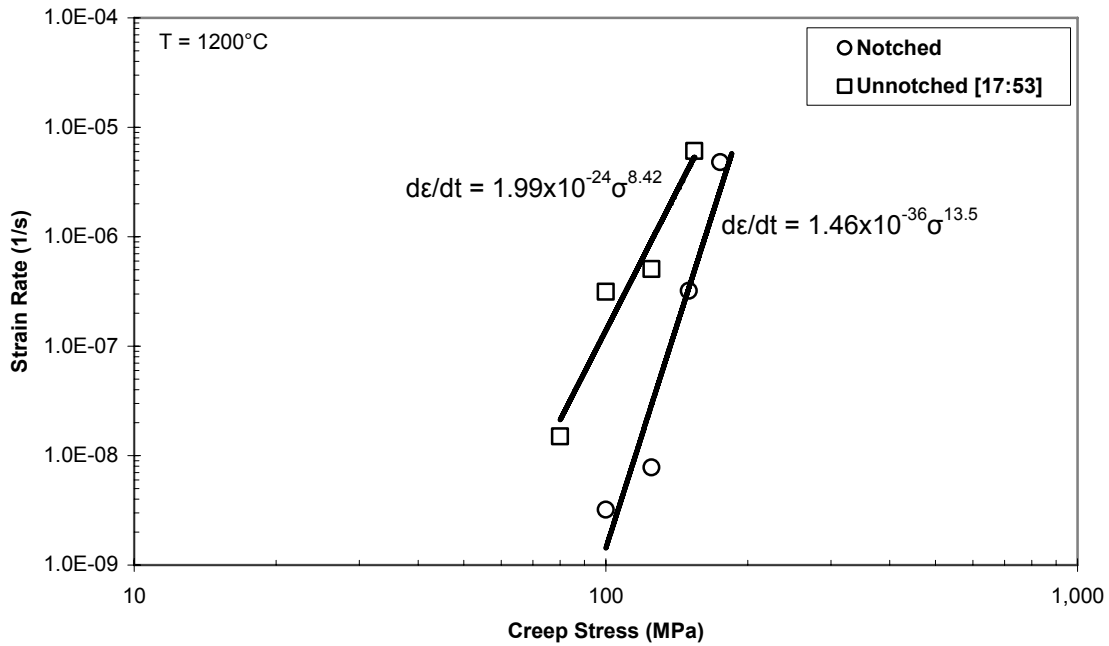
Figure 21. Minimum creep rate vs. creep stress for N720/A at 1200°C

average strain for the notched specimens makes it impossible to directly compare constants for the two curves. The lower strain rate for the notched specimen is a byproduct of stresses dropping at increasing distance from the net-section.

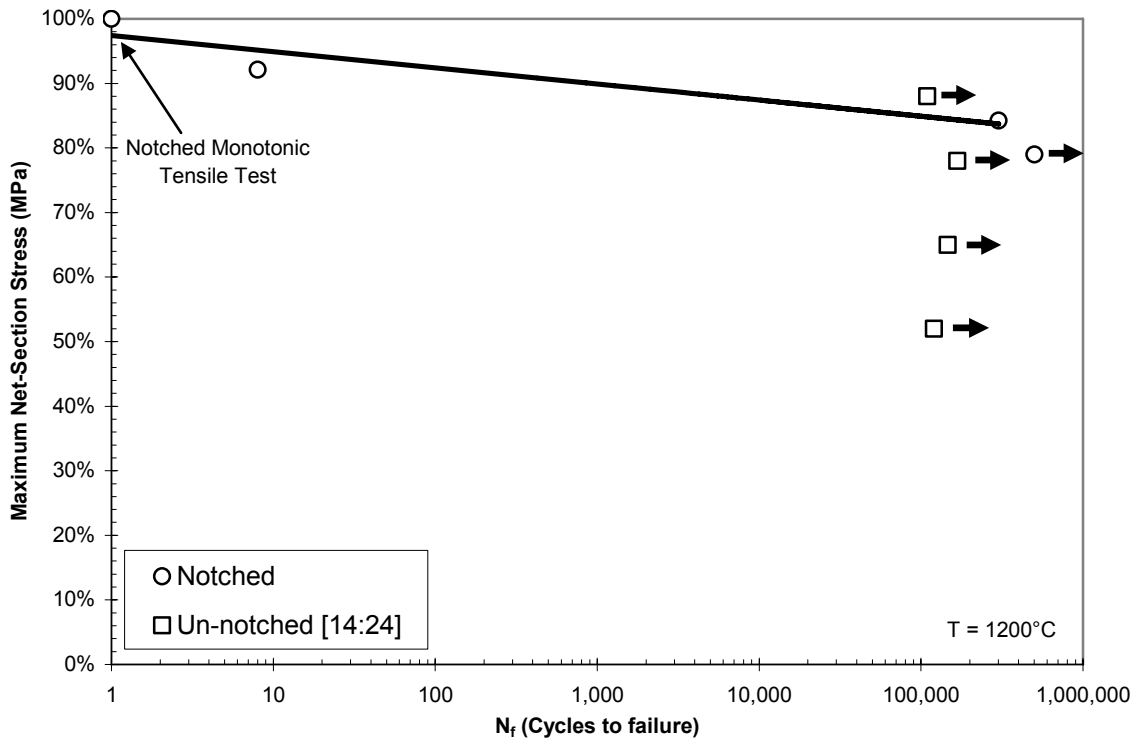
Figure 22. Fatigue stress vs. cycles to failure for N720/A at 1200°C

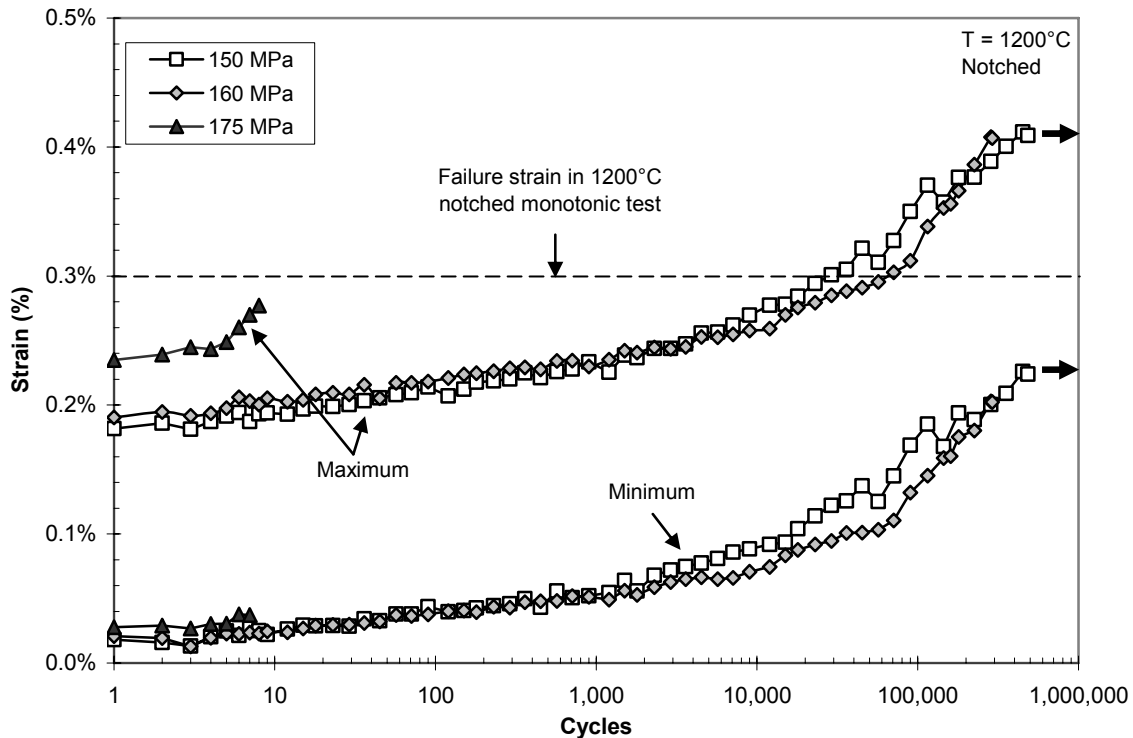
Figure 23. Maximum and minimum strain vs. fatigue cycles for notched N720/A at 1200°C

One method of monitoring the accumulation of fatigue damage is to plot maximum and minimum strains for each cycle. The notched data are presented in such a fashion in Figure 23, with the reminder that notched strains values are a measure of strain averaged over the gage length and not local strain values. The strains for 150 and 160 MPa tests closely follow each other and suggest there is little difference in the damage accumulation between the two stresses. The 175 MPa test displayed markedly different behavior. Over the first four cycles the specimen experienced higher maximum strains than the other tests, but the rate of strain increase differed little. Once beyond the fourth cycle maximum strain began accumulating at a much faster rate, leading to failure at the eighth cycle.

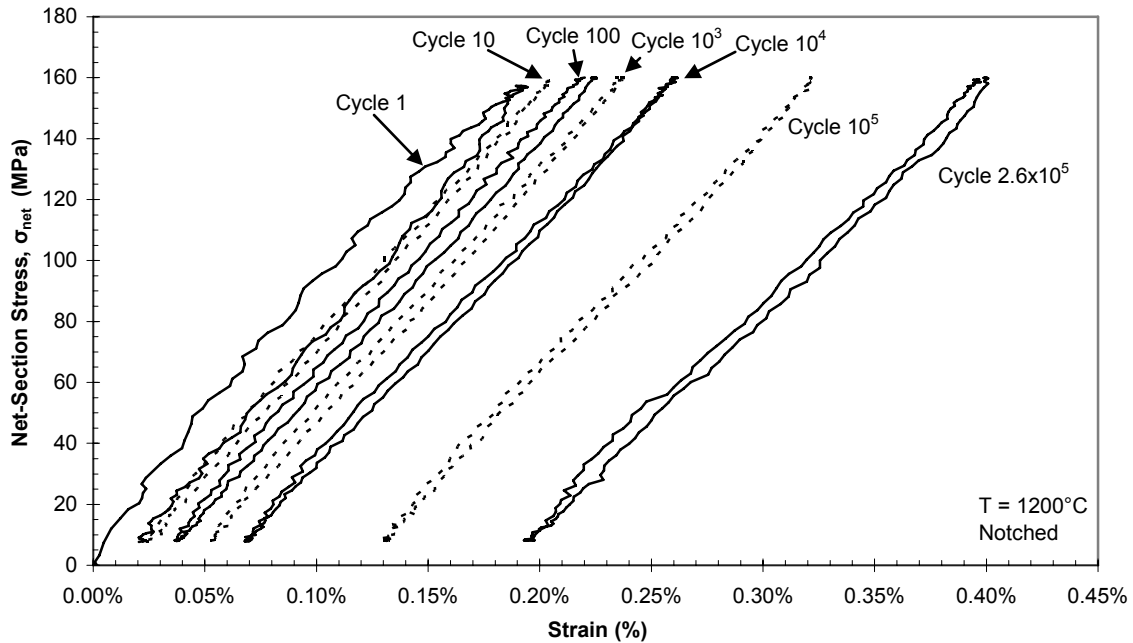
Figure 26. Hysteresis loops for N720/A at 1200°C, 160 MPa stress level

Hysteresis loops for 150 MPa and 160 MPa fatigue stresses are presented in Figure 25 and Figure 26. As expected, there was little difference between the two stress levels. Both show larger hysteresis for the first cycle, indicating cracking within the specimen. Cycles following the first showed linear-elastic loading and unloading behavior with minimal energy dissipated during the cycle. This suggests the cycling of the load itself causes little damage, but that creep might be the primary cause of increasing strain with increasing cycles.
