# **OBSERVED BEHAVIOUR OF OLD RAILWAY EMBANKMENTS FORMED OF ASH AND DUMPED CLAY FILL**

## **ABSTRACT**

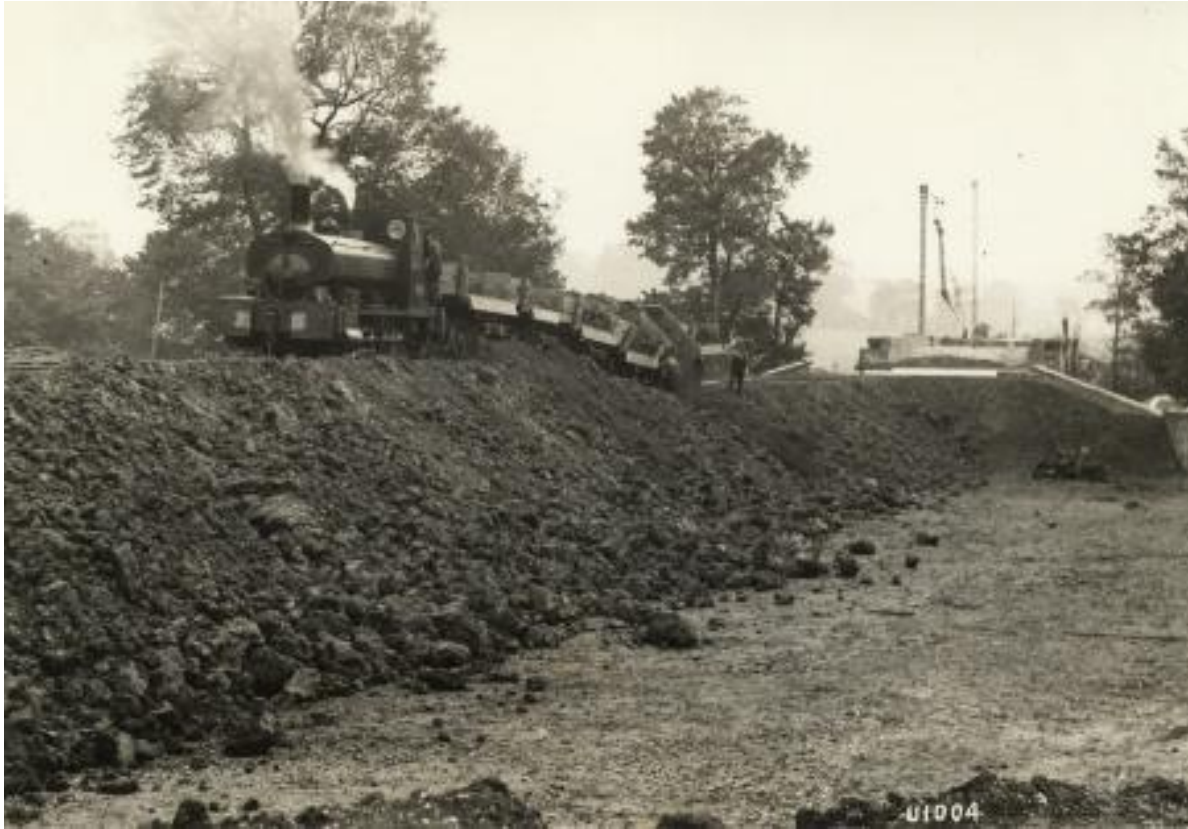
**Figure 1.** Formation of embankments from London Clay fill by side-tipping from railway carriages (photograph courtesy of the Transport Museum: site of Hendon Central Underground station, Northern line by Topical Press, 03/10/1922).

London Underground Limited (LUL) owns some 70 km of suburban surface track on clay embankments between 2 and 12 m high. Most were formed by end- and side-tipping clods of London Clay with some hand spreading but no compaction (Skempton, 1995). An example of this process is shown in **Figure 1**. The natural tipped slopes could be as steep as 1:2, although the open lumpy clay often spread to something flatter without actually forming a slip. Large post-construction movements were characteristic of these embankments of uncompacted fill (Wiseman, 1888). The higher embankments often slipped during construction, in the fill, in clayey alluvium where they crossed small valleys and sometimes in the top of the London Clay foundation usually present. As a consequence of the deformations and slips within these embankments (which could result in slopes as flat as 1:4), they were usually finished and subsequently topped up with steam locomotive ash, used because of its light weight, high shear strength, free-draining nature and ready availability. This locomotive ash typically is vesicular in nature, well graded with particle sizes ranging from fine sand to coarse gravel (roughly 40% sand to 60% gravel size by mass), and has an in-situ dry density of about  $1\pm 0.2 \text{ t/m}^3$ . Crest slopes in ash were as steep as 1:1.5 with up to about 4 m of ash being placed to maintain track alignment. The London Clay fill material is variable with a mixture of London Clay clods in a softer broken-down clay matrix. ‘Best estimate’ strength parameters used in the numerical modelling of similar embankments are provided later for reference. Thus these embankments are characterised by steep narrow crests, steep upper slopes in ash and variable clay slopes below (**Figure 2**). Since about 1960 the slopes have been colonised by shrubs and trees of up to 0.5 m trunk diameter. Ash has also been employed as an embankment fill material in other parts of the UK besides London and other countries, e.g. the use of ash is detailed in the Malayan Railway Permanent Way Manual, (Way and Works Department, 1952) and the Roorkee Treatise on Civil Engineering, (Brandreth, 1899). More recently hopper ash from power stations has been used rather than

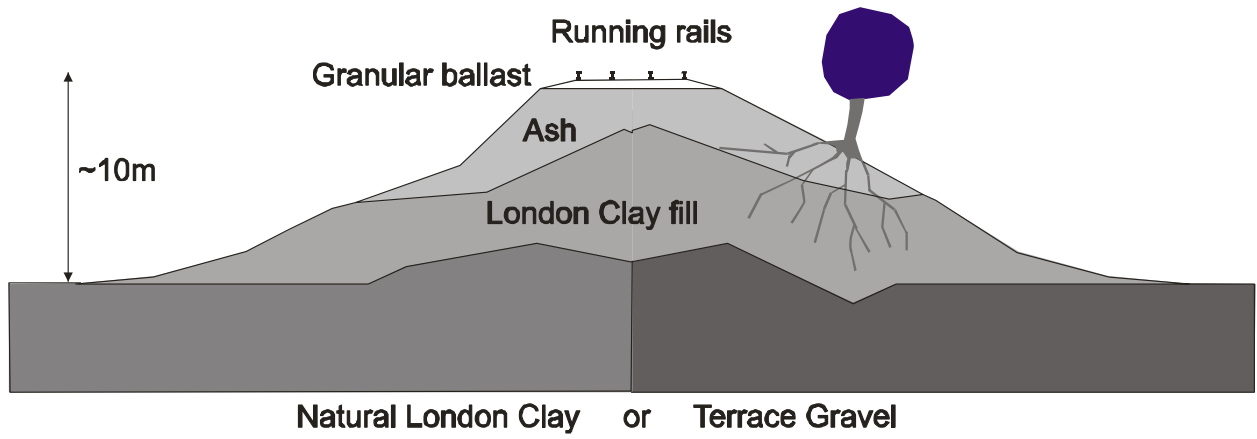
**Figure 2.** Typical ash embankment profile.

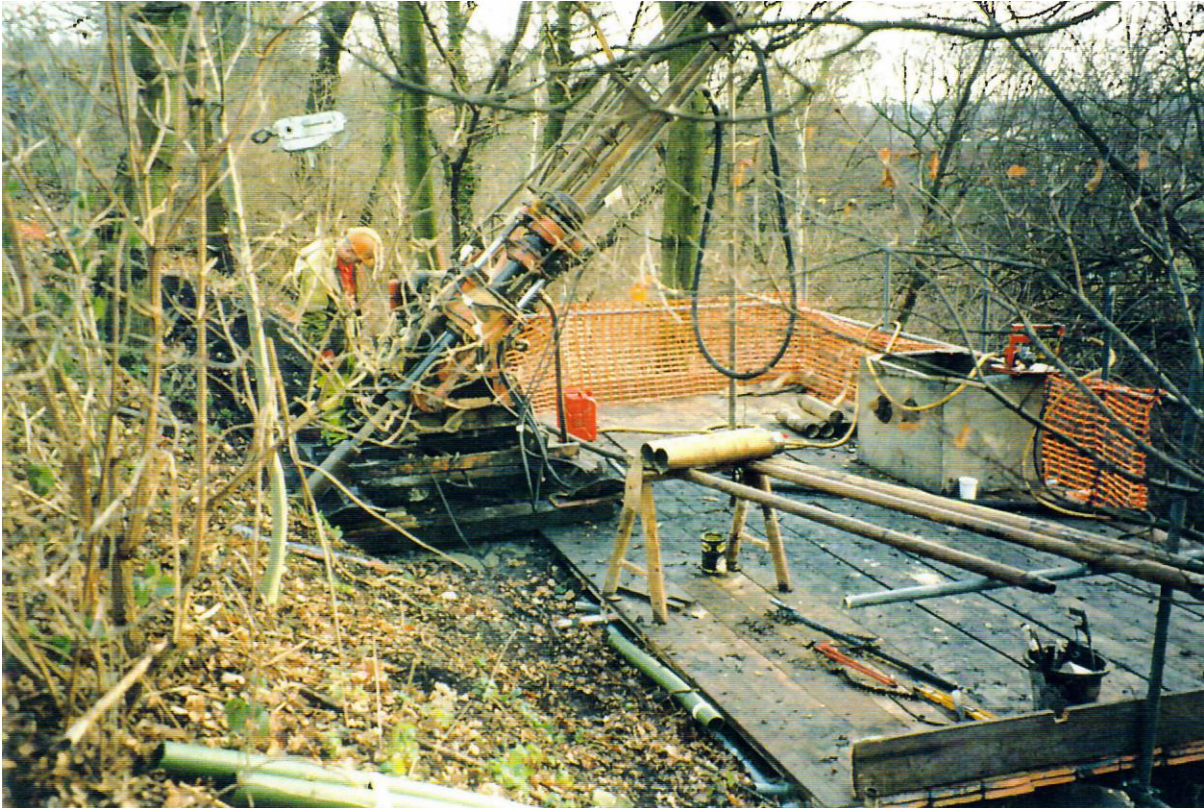
**Figure 5.** Drilling the raking hole at section A, Roding Valley (07.12.1993).

(suggesting an undrained strength of the clay of about 90 kPa). Holes were advanced using a rotary drilling rig with a water/foam flush and 100-mm diameter casing (**Figure 5**). The PVC tubing was then installed, the annular space filled with grout pumped down a tremie pipe and the casing withdrawn.

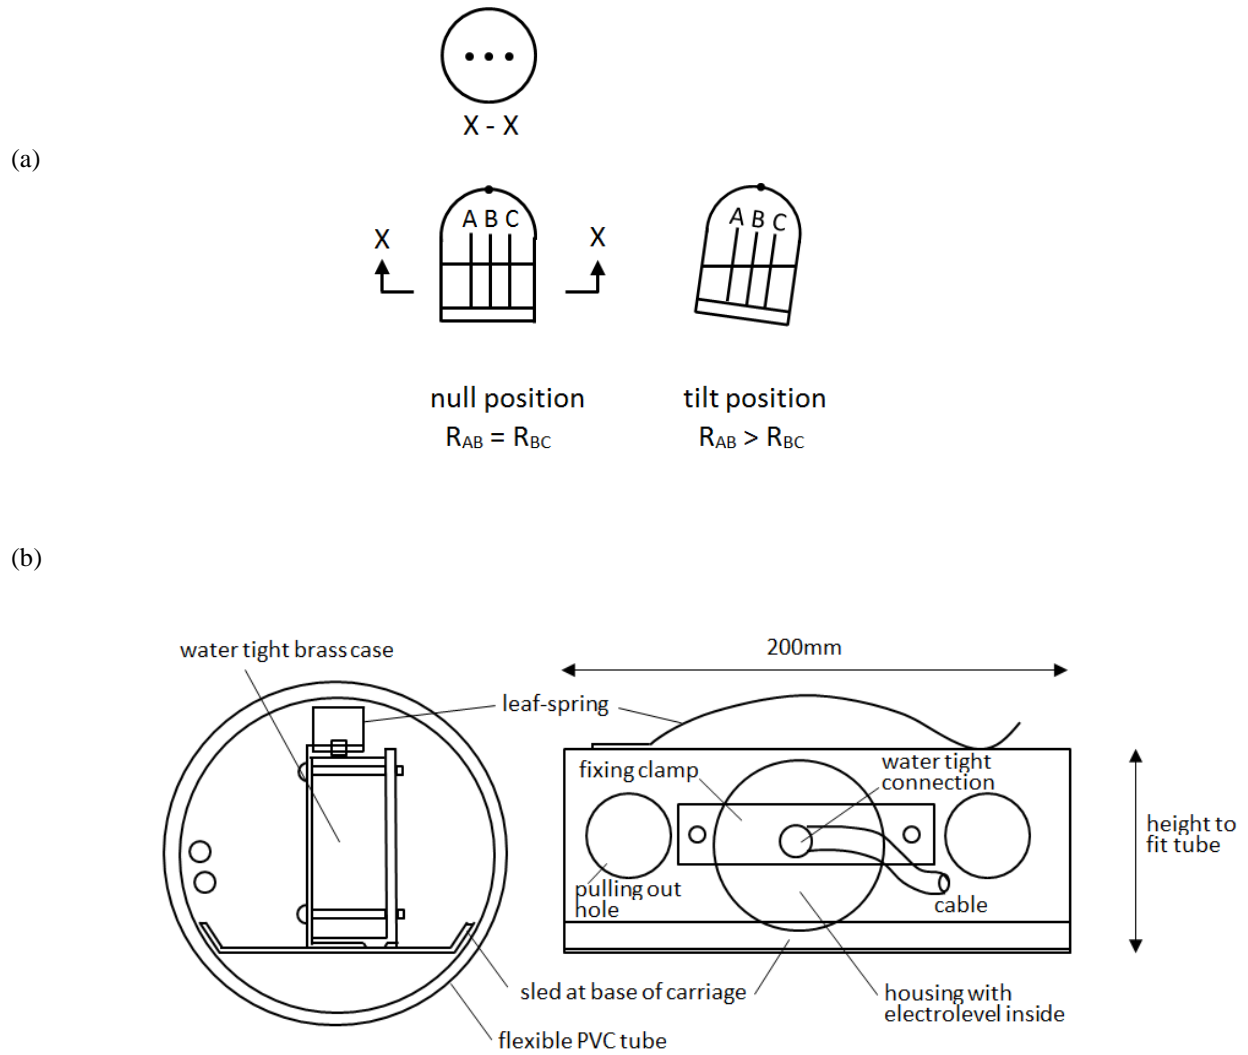
**Figure 6.** Schematic details of the electrolevel devices: (a) operating principle; (b) carriage on which the devices were mounted, shown in horizontal position (within inclinometer tube on left).

Static deformations were measured using ‘strings’ of electrolevels positioned along the lengths of the tubes. Electrolevels measure rotations by recording changes in resistance across three electrodes partially immersed in an electrolytic fluid as shown in **Figure 6a** and the output data are converted to angular measurements using calibration factors (see Standing et al., 2001). The devices used were  $\pm 3^\circ$  series 0715 electrolevels supplied by Fredericks and calibrated under laboratory conditions to give a resolution of 1 arc second. Each electrolevel was mounted on a carriage of 200 mm length and held in place within the access tube by a leaf-spring as shown in **Figure 6b**. Prior to installing the devices within a given tube, one carriage with electrolevel was pushed to the base using a series of rods, taking a reading at each location where an electrolevel was to be installed. In this way the exact orientation of the tube was mapped and each individual electrolevel could be rotated within its housing to be close to the null position once in its appropriate position along the tube, to maximise the range of measurable rotation. The carriages are not connected together in any way. In standard inclinometer tubes there are two pairs of keyways to guide the torpedo or inclinometer device. As the inner surface of the tubes used was smooth, care was taken when pushing the carriages into position to avoid any rod twisting to ensure that measurements were within the correct plane of the embankment. The electrolevel positions within the embankment sections are shown in **Figure 4**, these were left in place and logged for periods of several months and typically read every three hours.

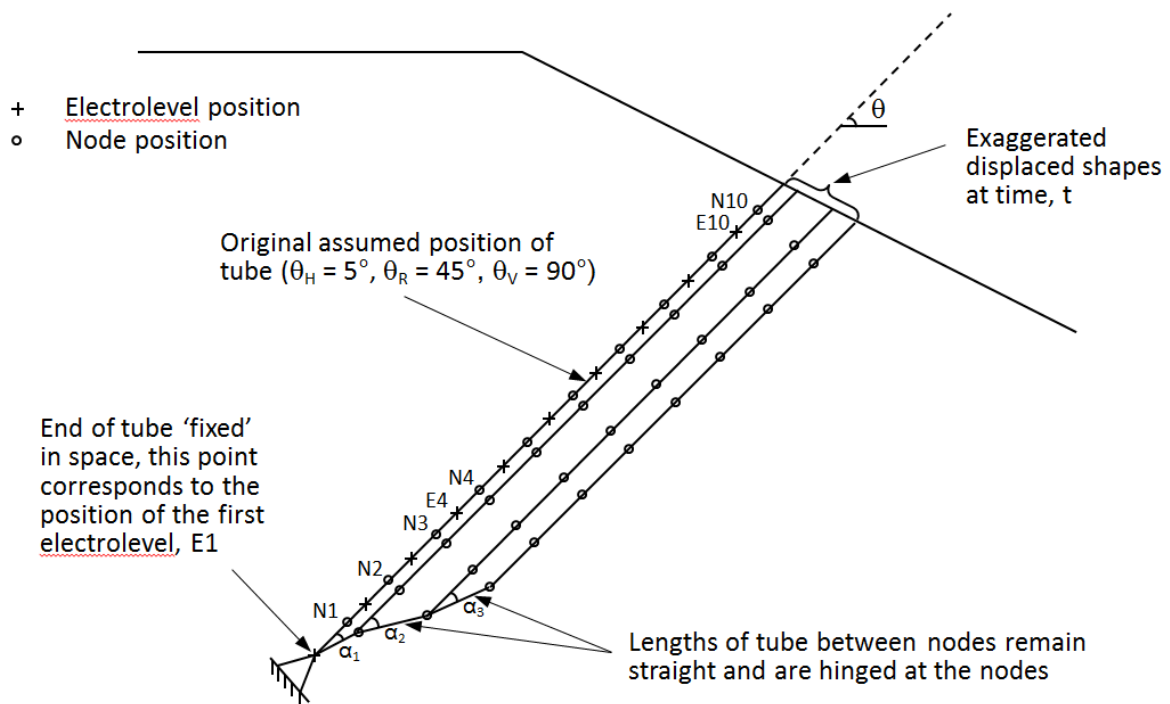
**Figure 7.** Sketch showing assumptions and methodology used in determining displacements from electrolevel rotations.

Rotations measured by the electrolevels rotations were integrated along the length of the tube to provide displacements. Relative lateral displacements along each tube (i.e. normal to them) were determined by assuming that each electrolevel measured the change in angle of a straight length between mid-point nodes between them, starting from the deepest device, E1, which was assumed to be fixed in space, as shown schematically in **Figure 7**. Thus integration of rotations starts from E1, with any rotation registered from E1 being applied to node N1 (a virtual point) midway between E1 and E2, through simple geometry assuming that the chord between E1 and N1 is a straight line (while in reality there is no connection between electrolevels and adjacent nodes). Node N2 is displaced by the equivalent amount as node N1 but then has the additional displacements added to it from the rotation of E2. The process is repeated along the string, cumulating displacements to the final node position near the top of the tube.

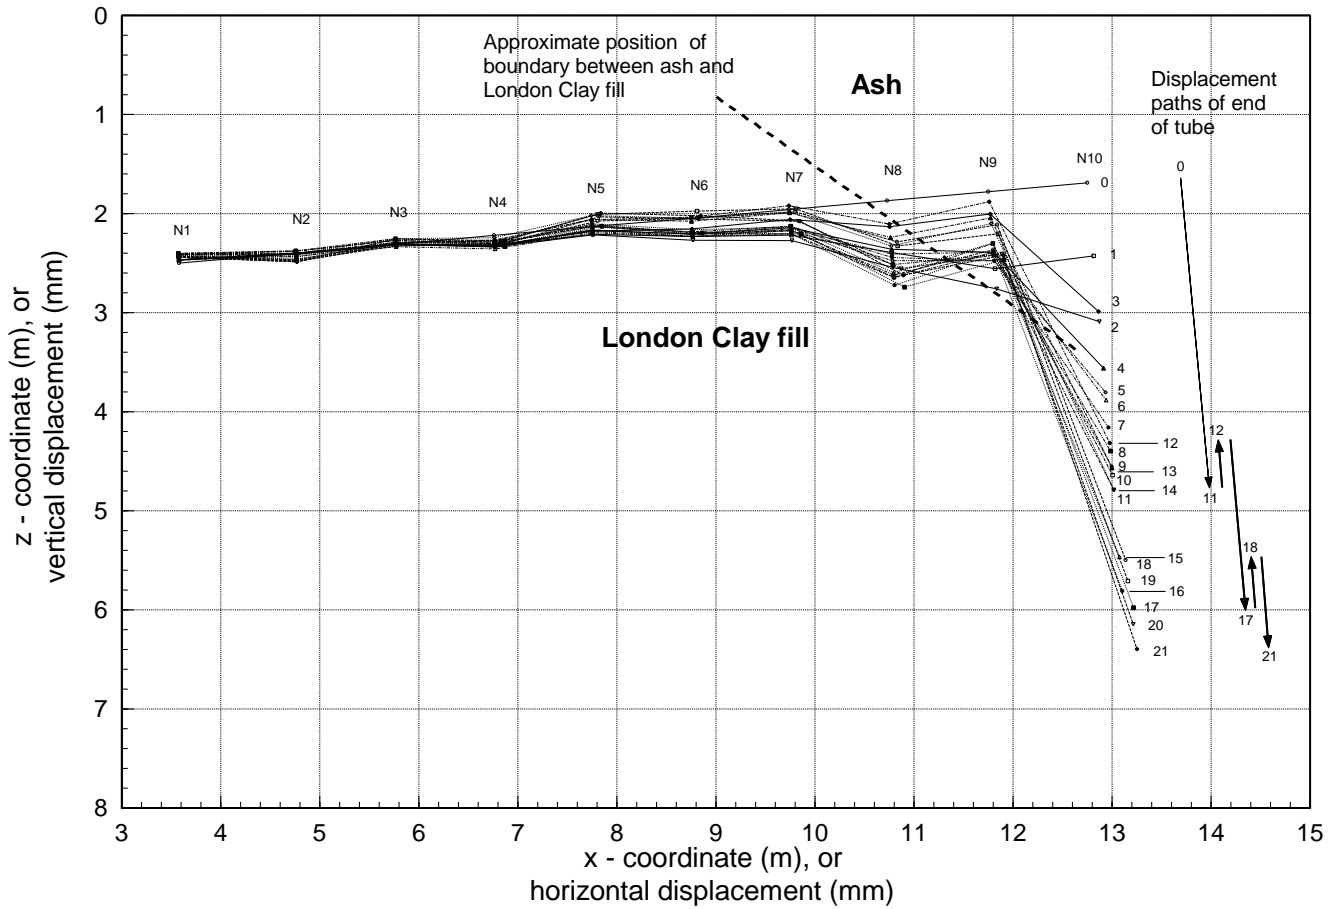
**Figure 9.** Processed electrolevel data from High Barnet expressed with dual scale for: (a) horizontal tube (with inset sketch showing assumptions and methodology used in determining displacements from electrolevel rotations); (b) raking tube; (c) vertical tube; and (d) summary plot. Note that values at ends of each profiles relate to week numbers.

Detailed displacement profiles derived from the electrolevels in the three tubes, plotted on an average weekly basis, are shown in **Figure 9a to c** where a dual scale is used on both axes. One, at a metre scale using arbitrary coordinates, relates to the spatial position of the nodes between electrolevels (N1 to N10) at the start of the monitoring period (week 0) and the other, at a mm scale, relates to the profiles of nodal displacement along the tubes during subsequent weeks. Each displacement profile plotted in **Figure 9a to c** is the average for a given week, the week numbers are marked at the end of each profile in the figures and corresponding dates and any activities taking place at these times are given in **Table 1**. Because of the resolution and high frequency of readings, the accuracy of the relative displacements are judged to be about  $\pm 0.1$  mm over a length of 10 m, evident from the very limited scatter of data at the deeper nodal points of each tube as shown in **Figure 9**. The real accuracy of the observation depends on the shape of the profile between electrolevels, on the extent to which the rotation of the access tube is typical of the soil and on how well the electrolevel carriages follow the tube. It has been noted from **Figure 4b** that the vertical and raking tubes extend well into the natural in-situ London Clay foundation, providing a stable fixed datum and it is reasonable to suppose that the deduced displacements are absolute. The horizontal tube is not anchored in this way (its far end is within the London Clay fill) and the movements observed are relative to the inner end, which is beyond the centre of the embankment. However, no significant movements of electrolevels H1 to H5

The horizontal tube (**Figure 9a and d**) shows that there is well-defined movement of the outside of the embankment in the ash fill, with vertical displacements of about 4-5 mm over the period of observation. If ground (ash) movement is actually down the slope rather than near vertical, as is likely, the downslope movement giving rise to this settlement would be about 9-12 mm (taking a slope angle of about 25°). Both the raking and the vertical tubes show a dual movement with small displacements occurring over the depth of the clay fill, typically 1 to 2 mm, and markedly larger movements occurring in the outer 1 to 2 m of the slope. The difference in displacements at the top of the two tubes is significant, the raking and vertical tubes exhibiting about 2.5 and 7.5 mm normal

displacement respectively. It appears that the movements are increasing downslope, suggesting that the fill between must therefore be expanding. However, the difference can be explained more realistically by the position of the uppermost electrolevel in each tube, V10 being very near the surface while R10 is about a metre below it. This depth difference has a significant influence on displacements as is evident from the change in magnitude of displacements 1 m down from the upper node of the horizontal and vertical profiles (**Figures 9a and c**).

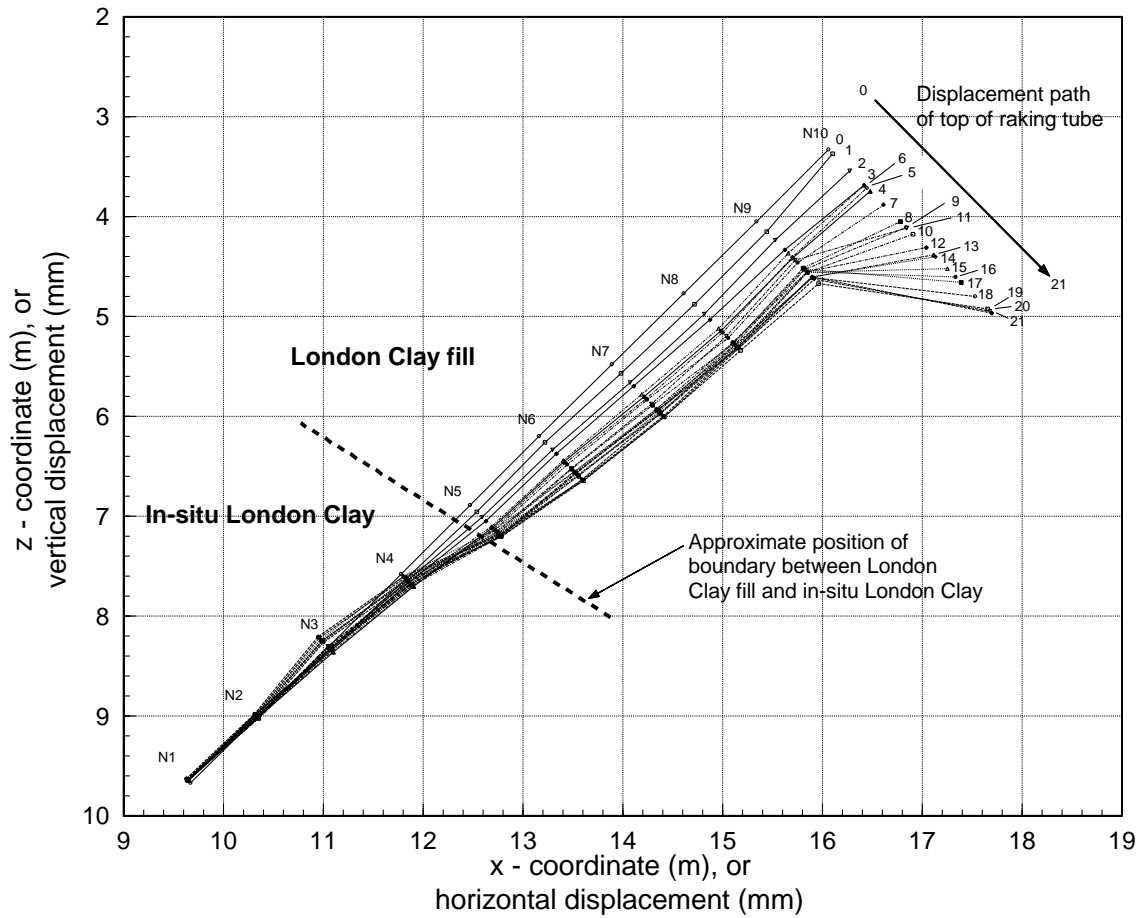
**Figure 9.** Processed electrolevel data from High Barnet expressed with dual scale for: (a) horizontal tube; (b) raking tube; (c) vertical tube; and (d) summary plot. Note that values at ends of each profiles relate to week numbers.

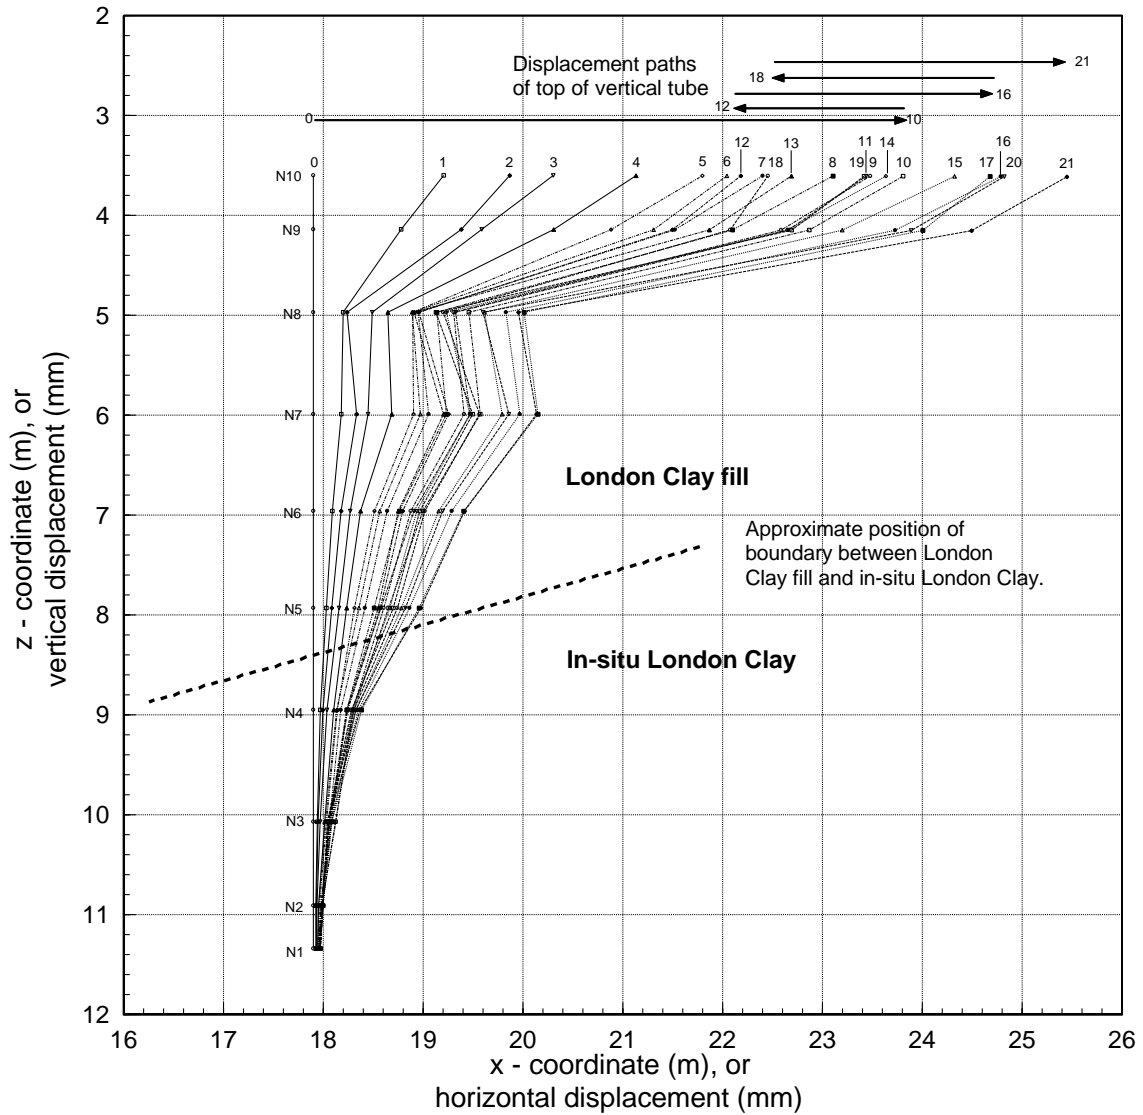
**Figure 9.** Processed electrolevel data from High Barnet expressed with dual scale for: (a) horizontal tube (with inset sketch showing assumptions and methodology used in determining displacements from electrolevel rotations); (b) raking tube; (c) vertical tube; and (d) summary plot. Note that values at ends of each profiles relate to week numbers.

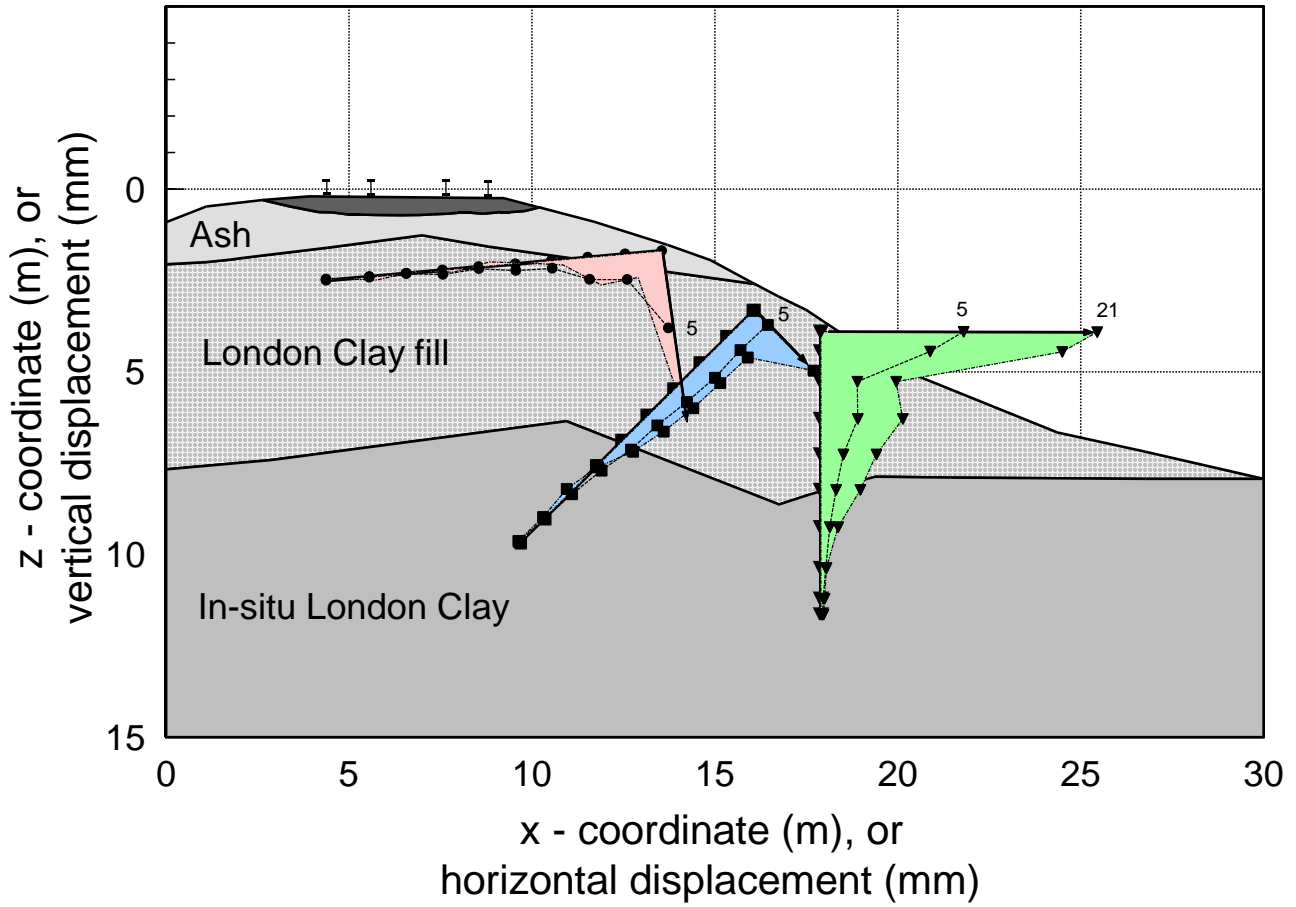
Figure 9. Processed electrolevel data from High Barnet expressed with dual scale for: (a) horizontal tube (with inset sketch showing assumptions and methodology used in determining displacements from electrolevel rotations); (b) raking tube; (c) vertical tube; and (d) summary plot. Note that values at ends of each profiles relate to week numbers.

The observations have shown that there are significant annual movements in the *ash fill* in the steep slopes of the embankment crests (see summary **Figures 9d and 13d**). Most of these movements occur in the Summer and Autumn when the SMD is high and the ash is dry. Numerous tree roots were found within the ash which would dry it out during the Summer. Drying the ash results in a loss of meniscus forces between particles (see schematics shown in **Figure 15**), making the ash more mobile especially under cyclic loading by trains (c.f. dry sand moving under wheel loading, which does not occur when the same sand is moist). This observation suggests that the track deteriorates faster in the Summer, particularly where the ash is thick.

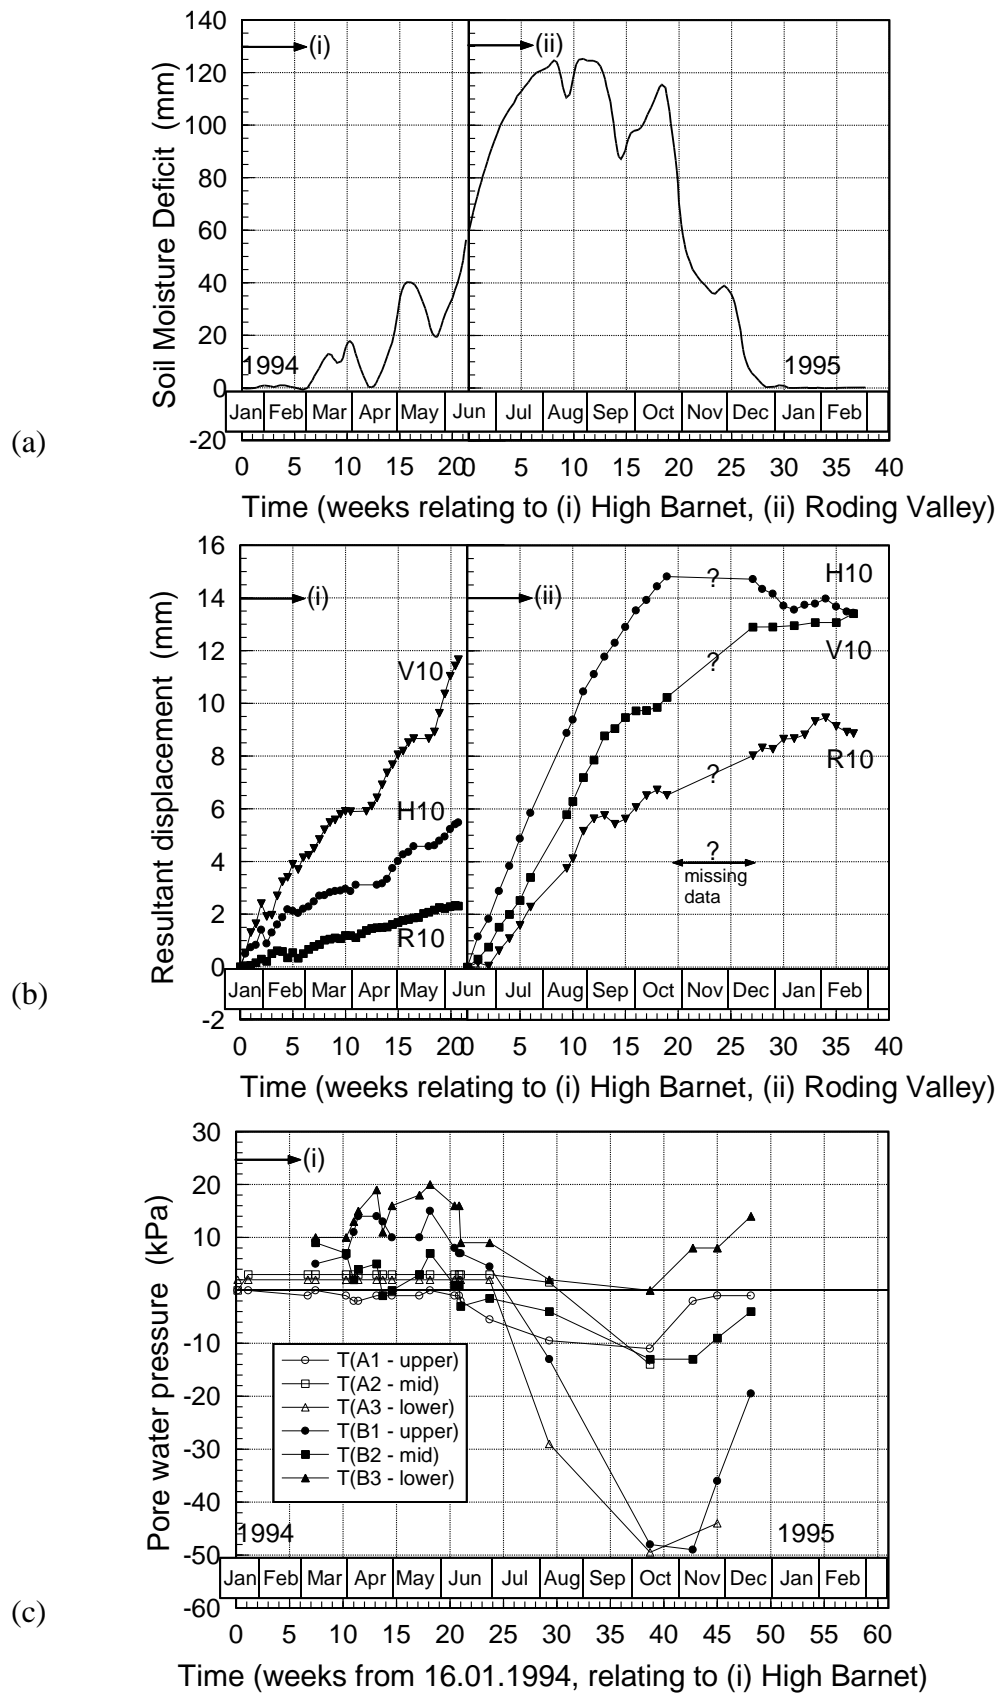
**Figure 10.** Relation of displacements and pore water pressures with SMD plotted against entire duration of monitoring at High Barnet and Roding Valley: (a) SMD; (b) progressive development of displacement of upper most electrolevel tubes (with effects of fettling removed; and (c) pore water pressures from tensiometers at High Barnet.

The tensiometers were observed periodically during 1994 as evident from the data in **Figure 10c**. The observations follow the seasons, with suctions developing from the end of June (when SMD increases) and starting to decay from mid-October (as SMD reduces). Note that because of a pre-set pressure limit of zero in the instruments in section A, the pore pressures plotted for the first half of 1994 in **Figure 10c** could have been higher than zero. The pore pressure-SMD trends are typical of the change in the balance between evapo-transpiration / drying and infiltration between Summer and

The observations at section B show positive Winter pore pressures (**Figure 10c**). The depth of the tip of each piezometer was 1.5 m and there was little ash present at the locations where they were installed. The maximum pressure measured at the lower tensiometer is 20 kPa, implying some measuring error given the tip depth. However, in general the results are consistent with near hydrostatic Winter pore pressures, suggesting infiltration into a high permeability superficial zone. Such zones would form from shrinkage cracks developing in the predominantly clay fill at this section due to Summer drying, thus markedly increasing permeability (Vaughan, 1994; Dixon et al., 2019). The maximum suction measured in the upper tensiometer (T(B1)) near the top of the embankment slope after the Summer is 50 kPa, while in the tensiometer mid-way up the slope it was only 13 kPa. These magnitudes are similar to those in profiles observed elsewhere (Vaughan, 1994; Smethurst et al., 2006). The lower tensiometer near the base of the slope shows no suction. This is surprising but a drain that exists at the toe of the slope may have an influence on this response.

In **Figure 10b** the normal movement of the tops of the outer ends of the tubes are plotted relative to: (i) node N5 in the case of the horizontal tube; (ii) the inner/lowest end of the raking tube; (iii) the inner end of the vertical tube until week 27, after which the readings are relative to node N8. There is a clear trend, as also evidenced from the High Barnet monitoring data, that greater near surface displacements occur as SMD increases. The results shown in the detailed and summary plots (**Figures 13a to d**) clearly indicate that the ash fill moves substantially from June to November (Summer and Autumn) while there is a significant SMD. The rate of movement in the ash decreases as SMD reduces and it becomes very small when it becomes zero. Conversely, the clay appears to move by only small amounts and inwards (as evidenced by the displacements observed in the vertical tube below node N5 in **Figure 13c**) during this period when the ash moved outwards. Similar inward movements of clay fill have been observed within a railway embankment formed of London Clay fill (topped with ash) in Essex (Smethurst et al., 2015). The small backward displacements (maximum of 2 to 3 mm) of the lower length of the vertical tube in the London Clay fill at Roding Valley could also, to some degree, result from counter flexure of the tube from the large displacements in the ash above the clay fill. Subsequently, during late Autumn and the Winter, when the SMD reduces to zero,

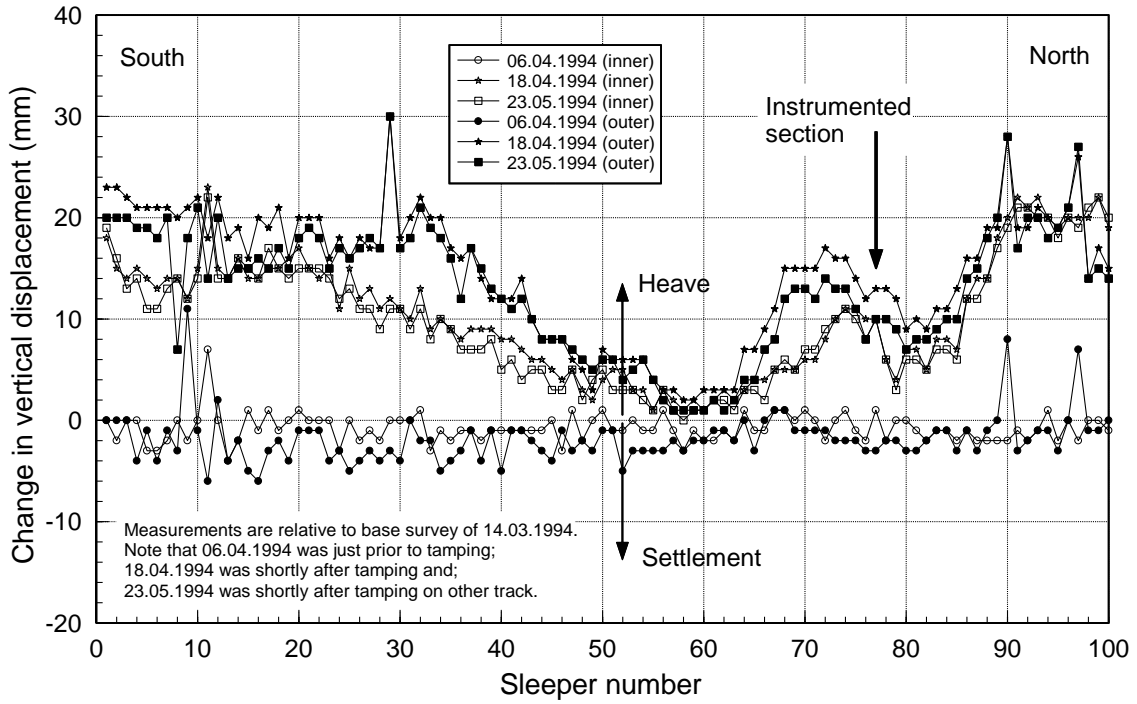
**Figure 11.** Levelling survey data: effect of fettling works on sleeper levels (inner and outer) at High Barnet.

Seven surveys of the sleepers were conducted between 14.03.1994 and 31.01.1995 (see **Table 1**). The instrumented tubes (section B) line up with sleeper number 77 (**Figure 4a**). The southbound track was fettled on 07.04.1994, one day after the second survey. The changes in level observed for the inner and outer ends of the sleepers on the instrumented (southbound) side of the embankment are presented in **Figure 11**. During the 23 days prior to fettling the outer nails settled by up to about 5 mm and the inner nails less. Fettling raised the nails by up to 20 to 25 mm, except over the length from sleepers 45 to 65, the outer nails being raised more than the inner. Fettling of the northbound track took place on 19.05.1994 and so the displacement profile for the survey of 23.05.1994 shows little difference from the previous survey (18.04.1994).

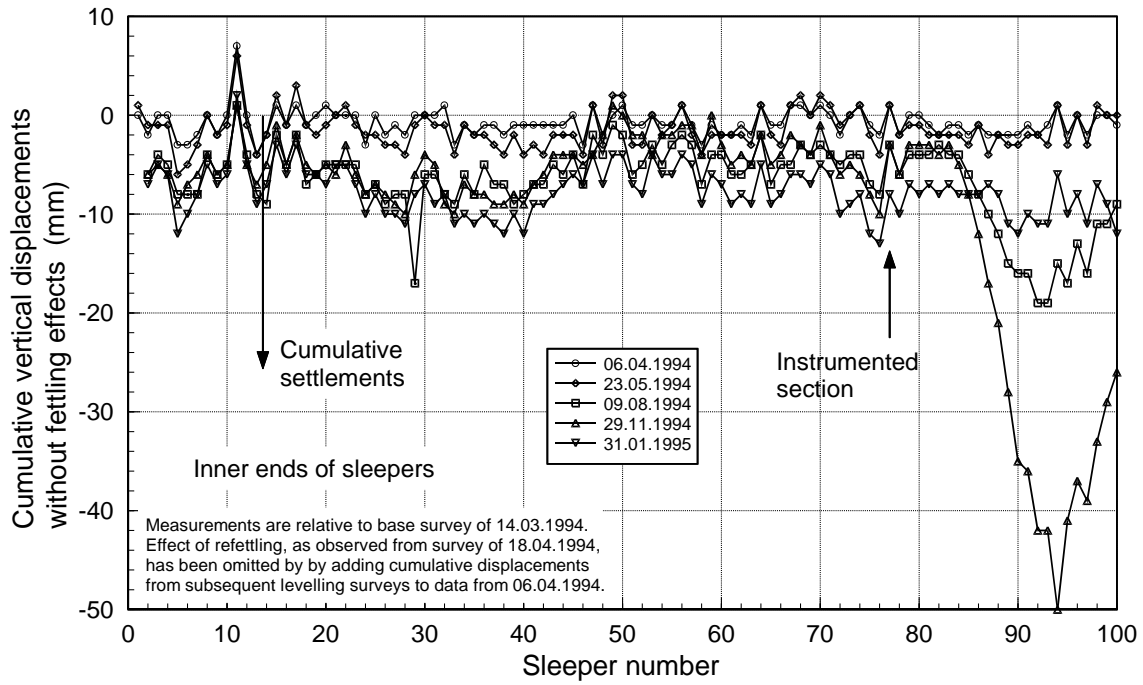
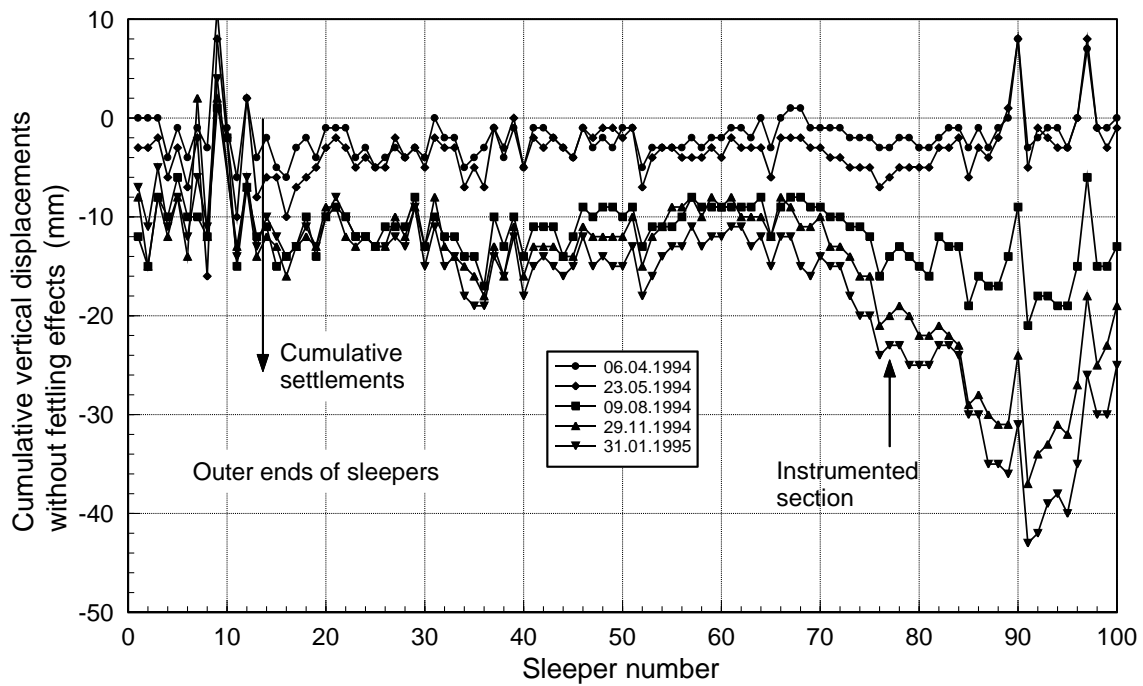
**Figure 12.** Levelling survey data: cumulative settlements (with fettling effects removed) over a ten-month period at High Barnet: (a) inner; (b) outer sleeper ends.

Settlements from 14.03.1994 to 06.04.1994 added to those measured after 18.04.1994 are shown in **Figure 12**. Thus changes during the 12-day period between 06.04.1994 and 18.04.1994, when fettling took place, are eliminated (i.e. both uplift from fettling on 07.04.1994 and any subsequent settlement). As mentioned above, there is little development of displacement between 06.04.1994 and 23.05.1994 as fettling of the northbound track took place on 19.05.1994. Most of the settlement occurs between sleepers 70 to 100 after the end of May, coinciding with the onset of Summer conditions and high SMD (see **Figure 10a**), with a maximum of about 50 mm developing on the inner ends of the sleepers by the end of November 1994 (**Figure 12a**). The northbound track on the opposite side to the instrumented section must have been fettled before the next survey on 31.01.1995 as the results from this survey indicate that the inner side of the track had been raised by about 30 mm.

Settlement was generally uneven with most of the surveyed length of the track tilting outwards but at the northern end (sleepers 85 to 100) the tilt was in the opposite sense. The surveys and electrolevel

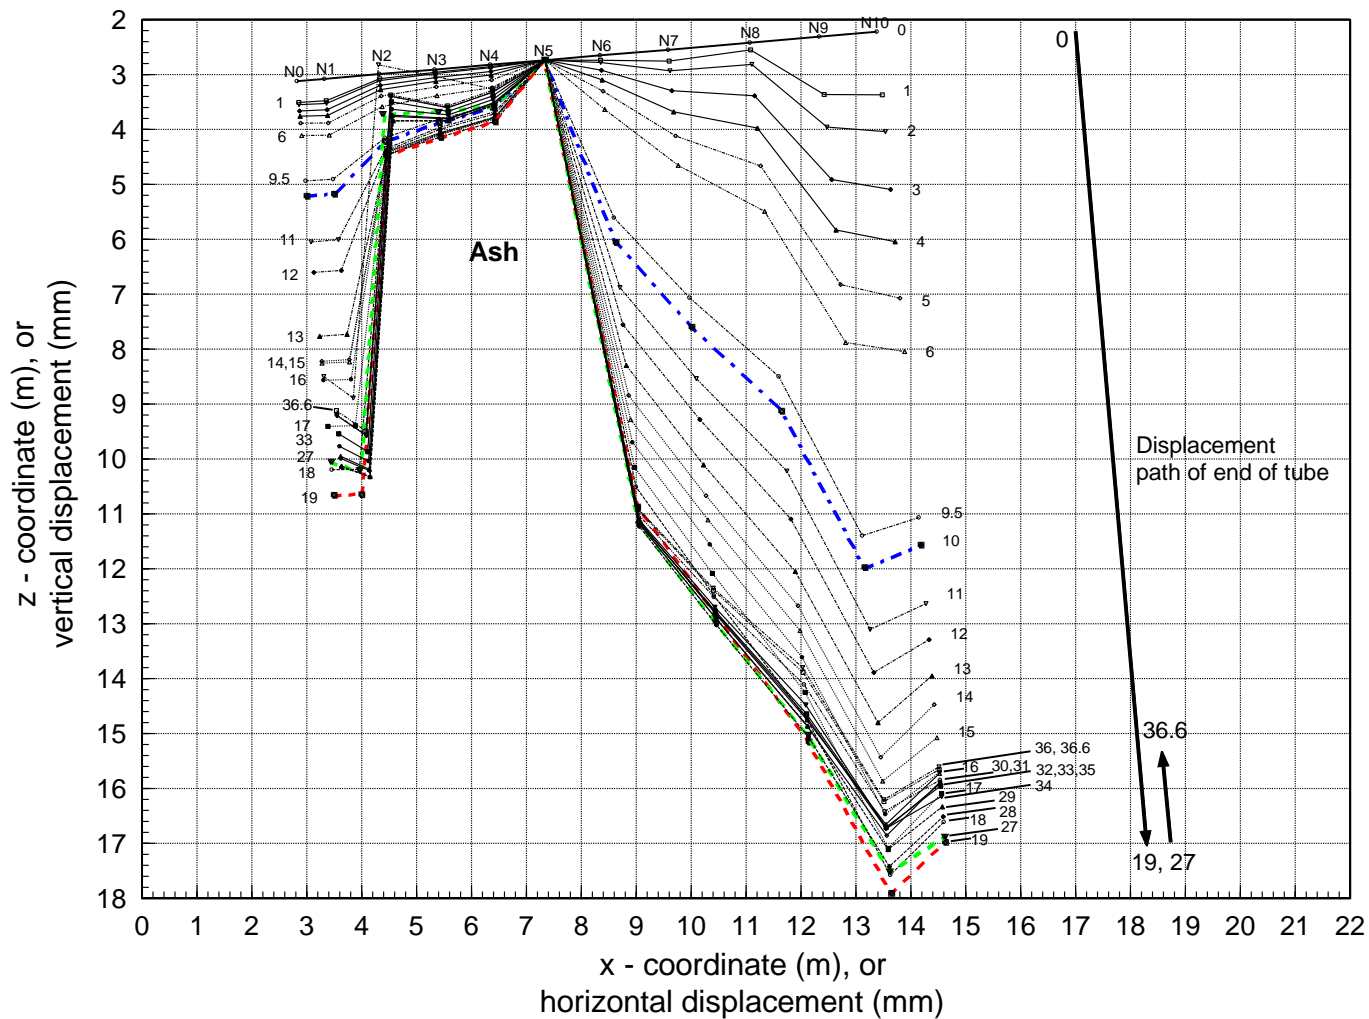
**Figure 13.** Processed electrolevel data from Roding Valley expressed with dual scale for: (a) horizontal tube; (b) raking tube; (c) vertical tube; and (d) summary plot. Note that values at ends of each profiles relate to week numbers.

The transition between the two senses of movement occurred roughly at N5 and so displacements were recalculated taking N5 to be the fixed point as shown in **Figure 13a**. The resulting profiles suggest a hump over the centre of the embankment with no settlement at the fixed point. In reality it would have moved downwards, as evident from the surveying results discussed in the next section, and so total displacement of the tube is underestimated. However, the profiles produced provide instructive and realistic insight into the mechanism of the embankment movements.

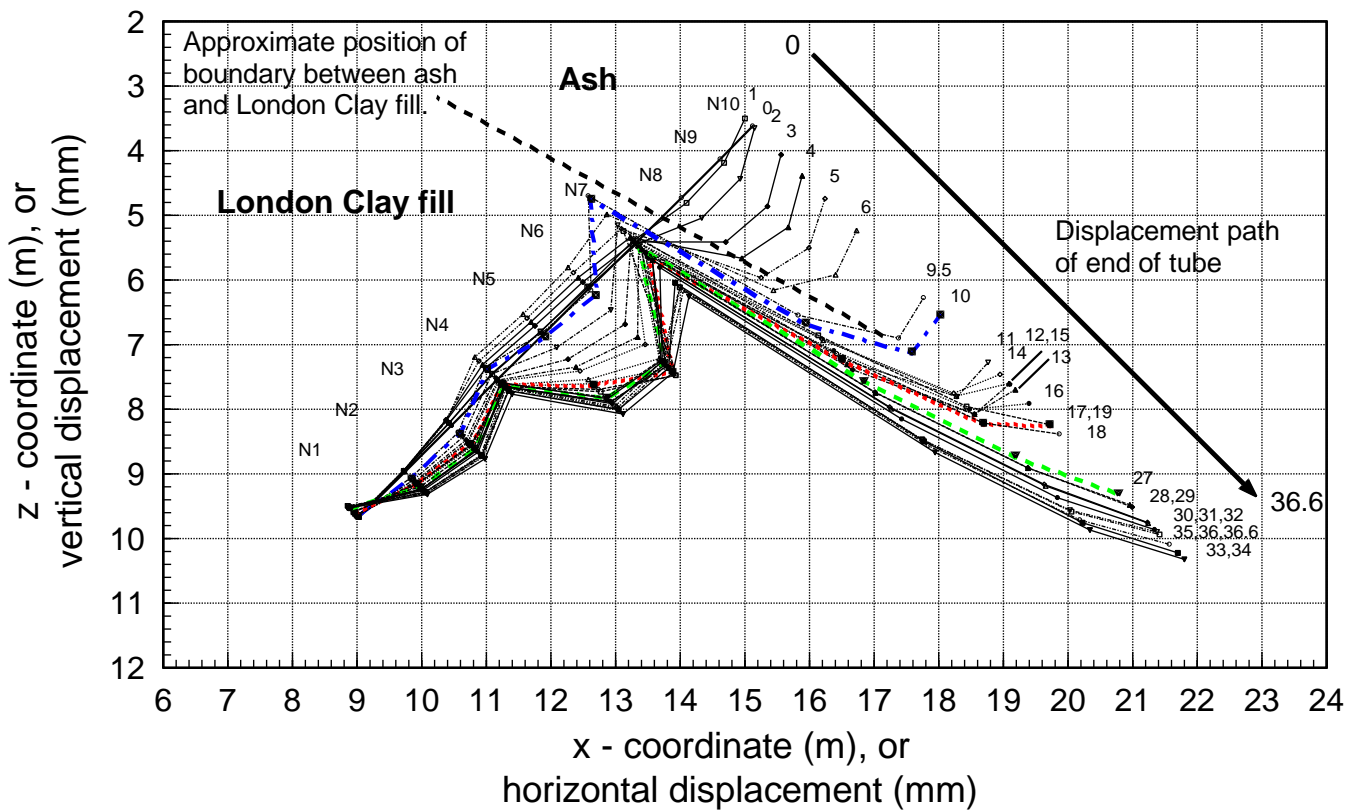
**Figure 13.** Processed electrolevel data from Roding Valley expressed with dual scale for: (a) horizontal tube; (b) raking tube; (c) vertical tube; and (d) summary plot. Note that values at ends of each profiles relate to week numbers.
