# **OBSERVED BEHAVIOUR OF OLD RAILWAY EMBANKMENTS FORMED OF ASH AND DUMPED CLAY FILL**

## **ABSTRACT**

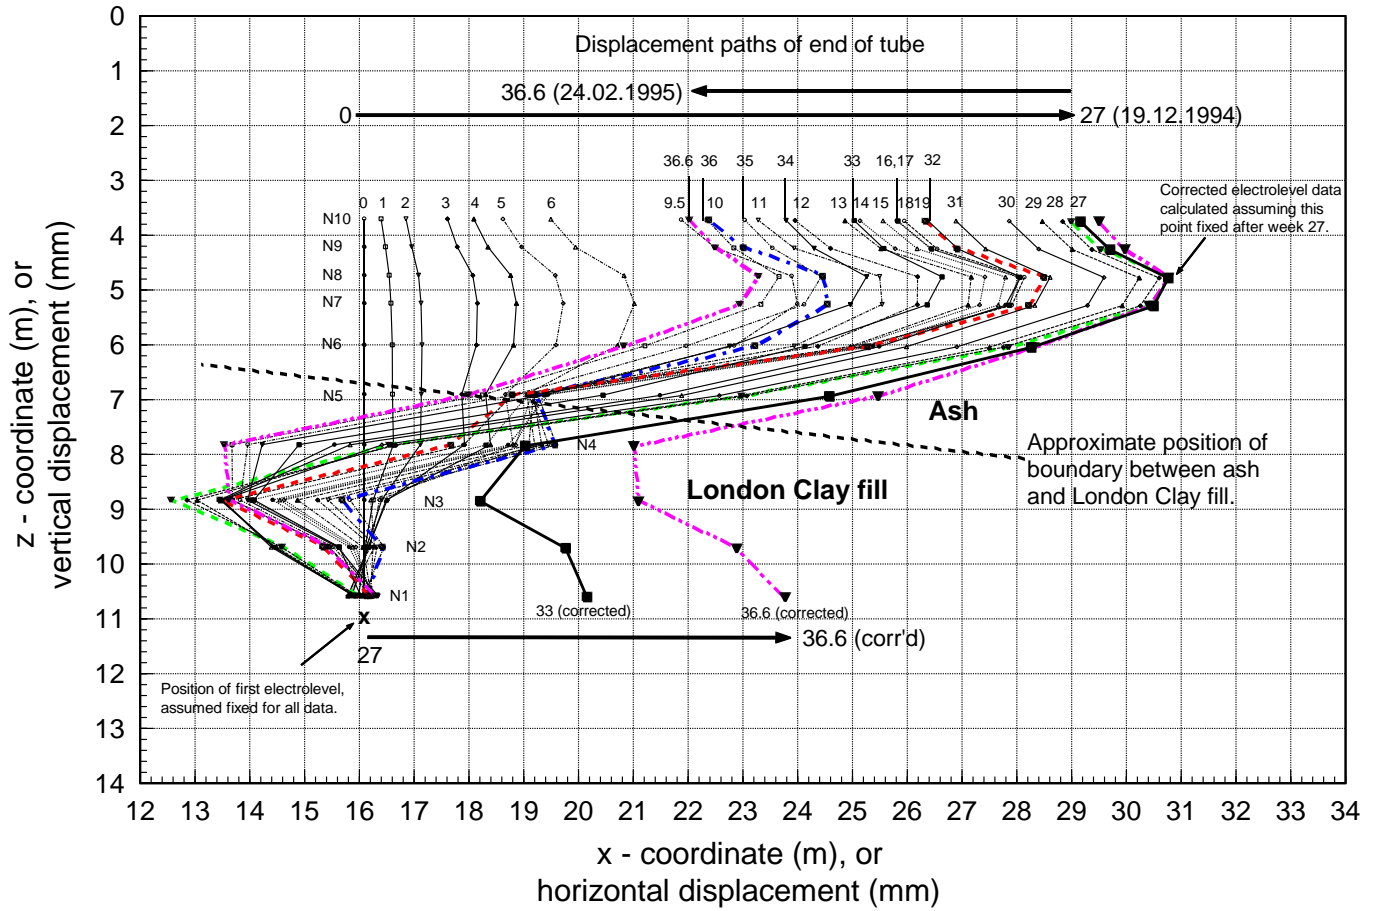
**Figure 13.** Processed electrolevel data from Roding Valley expressed with dual scale for: (a) horizontal tube; (b) raking tube; (c) vertical tube; and (d) summary plot. Note that values at ends of each profiles relate to week numbers.

The deduced swelling of the clay fill that led to the observed downslope / outward movement of the vertical tube (as interpreted through the corrected profiles of weeks 33 and 36.6 in **Figure 13c**) affected the results in the horizontal tube in a similar fashion (**Figure 13a**). However, in this case it is credible that the swelling of clay fill closer to the embankment slopes led to small degrees of heave, the magnitude of which are less than 2 mm (relative to the assumed fixed point, node N5).

the corrected profiles in **Figure 13c** indicate an outward movement of the clay fill, commensurate with swelling associated with the intake of water.

profiles in the vertical tube (**Figure 13c**) where lateral displacements are about five times larger than vertical heave. Net lateral swelling would cause the embankments to spread, leading to an overall downward movement of the crest and track. The lateral swelling displacement is not recovered during shrinkage. Spreading of the embankment is also apparent when the SMD increases, as evident from the results at High Barnet as Summer approached (**Figures 9 and 10**), despite the fact that inwards shrinkage would be expected. This can be reasoned from consideration of differential shrinkage: the outer clay fill clods would shrink more than the inner wetter fill, resulting in small degrees of potential downwards and outwards rotation (when a clay clod shrinks against the less affected deeper, sloping inner clay fill it moves downwards and outwards as a consequence). A sketch illustrating the mechanism for the high SMD case is shown in **Figure 15b**. The seasonal cycles of displacements, with little recovery from one to the next, would lead to a progressive spreading of the embankments. Smethurst et al. (2015) observed a steady outward movement of the London Clay fill embankment over a four-year period with larger displacements in the Summer (although this was after trees had been removed from the slopes). Spreading due to these seasonal effects may lead to the development of shear surfaces with lower strength than the surrounding mass (similar to the shear surfaces usually present in soliflucted slopes from historic freeze-thaw processes). Such weakened zones would contribute towards and help explain the occasional slips which occur long after the pore pressure regime should have reached equilibrium.

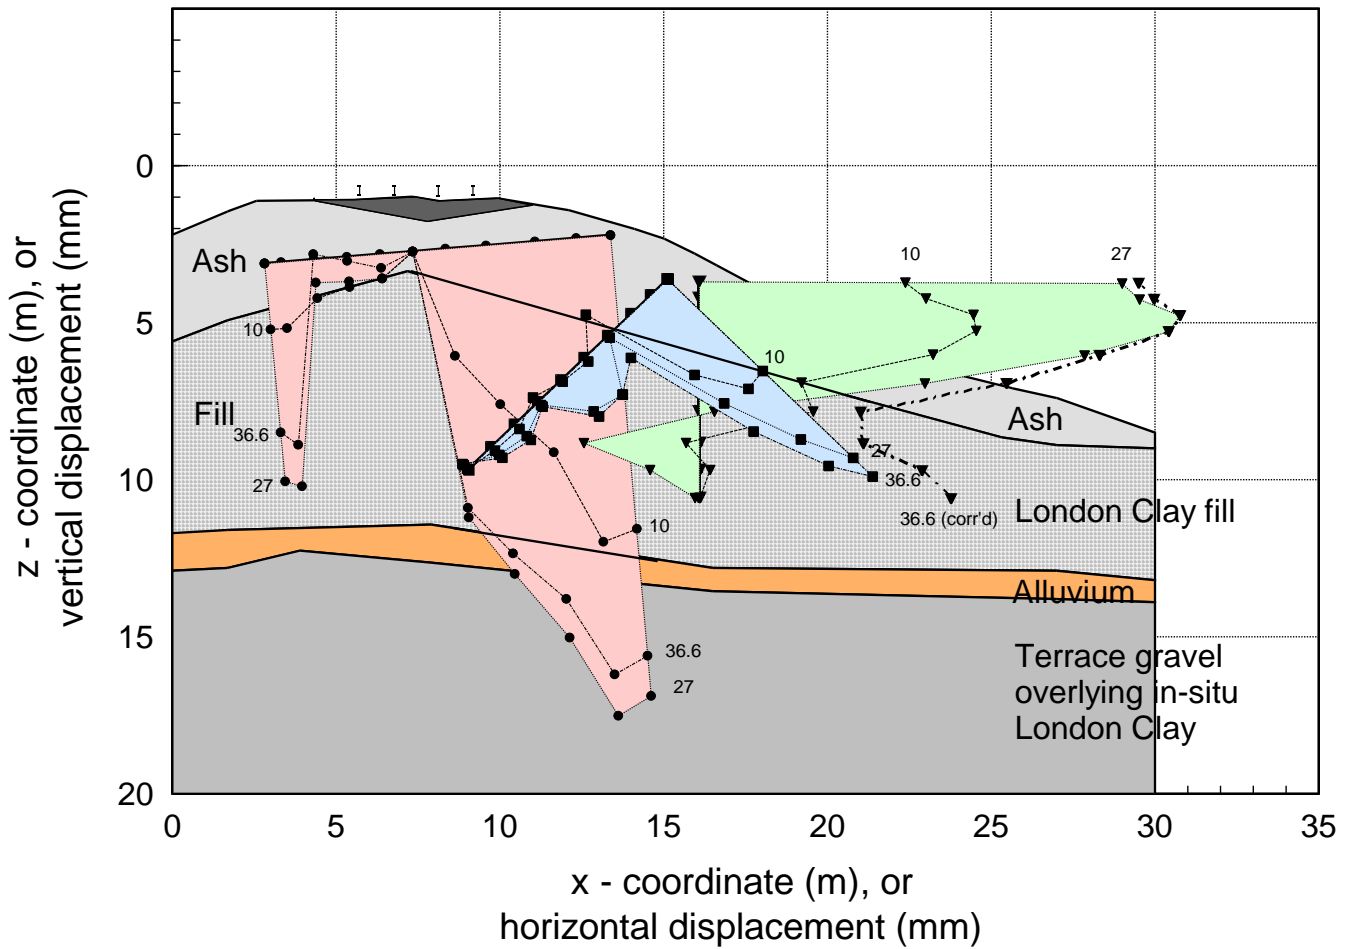
**Figure 13.** Processed electrolevel data from Roding Valley expressed with dual scale for: (a) horizontal tube; (b) raking tube; (c) vertical tube; and (d) summary plot. Note that values at ends of each profiles relate to week numbers.

The observations have shown that there are significant annual movements in the *ash fill* in the steep slopes of the embankment crests (see summary **Figures 9d and 13d**). Most of these movements occur in the Summer and Autumn when the SMD is high and the ash is dry. Numerous tree roots were found within the ash which would dry it out during the Summer. Drying the ash results in a loss of meniscus forces between particles (see schematics shown in **Figure 15**), making the ash more mobile especially under cyclic loading by trains (c.f. dry sand moving under wheel loading, which does not occur when the same sand is moist). This observation suggests that the track deteriorates faster in the Summer, particularly where the ash is thick.

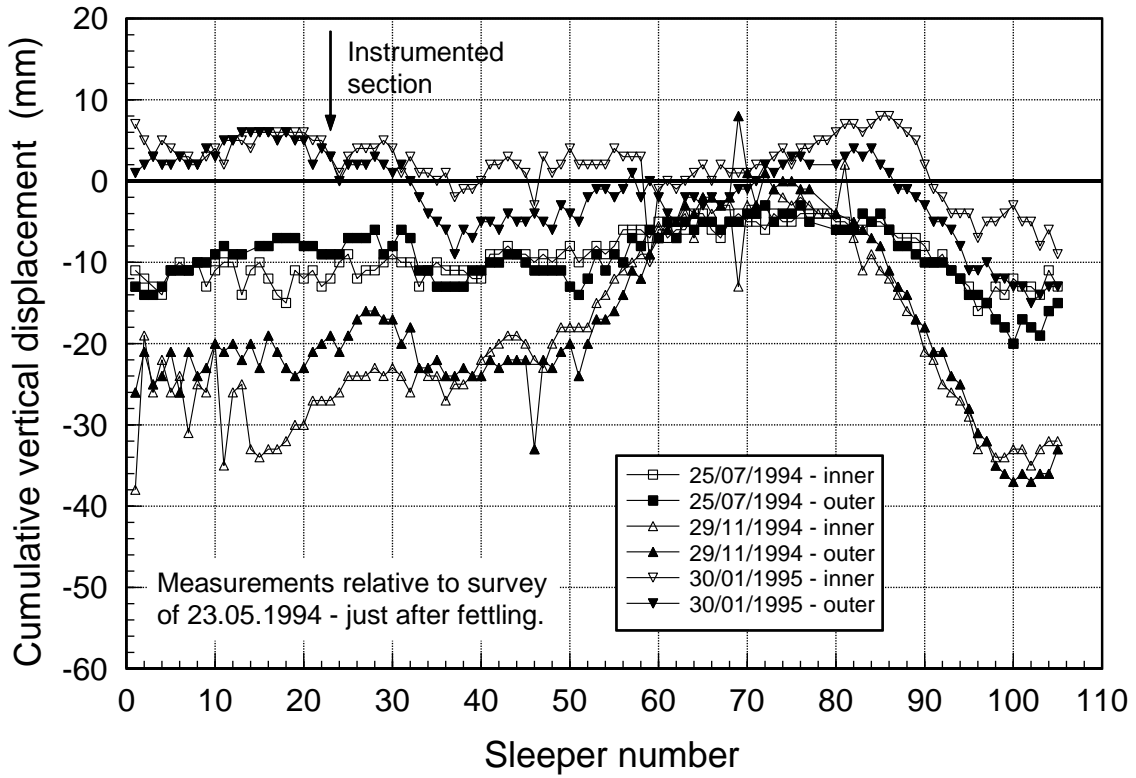
**Figure 14.** Track levelling survey data: cumulative settlements over an eight-month period at Roding Valley.

Five level surveys were undertaken to monitor changes in elevation of nails at the ends of 105 consecutive sleepers spanning the length of track with the electrolevel tubes using a deep benchmark as reference (see **Figure 4d**). Dates of the surveys and the two occasions when fettling took place are given in **Table 2**. Fettling operations took place just before the second survey and in view of this results from survey 1 are of little use. Settlements free of fettling operations can be assessed from surveys 2, 3 and 5 (23.05.1994, 25.07.1994 and 29.11.1994). Changes in level relative to survey 2 are plotted for the subsequent three surveys in **Figure 14**. Six months after fettling (i.e. 29.11.1994), settlements over most of the surveyed track length have developed by up to about 35 mm. At the west end, close to the electrolevel tubes, the inner rail has settled by up to 10 mm more than the outer rail. This is in conflict with the deformed shape of the horizontal access tube deep within the ash. It is also evident that the track becomes ‘bumpy’ on a short wavelength as it settles.

Between sleepers 60 to 80 there were only very small settlements. This length suffered an embankment fire in the past and an attempt was made to extinguish it by grouting. This would have had little benefit in terms of stabilising movements: this was found to be the case from extensive trials and investigations elsewhere (McGinnity et al., 1998). Although no difference in the ash fill was noticed during drilling for section B, it may have been fused sufficiently to suppress movement.

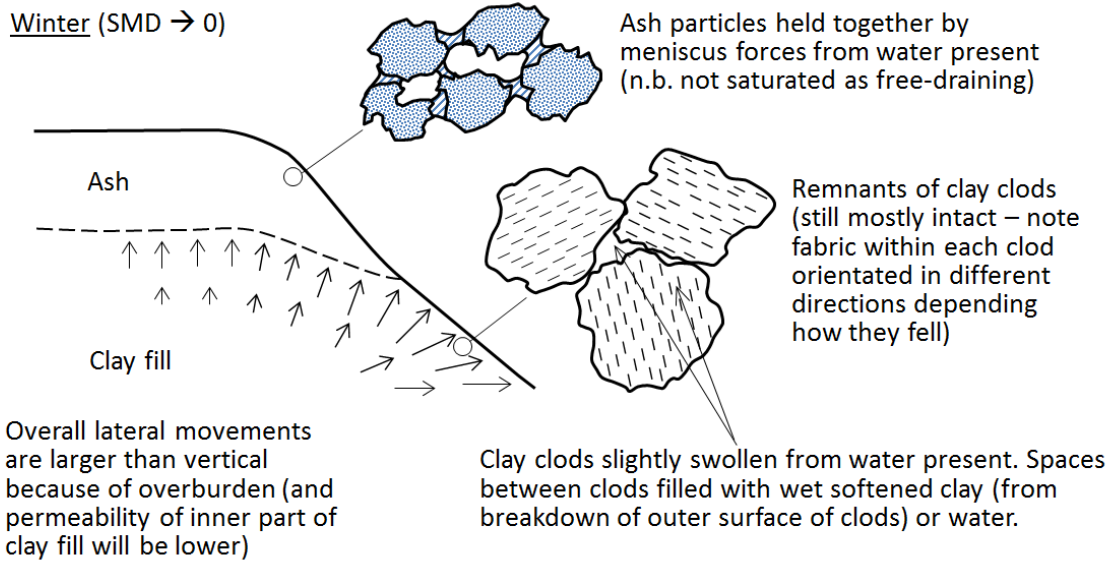
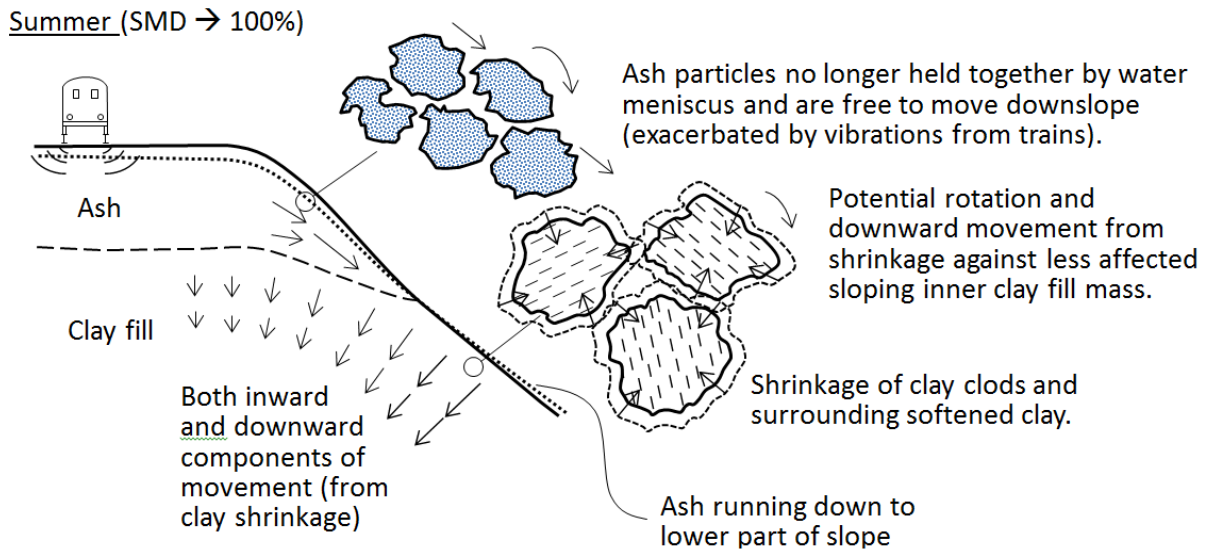
**Figure 15.** Schematics showing mechanisms of seasonal embankment fill movements for: (a) Winter; and (b) Summer conditions.

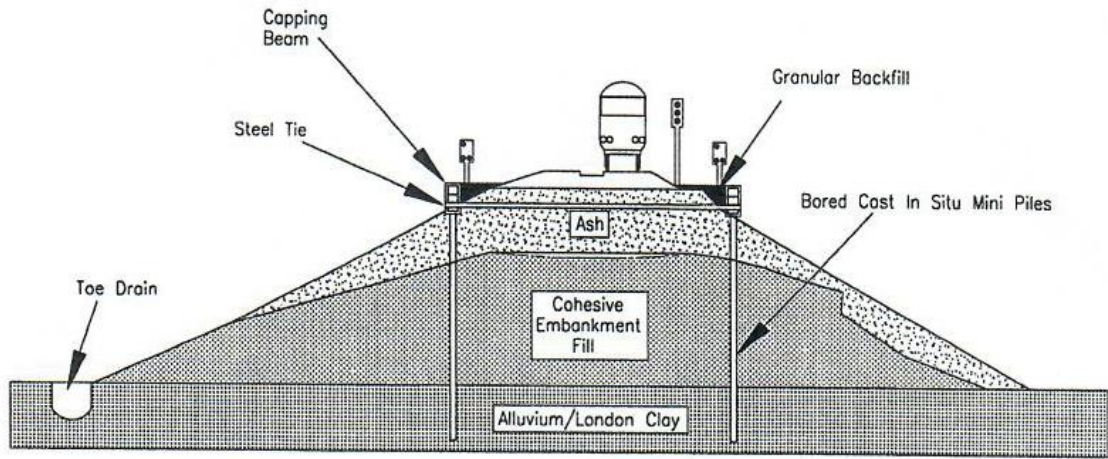
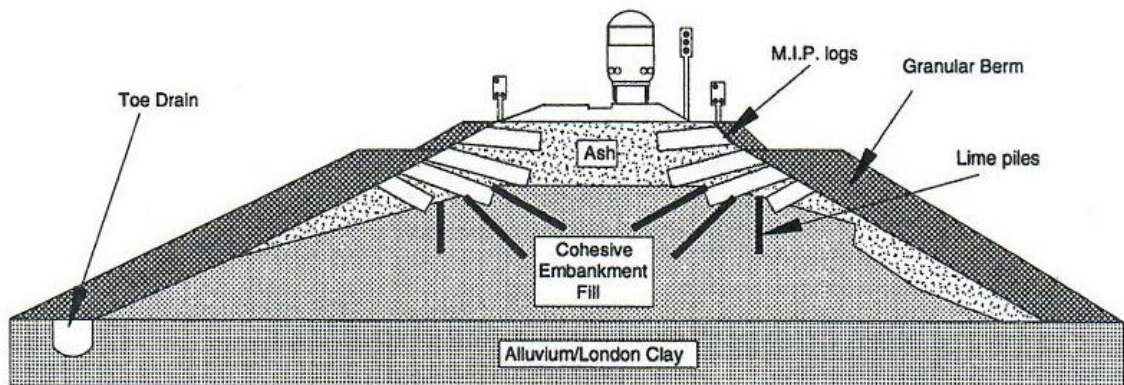
**Figure 16.** Stabilisation methods for the ash/clay fill embankments: (a) tied bored mini pile walls; (b) mixed-in-place (MIP) logs and lime piles (from McGinnity et al., 1998).
