CABLE FAILURES IN THE GULF OF CORINTH:
A CASE HISTORY

Bruce C. Heezen, Maurice Ewing, and G. L. Johnson

The Bell Telephone Laboratories
Murray Hill, New Jersey
July, 1960

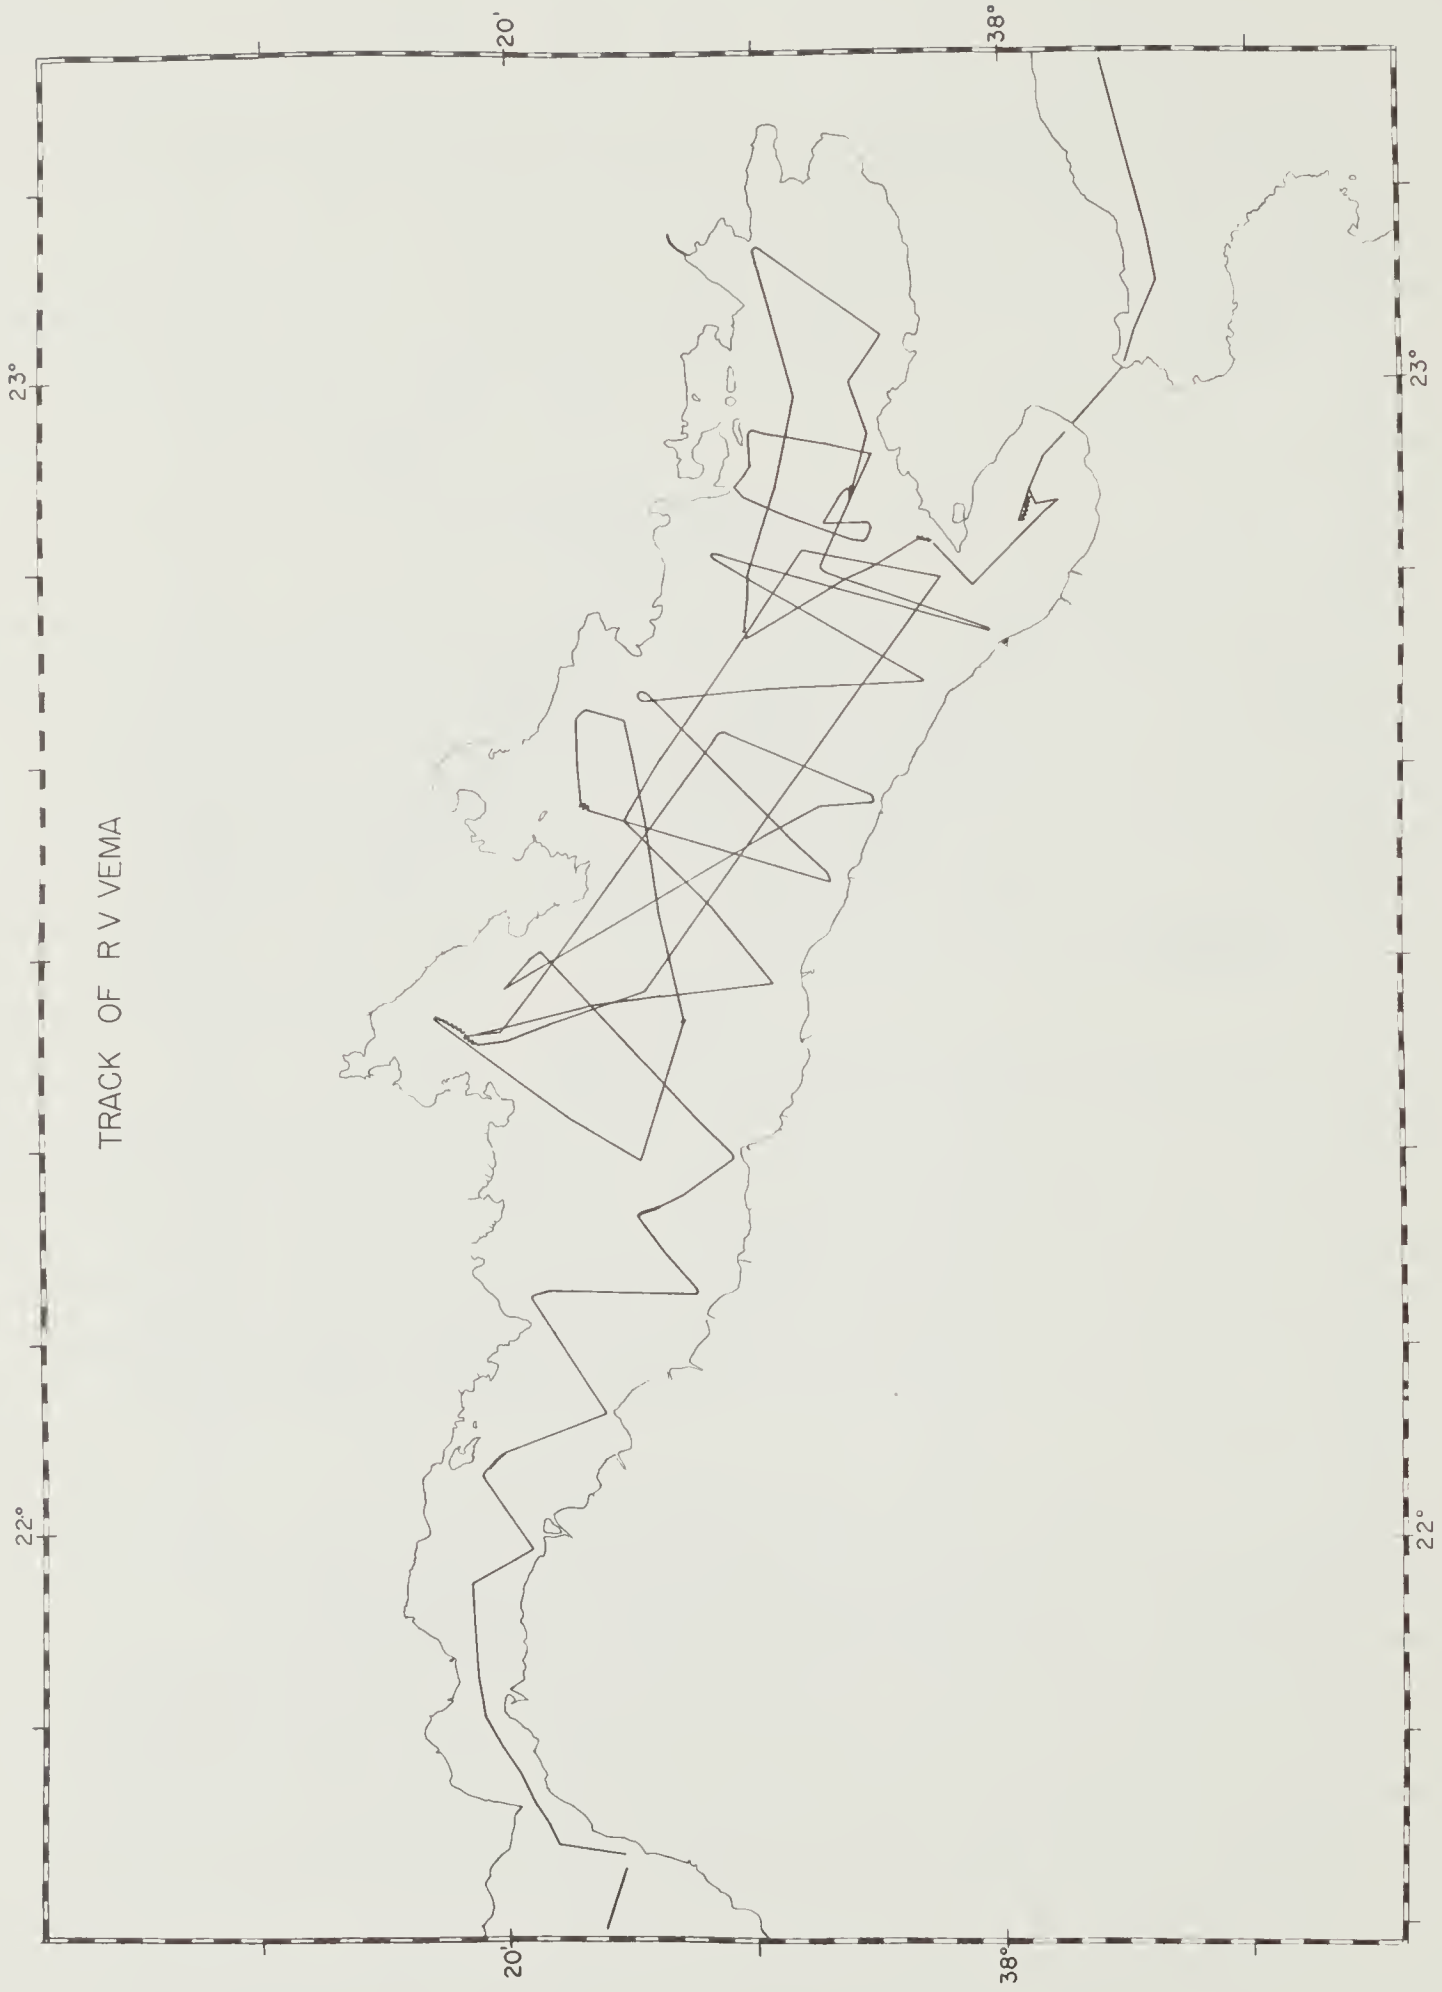
Fig. 2 Track of R. V. VEMA in the Gulf of Corinth, 22 to 24 July 1956.

The bathymetric chart of the Gulf of Corinth (Fig. 3) and the physiographic province chart (Fig. 4) are based on the PDR (Precision Depth Recorder) soundings made by R. V. VEMA (Fig. 2), the spot depths shown on the U. S. Navy Hydrographic Office chart number 3963, and soundings by the cable repair ships. The VEMA PDR soundings were corrected to true depths according to the values given by Matthews (1939) [Area 50]. A graph of sound-velocity corrections for echo soundings in Area 50 is shown in Fig. 5. Selected PDR profiles are shown in Plate 1 and indexed in Fig. 6.

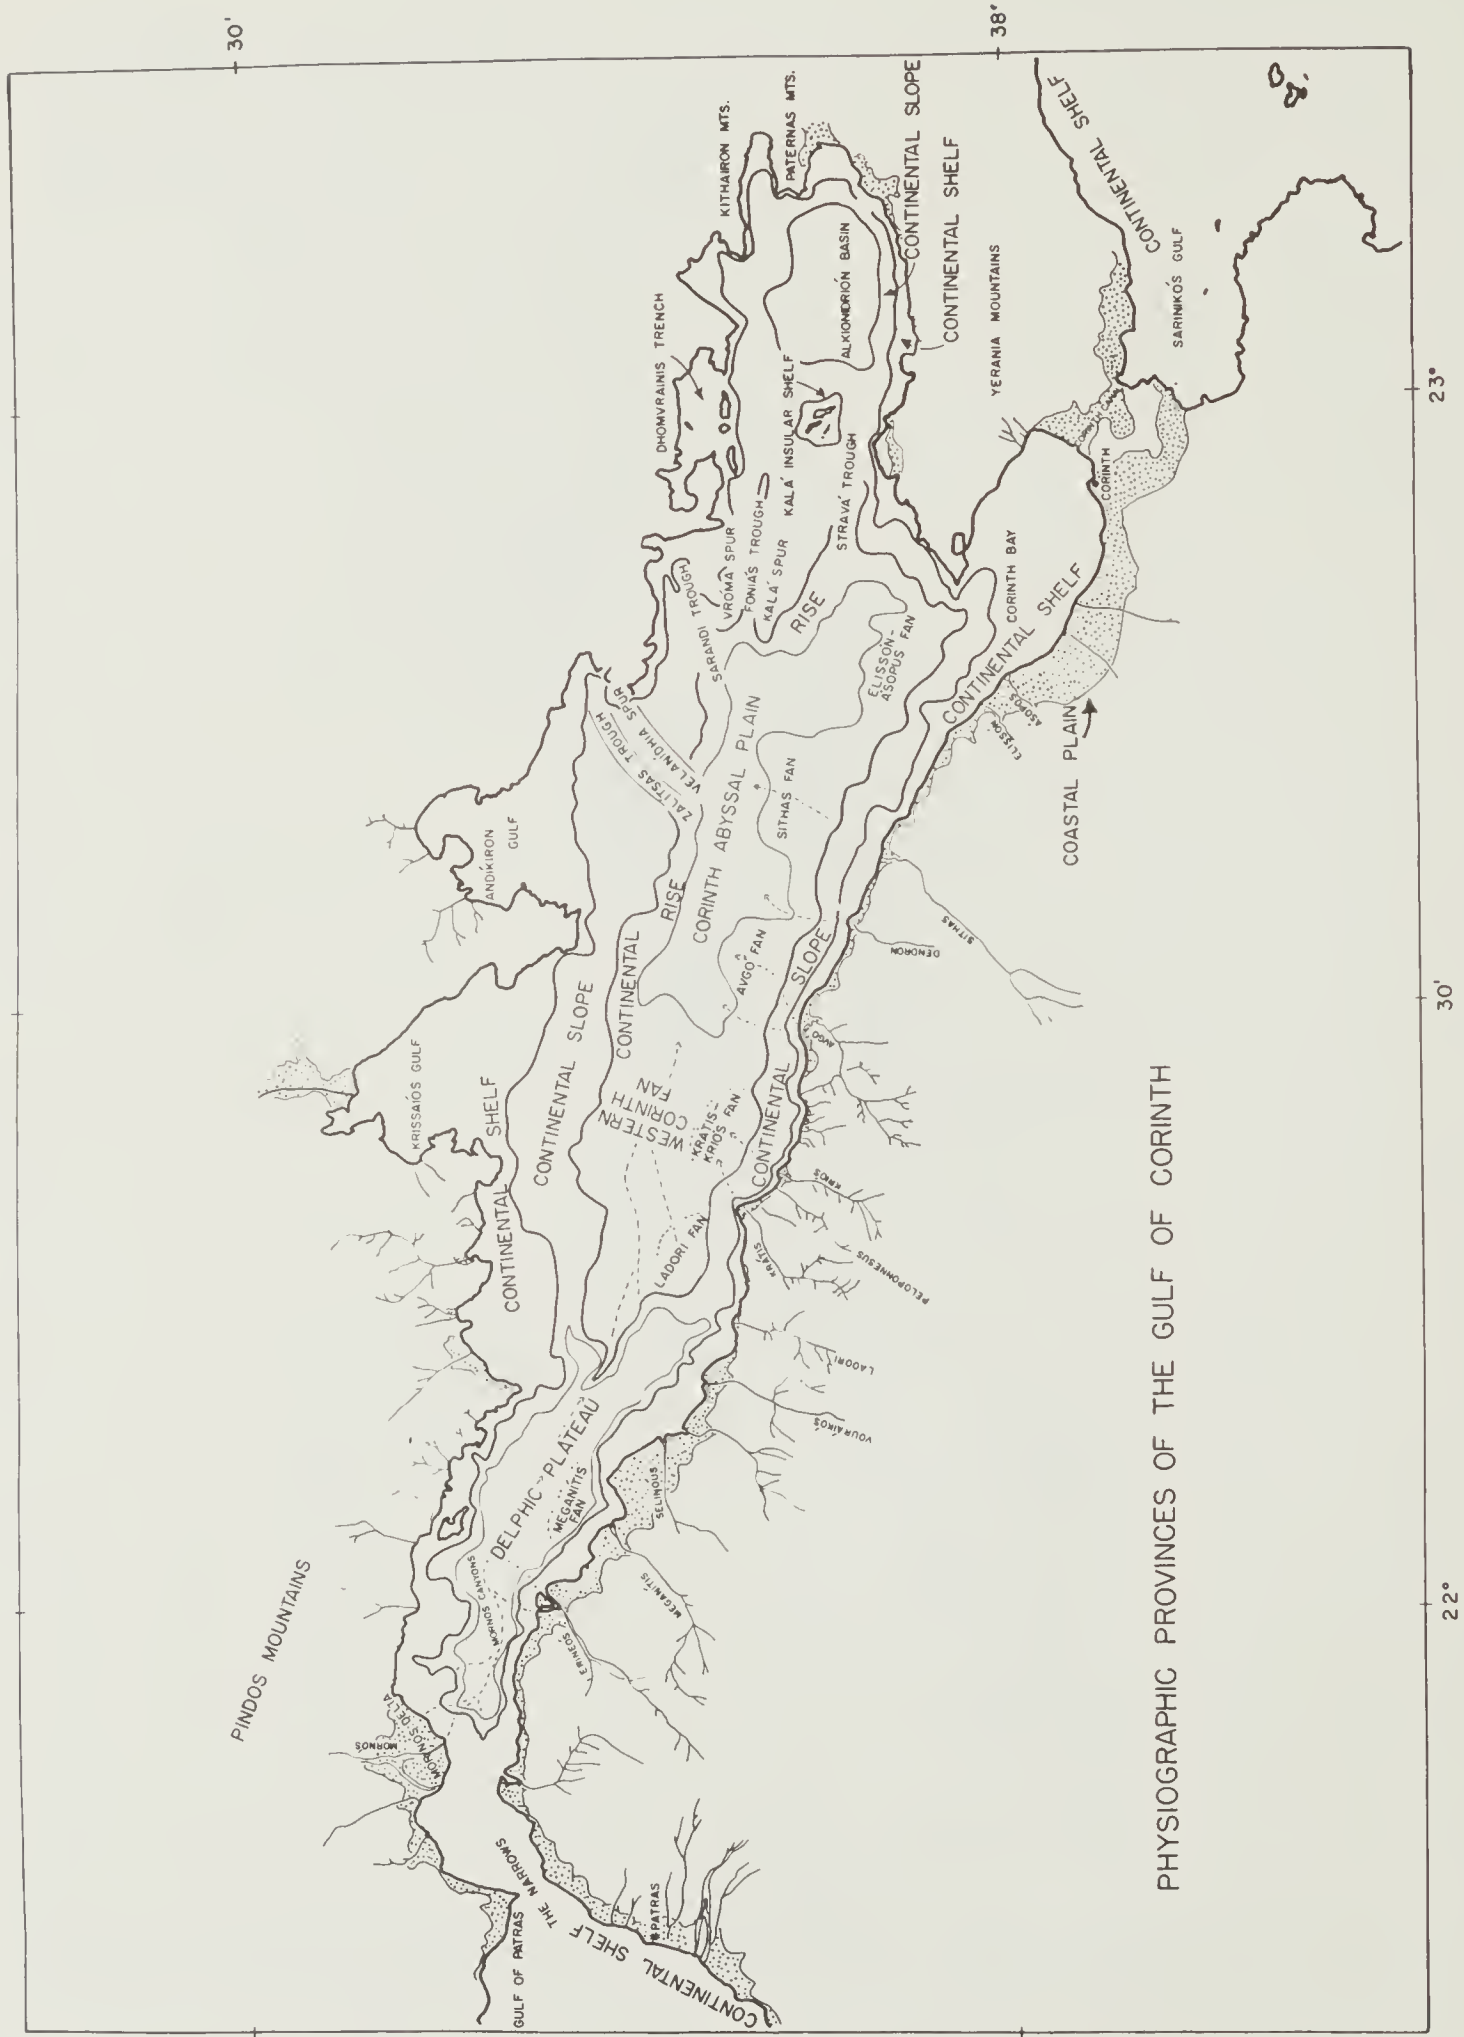
Fig. 4 Physiographic provinces of the Gulf of Corinth.

The physiographic provinces delineated in Fig. 4 are based on a study of the morphology represented on the PDR echograms. The division of a small land-locked arm of the sea into provinces similar to the grand division of the major ocean basins may seem unjustified. However, the shelf of the gulf is directly connected with the continental shelf of the Gulf of Patras; the slope descending from the shelf break to the gulf floor greatly resembles the continental slope, and the rise and abyssal plain of the gulf floor also resemble ocean features. Although

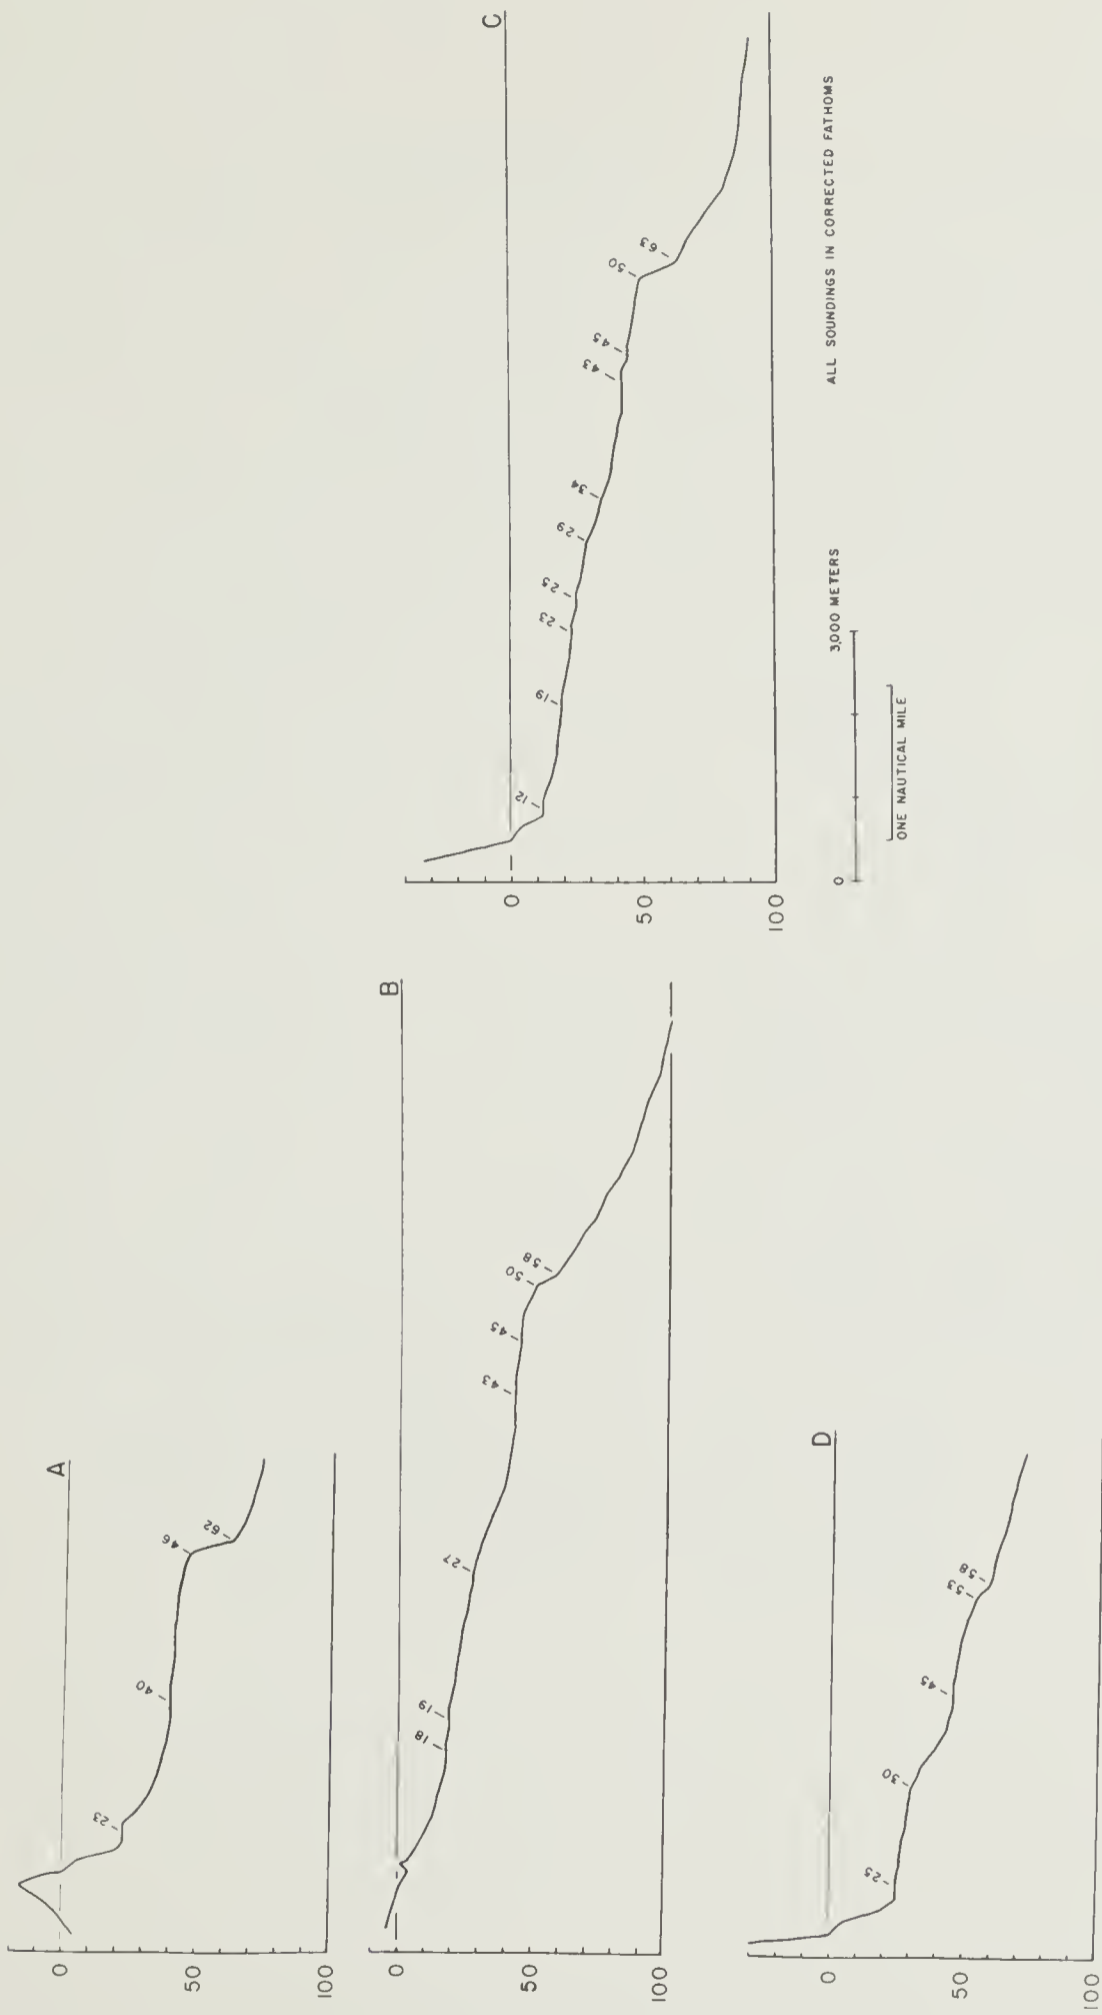
Fig. 7 Profiles in the Gulf of Krissaiós.

The shelf break ranges in depth from 15 to 120 fathoms. In general, the narrower the shelf, the shallower the shelf break. Thus the shallowest shelf break is found along the southern shore and the deepest (120 fathoms) seaward of the northern gulfs. Shelf terraces are represented in Figs. 7 and 9 (the profiles are indexed in Figs. 8 and 10). The most prominent terraces are at 19 fathoms, 23-25 fathoms, 40-41 fathoms, 42-43 fathoms and 45-47 fathoms. The capes of Vróma Island and Kalá Island are carried beneath the gulf by the subsea spurs of the same name (Figs. 4 and 11).

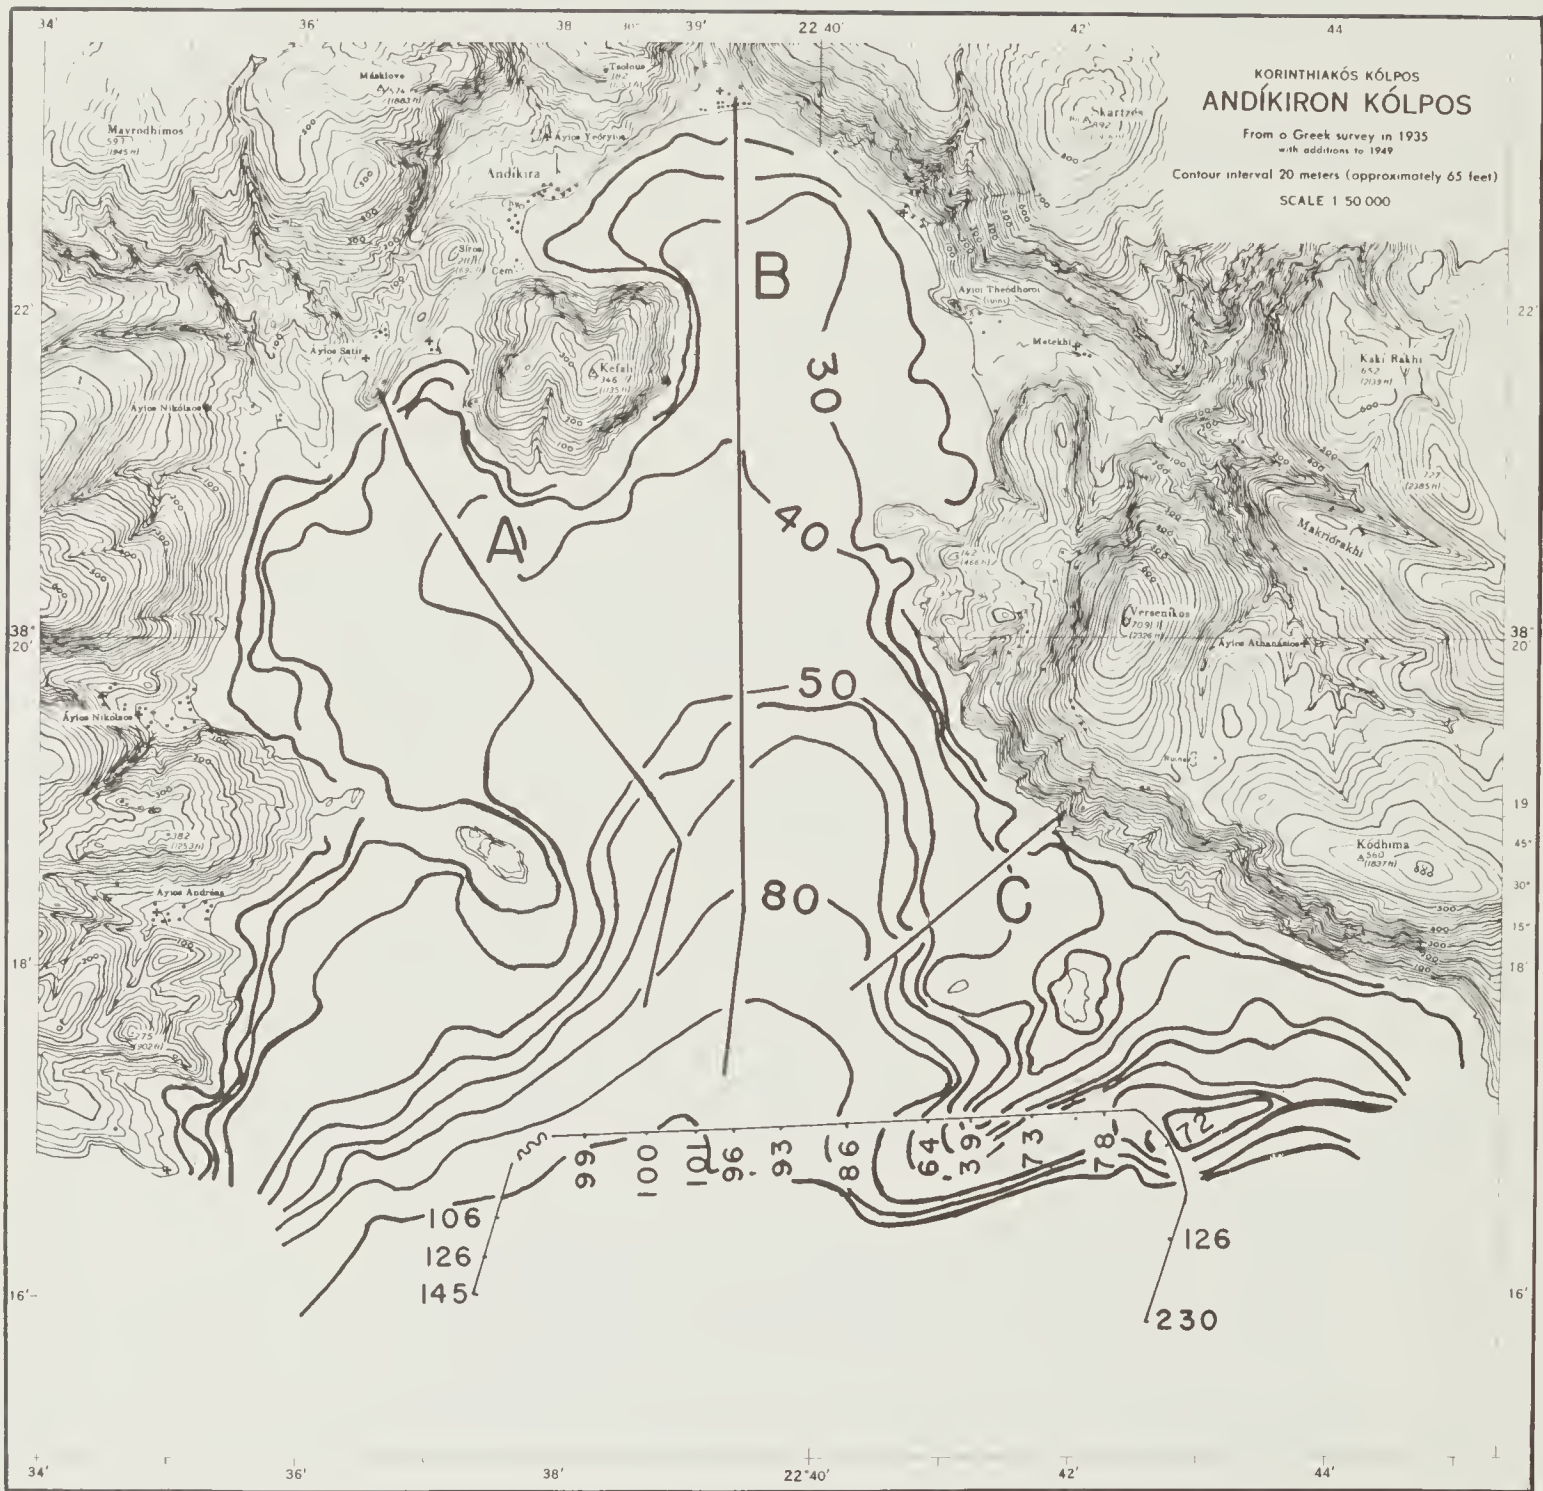
Fig. 10 Bathymetric sketch of the Andíiron Gulf.
 Andíiron Gulf after U. S. Hydrographic Office Chart 4092.
 Profiles A, B and C are shown in Fig. 9. Contour interval
 20 meters (10.9 fathoms) on land, and 10 fathoms in
 Andíiron Gulf.

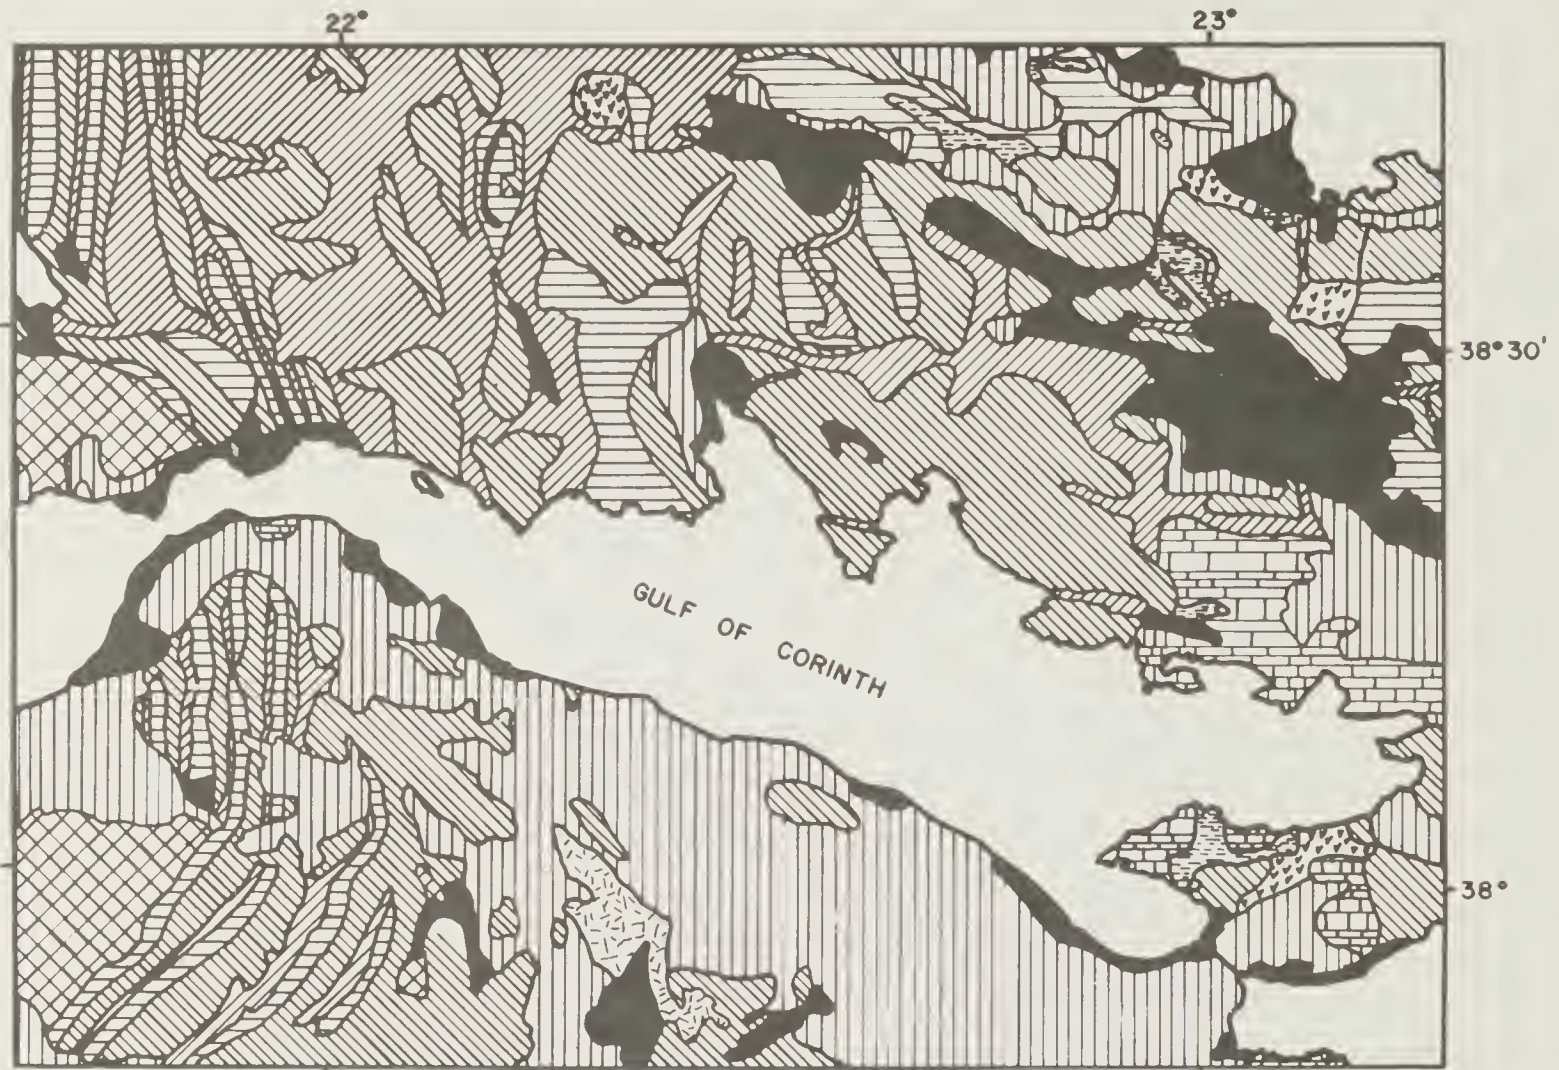
SURFACE GEOLOGY OF GULF OF CORINTH AREA

from Zachos, 1954

SCALE=1:500,000

Fig. 19 Regional surface geology of the Gulf of Corinth area. Based on "Geologic Map of Greece" by the Institute for Geology and Subsurface Research, Athens, 1954.

A portion of the 1954 Geological Map of Greece (Zachos 1954) is reproduced in Fig. 19. The Pindos Mountains, which are part of the Alpine belt, form the backbone of Greece. The Pindos are composed of a hard core of granites and serpentines flanked with Cretaceous limestones.

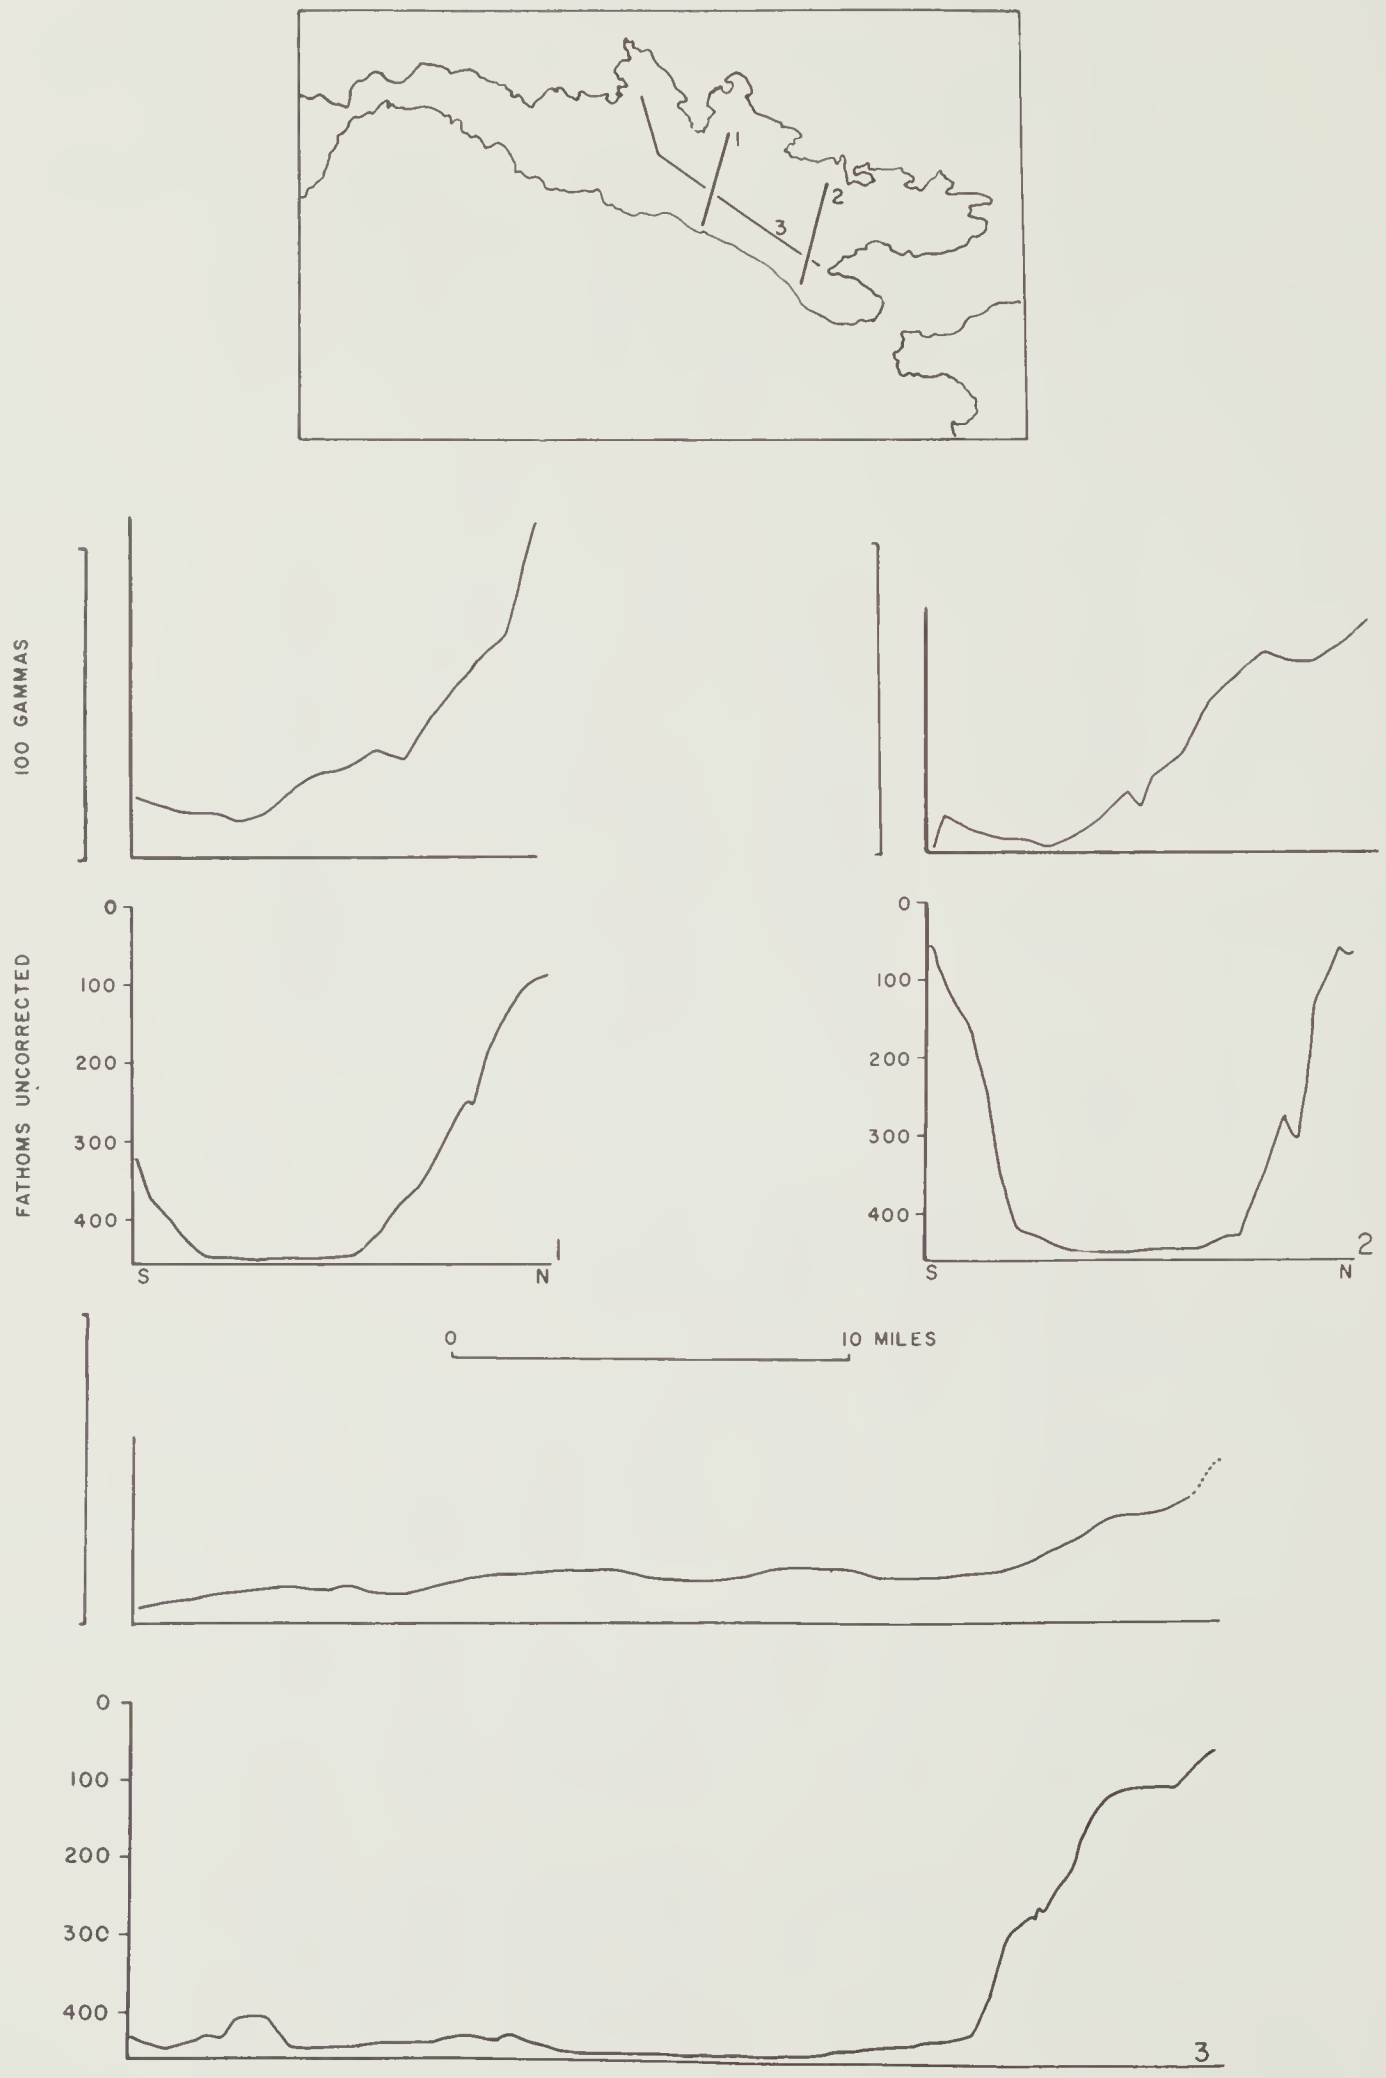
Fig. 20 Three geomagnetic profiles in the Gulf of Corinth with associated topographic profiles and index.

A continuously recording total-intensity fluxgate magnetometer was towed behind the R. V. VEMA during the reconnaissance survey of the Gulf of Corinth. Three typical profiles across the Gulf of Corinth reproduced in Fig. 20 show a general lack of large magnetic anomalies. This general lack of magnetic anomalies over the steep slopes of the gulf is surprising. However, this is not the first example of apparent large faults failing to produce significant anomalies (Miller and Ewing 1956) (Davidson and Miller 1955).

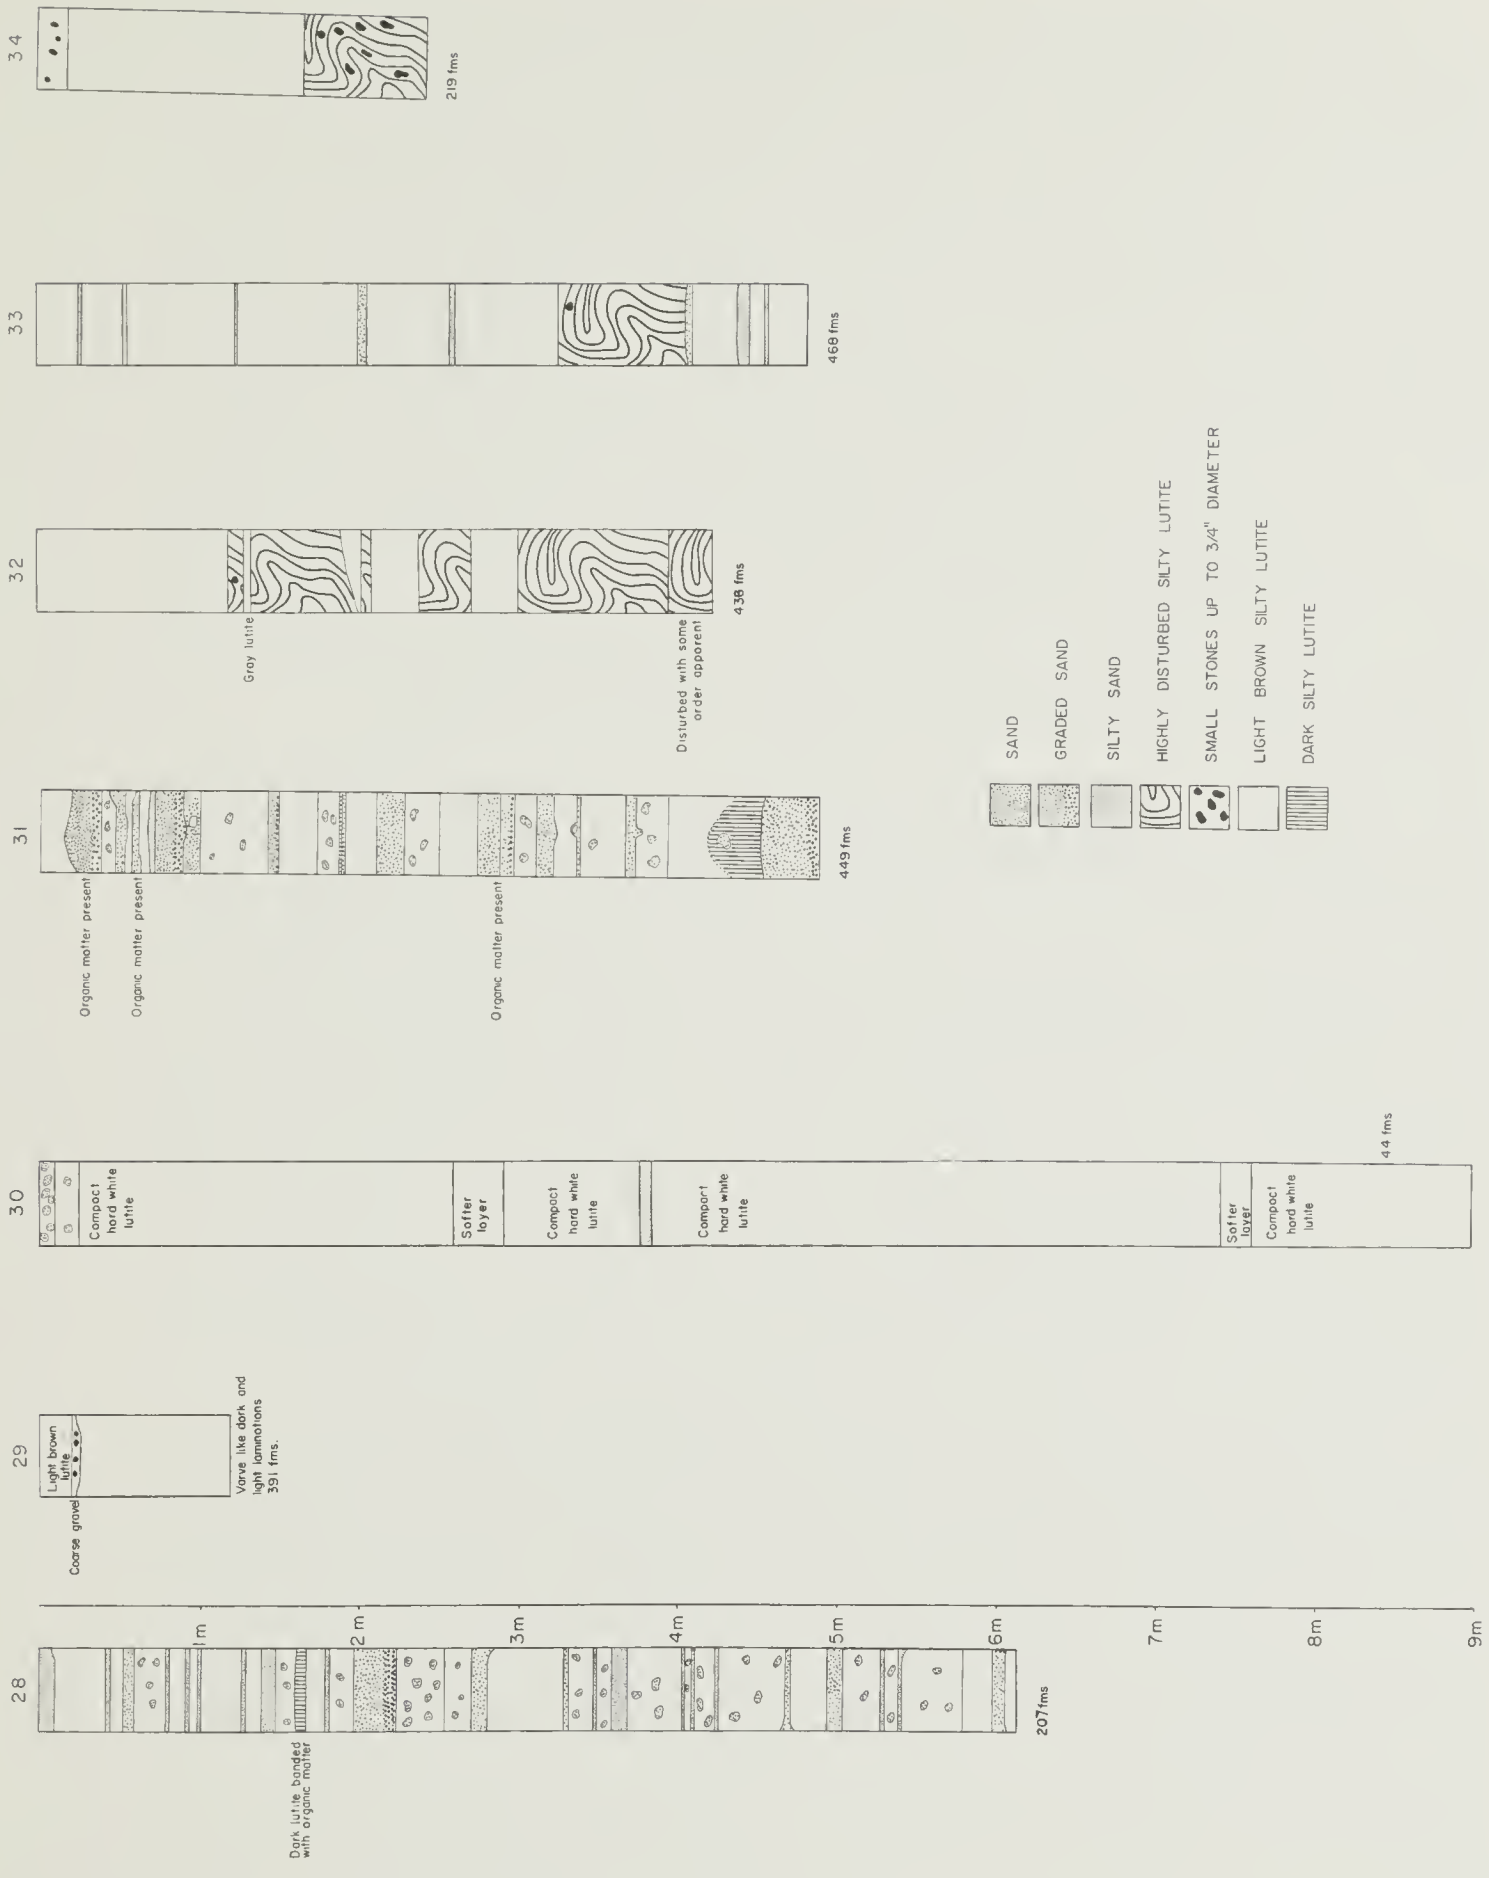
Fig. 21 Graphic logs of core lithology.
Lithology of all cores taken by R. V. VEMA 22 to 24 July 1956.

East of the Perched Plain a submarine canyon or trench leads to the Western Corinth Fan. Core V-10-31 taken on the Western Corinth Fan contains the thickest and coarsest sands found in any of the cores from the gulf. Nearly half the core consists of sand. The beds are consistently and obviously graded. In addition to these, there are several silt layers with sand pockets and sand layers with silt pockets. In three of the sandy layers there are bits of vegetable matter up to 0.5 mm in diameter.

The somewhat speculative topographic identification in the west part of the central basin of a depositional fan (Western Corinth Fan) is supported by the thick graded sands found in Core V-10-31. Similar thick beds found in Core V-10-28 at least suggest that the Perched Plain as well as the Western Corinth Fan are fed from the west with significant contributions from the Mórnos River.

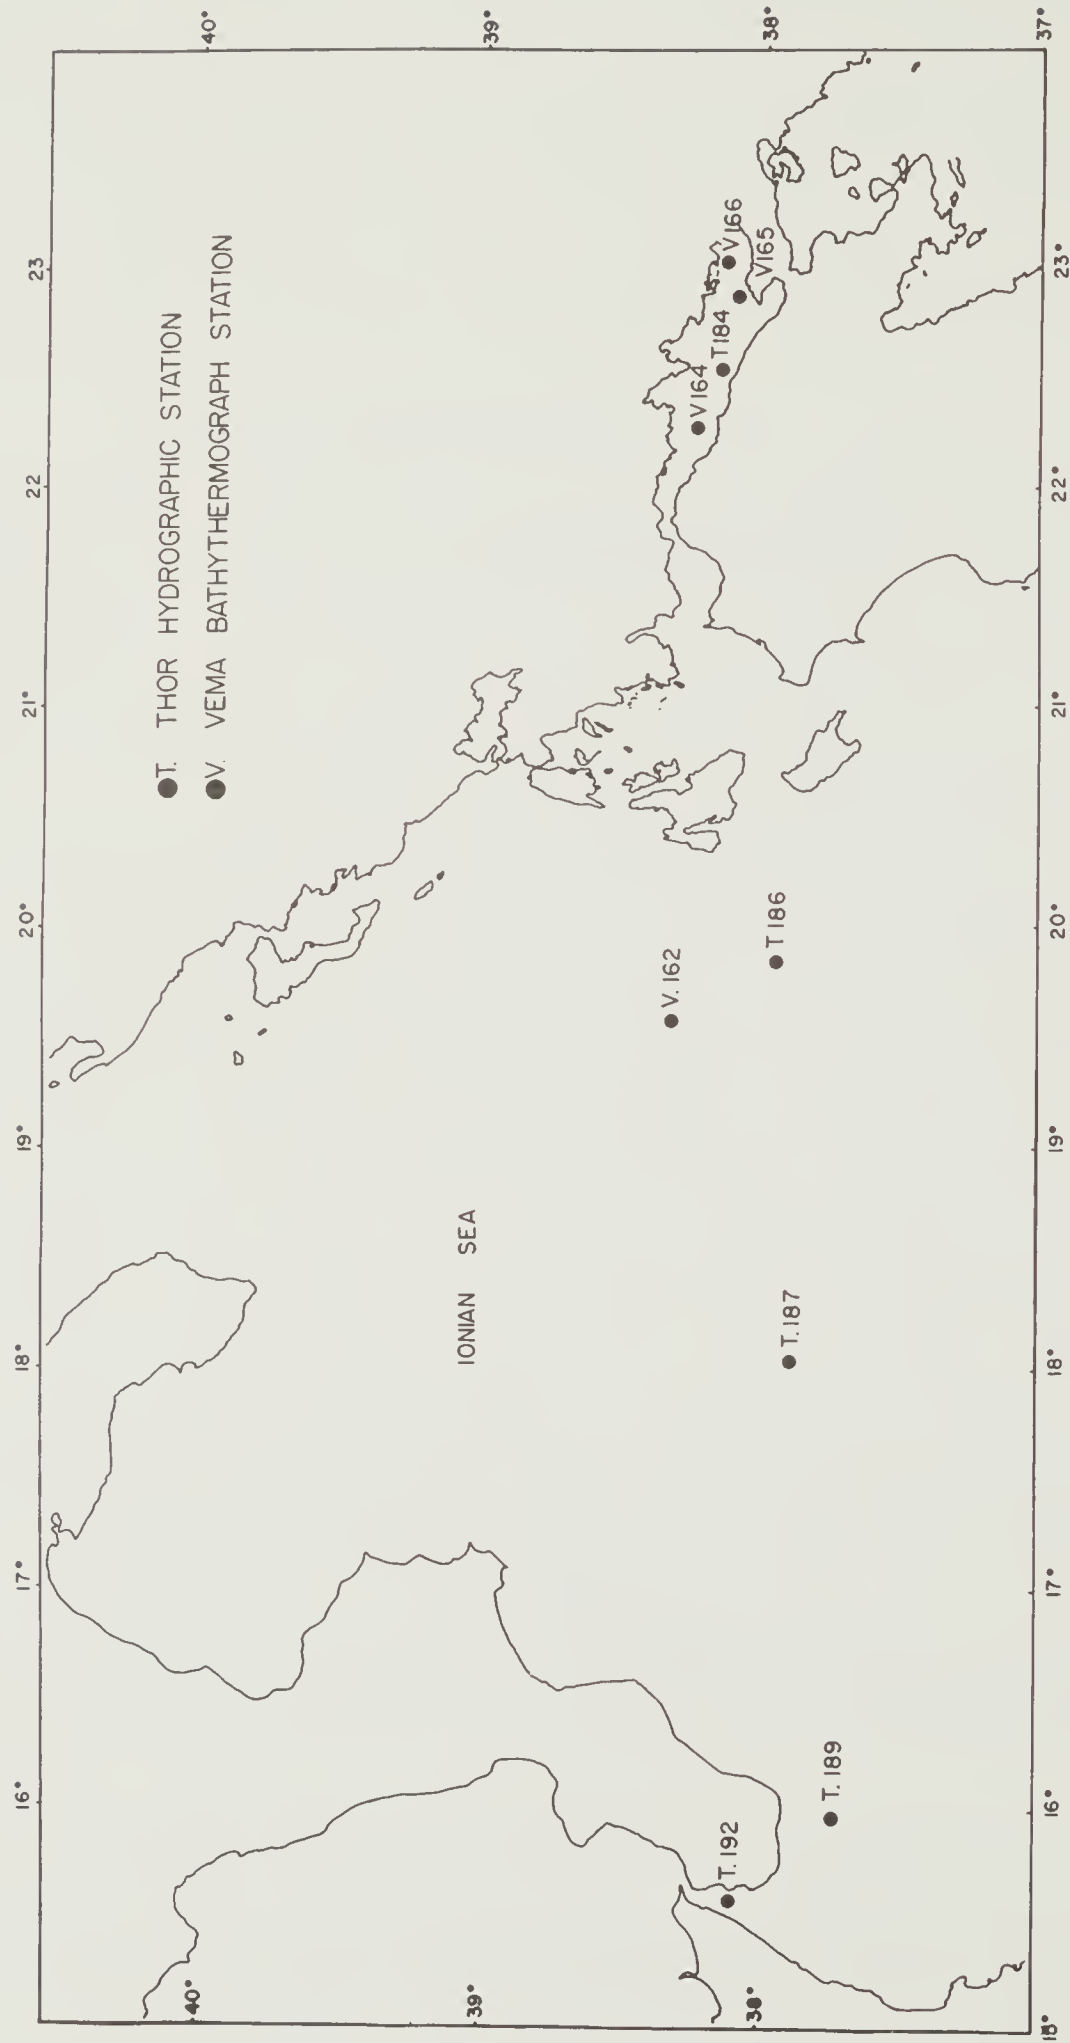
Fig. 28 Index chart showing location of THOR and VEMA hydrographic stations.

Serial Oceanographic Observations. In August 1910 the Danish research vessel THOR made a serial hydrographic section consisting of 5 stations across the Ionian Sea, including one station in the Gulf of Corinth (Figs. 27 and 28). In July 1956 VEMA occupied two serial stations in the gulf and made 3 bathythermograph lowerings (Figs. 28, 29, 30, 31). It is clear that with such meager data only the most general conclusions are permissible.

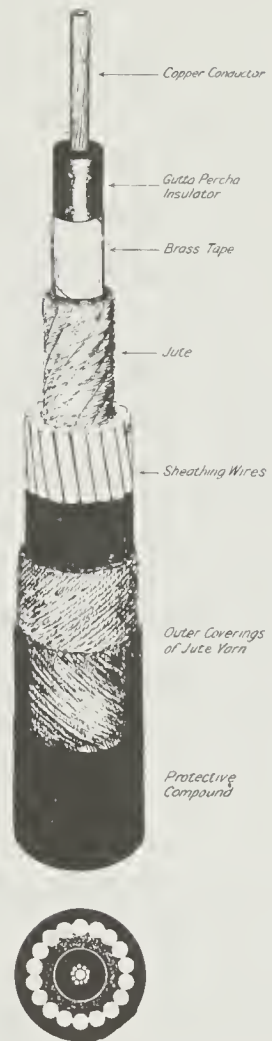
Fig. 38 Component parts of a typical deep sea telegraph cable.
