CABLE FAILURES IN THE GULF OF CORINTH:
A CASE HISTORY

Bruce C. Heezen, Maurice Ewing, and G. L. Johnson

The Bell Telephone Laboratories
Murray Hill, New Jersey
July, 1960

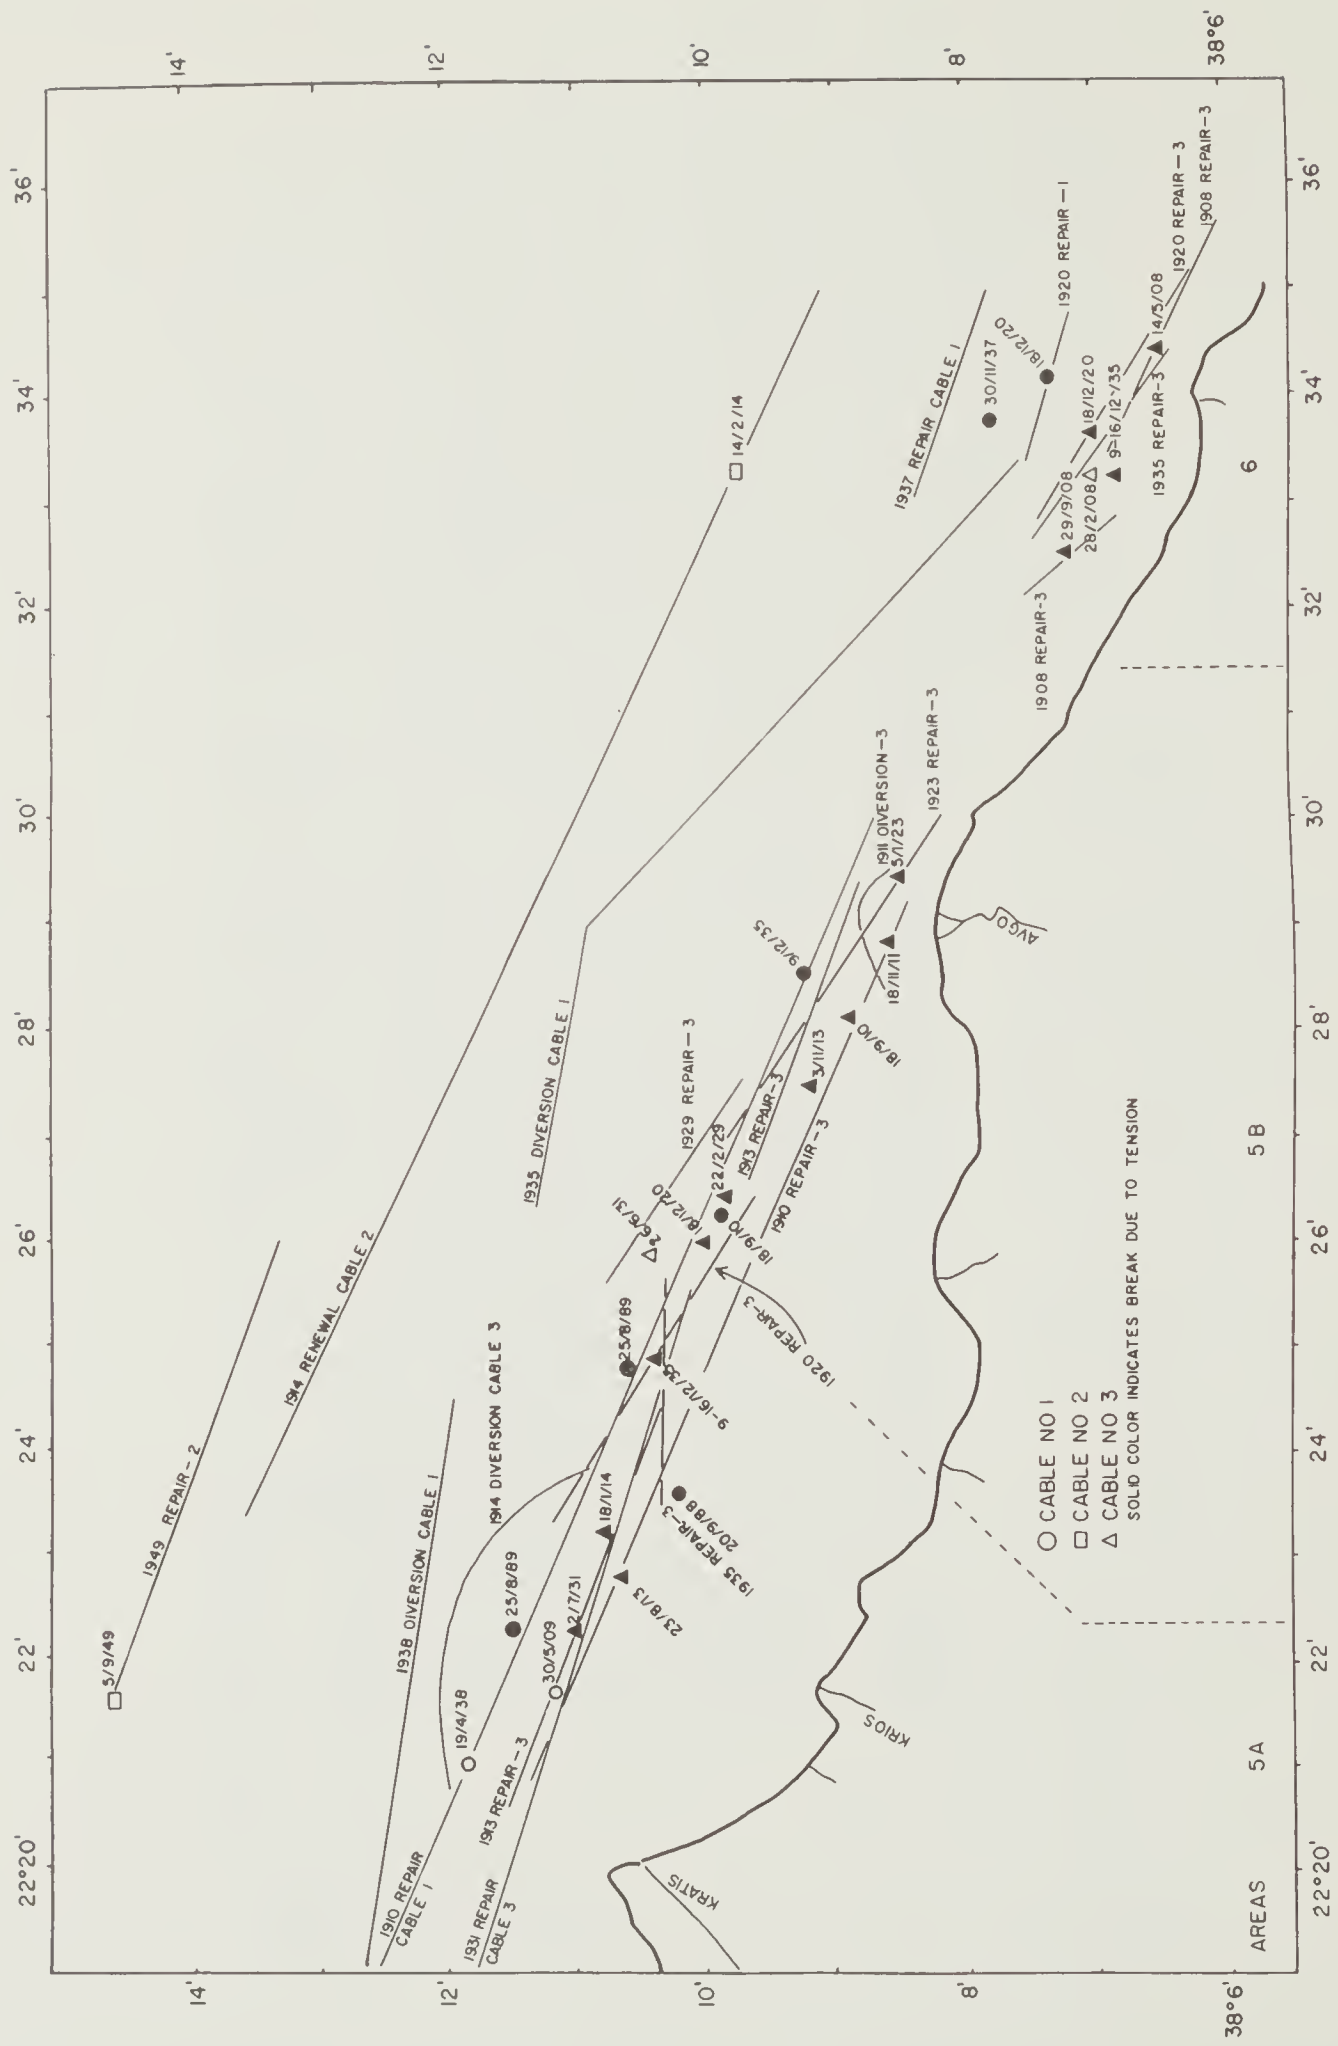
Fig. 39 Location of all cable failures and cable repairs in areas 5A, 5B and 6.

Continental Slope Seaward of the Avgó River, Area 5B. (See Table X and Figs. 32 and 39.) There have been eight failures in this area. Seven are clearly due to turbidity currents or slumping. The fault repaired on 3/11/13 is most likely related in cause to the other seven. All these failures occurred from September to February, which corresponds well with the maximum precipitation (Fig. 23). The failures are aligned in a NW and SW pattern along one large canyon. At 1630 L. M. T. on the 18th of September 1910, both cables 1 and 3 were broken. They must have been broken by one large flow down the axis of the canyon. On all other occasions, however, only one of the two cables broke. Cable #3, which lay closer to the mouth of the Avgó, failed five more times, but cable #1 failed only once again, during the December 1935 storms. Cable #3 possibly escaped injury in 1935 because it was newer and therefore stronger than the #1 cable, but it may have been buried; or lacking obstructions or brush entanglements, the flow could have swept over it without breaking it.
