# The Role of Construction Materials in Building Collapse in Nigeria: A Review

G. O. Bamigboye<sup>1\*</sup>, T. Michaels<sup>1</sup>, A. N. Ede<sup>1</sup>, B. U. Ngene<sup>1</sup>, C. Nwanko<sup>1</sup> and I. Davies<sup>1</sup>

<sup>1</sup>Department of Civil Engineering Covenant University, Ota, Ogun State, Nigeria

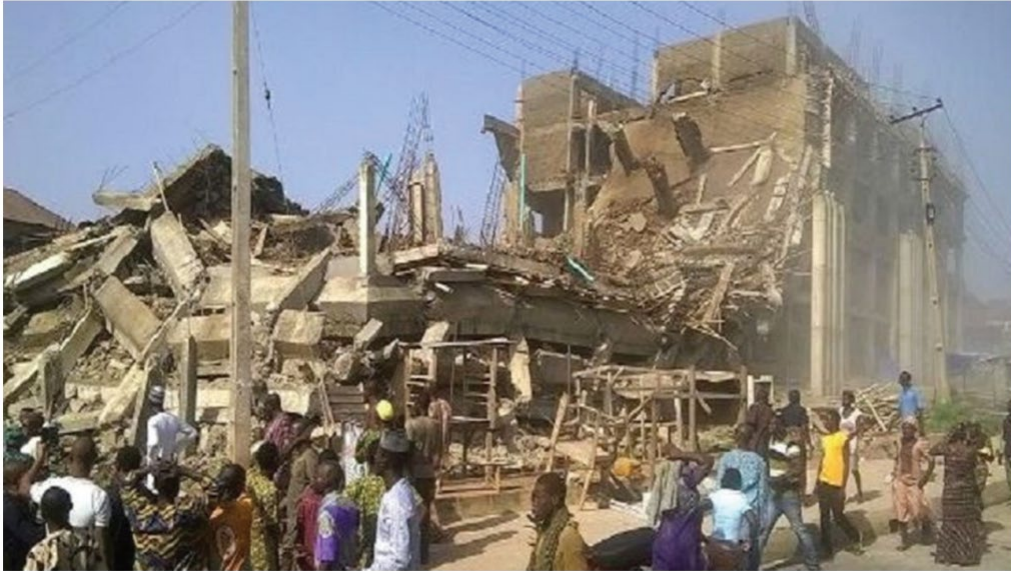
According to Adewale et al [17] case study of Meiran building collapse which is a bungalow with a decked shop extension collapsed on 22nd of July 2017 with two deaths toll. The building is said to have collapsed due to the use of inferior materials used during construction to support

the heavy loads the building was subjected to. The building had no building permit from the state government.

Figure 1: Meiran Building Collapse. Source [17].

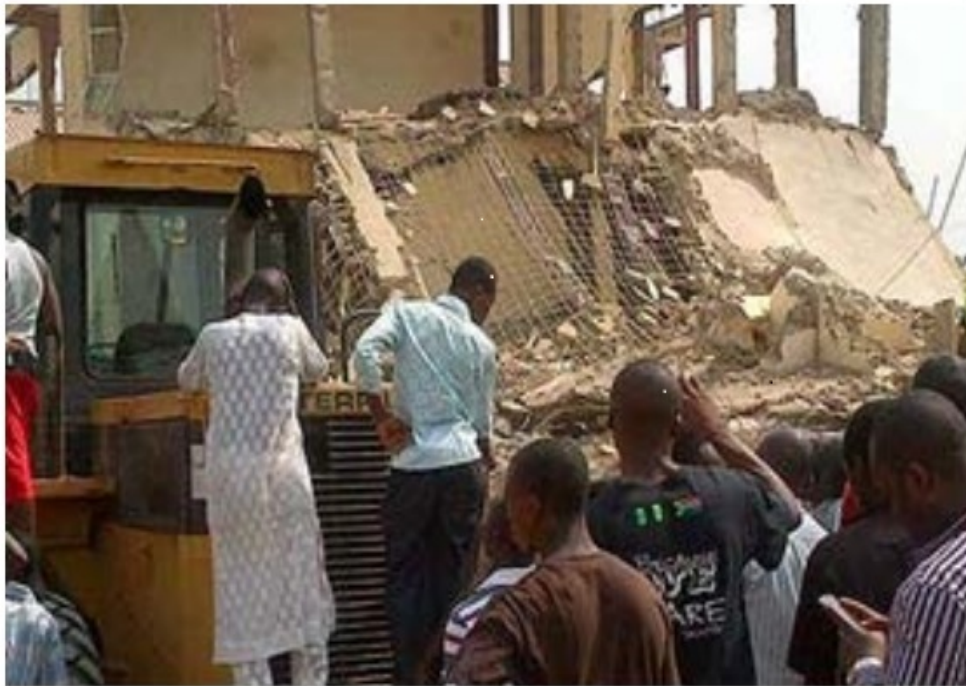
Fakere et al [18] and Adewale, et al [17], reported case of Naval building collapse in Nigeria as showed in Figures 2 and 3. The building located at Naval quarters 45 road, 1st Avenue, Gwarimpa Estate collapsed at about 10 am on 28th January, 2012. The contractor or construction team was already issued a stop-work order on the renovation works being carried out because of some noticeable structural defects. The stop-work order was issued by Federal Capital Development Authority (FCDA) and marked the structure as a ‘tragedy waiting to happen’. It is noteworthy to say that the investigation unveils the deterioration of the building element over time. The columns were becoming twisty and also noticed to be wangling. The steel later buckled, materials crushed and the cover to concrete gave way while the entire reinforcing steel was exposed because of the manual and crude demolition method employed. The building collapsed suddenly without any notice in less than a minute of loud noise as the steel yielded. From investigation and report of Fakare et al [18] impurities were discovered to be mixed with aggregates utilized for the erection of the said structure which could have been one the major factors leading to state of unhealthy structural members of the building. It was inferred that oxidation might have taken place due to impurities found in the components of the concrete which might have also be accountable for the poor strength of the structural members. Further investigation of the collapse revealed that materials that are sub-standard, such as reinforcement and poor concrete mix ratio must have contributed immensely to the sudden collapse of the building.

Figure 2: Clearing of debris on the Naval Building site. Source: [18].

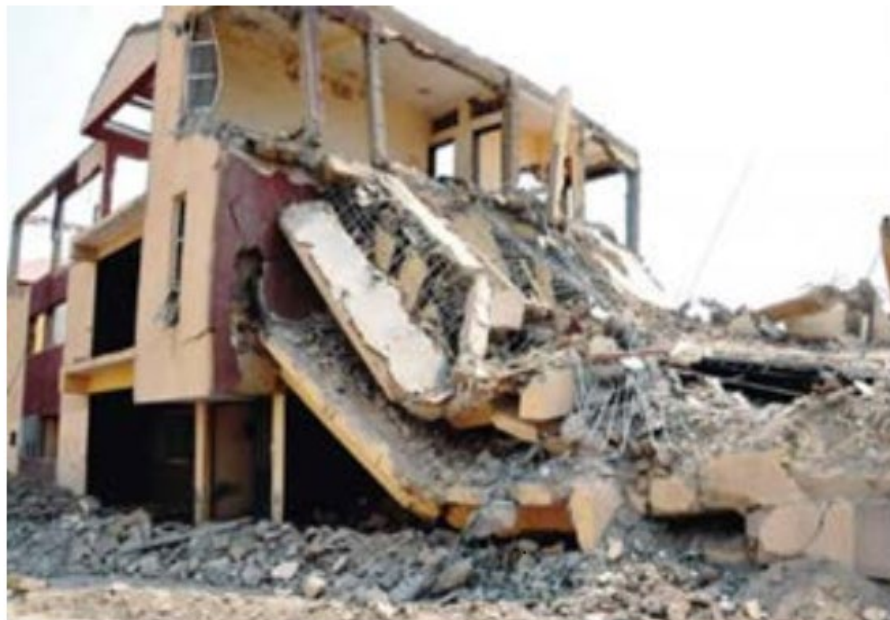
Figure 3: Another view of the building showing the wreckage. Source: [18].
