## Potential and Electric Field Characteristics of Broken Porcelain Insulator

H. Rosli, N. A. Othman, N. A. M. Jamail, M. N. Ismail

Department of Electrical Power Engineering, Faculty of Electrical & Electronic Engineering,  
Universiti Tun Hussein Onn Malaysia (UTHM), 86400 Batu Pahat, Malaysia

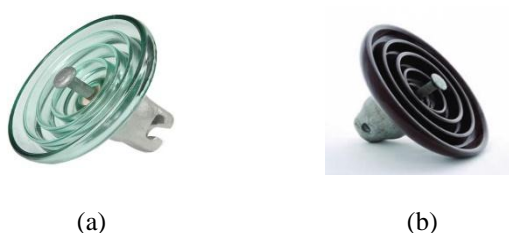
Figure 1. Example of (a) glass insulator and (b) porcelain insulator

Ceramic insulators which consist of glass and porcelain are the earliest insulators used in the power system transmission lines [3]. The pictorial view of glass and porcelain insulators is depicted in Figure 1. Both insulators have been used for over a century and their application can be considered as a safe choice. The raw materials for glass insulators includes soda ash, feldspar and cullet as well as a few other ingredients that crushed to form powder and melted in a furnace [4]. Toughening significantly increases the mechanical strength, making the glass shell suitable for the use of HV insulator. Meanwhile, high strength electrical grade porcelain for line insulators is usually made by the classical wet process. Raw materials like clay are mixed in water to facilitate blending. Therefore, even a small crack in the porcelain insulator may effect on the puncture strength of the insulator [5].

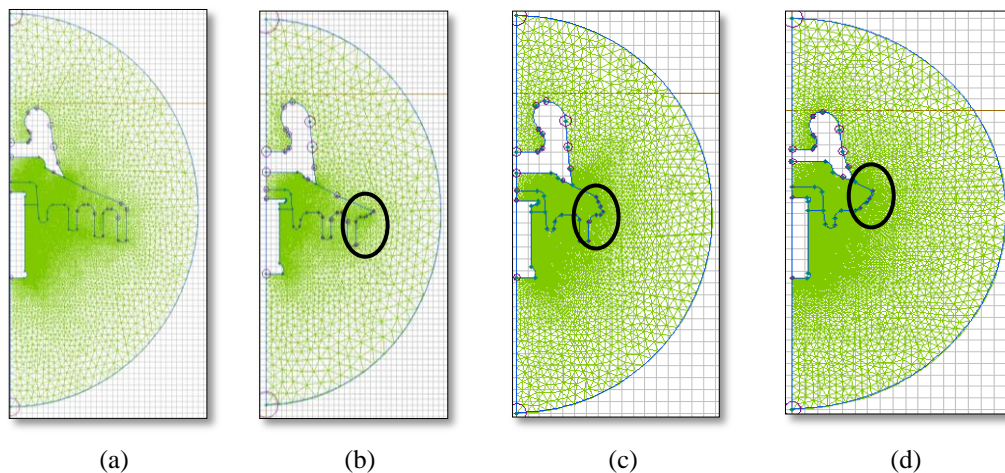
Figure 3. The configuration of broken insulator for (a) Perfect, (b) Case A1, (c) Case A2, (d) Case A3

For each case, the number of broken shed is different as indicated in black circles in Figure 3. As clearly seen from the figure, the number of mesh is increased at the broken part approaches the insulator pin.

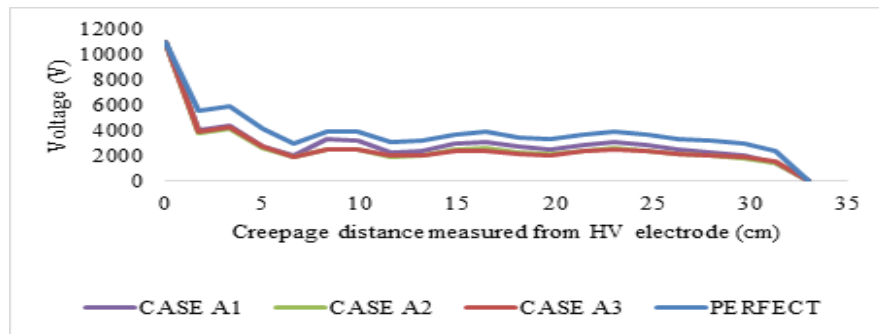
Figure 5. Potential distribution for all cases of broken porcelain insulators when compared to the perfect insulator

Figure 5 illustrates the potential distribution along creepage distance for all cases of broken porcelain insulators when compared to the perfect insulator. It is apparent that the potential distribution of perfect insulator retain the highest value compared to the broken insulators; this findings affirmed by [12]. Generally, the potential distribution pattern can be said as non-uniform along the creepage distance when measured from HV electrode for all cases. However, the broken shed of case A3 bears the most significant potential value and contribute the highest percentage reduction of potential compared to other cases as the reduction value is the highest when compared to perfect case.

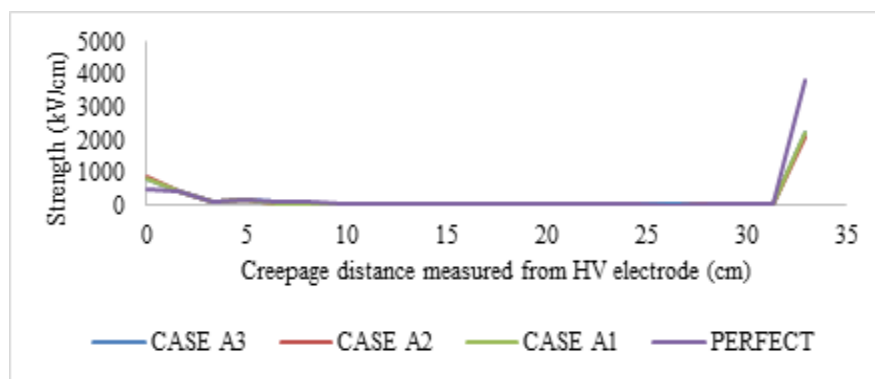
Figure 7. Electrical field distribution of single porcelain insulator compared with all cases of broken porcelain insulators

Figure 7 illustrates the graphs of electrical field distribution of single porcelain insulator compared with all cases of broken porcelain insulators. Generally, the distribution of electric field for perfect and all broken cases single porcelain insulator presents the similar pattern along the creepage distance. However, there is a slight decrease in the electric field strength value at beginning before become almost constant in the middle of the contour across insulators and experienced a fast develop at the end for perfect insulator. Contrarily for all broken case where the electric field strength is much higher at the beginning and lower at the end when compared to perfect insulator.

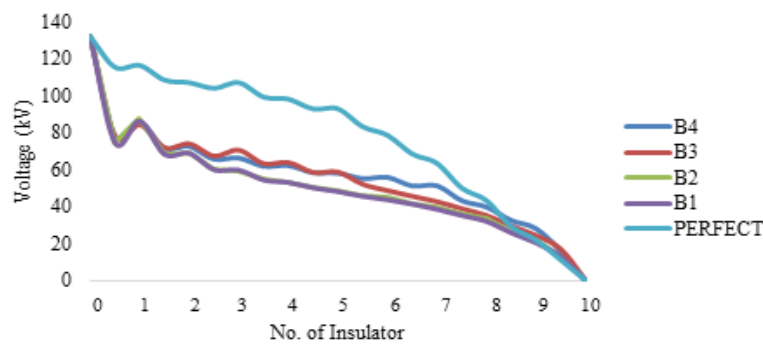
Figure 9. Potential distribution of all cases of string insulators

Figure 9 shows the potential distribution of 10 units of porcelain insulator in a string. It is obvious from the figure that the voltage distribution is affected when broken insulator exists in the string. This finding is supported by Xiu-chen [16] which concluded that the insulators near the earth are sensitive to the voltage-change of the insulator near the power line, but the latter are not sensitive to that of the frontier. By their analysis, it can be concluded that the sensitivity of string insulator is most affected when broken insulator exist near the ground (earth).

The lowest average potential value of 50kV was recorded at the B1 case string with 35.06% reduction from the perfect string insulator can be calculated from Figure 9. The graph is then dramatically decrease for all the cases. It can be shown that the potential which should bear by the first insulator have been transferred to the second insulator and so on. Table 5 tabulates the average, maximum and minimum value of voltage across string with 10 units of porcelain insulator in all cases. It is noticed that the average value indicate that the presents of broken insulator in a string affects the voltage across the string insulator. But, the result shows that the B4 case bears the most significant effect on the potential distribution of string with 10 units of porcelain insulator due to the highest reduction value of voltage at the end of the string insulator in ground terminal.

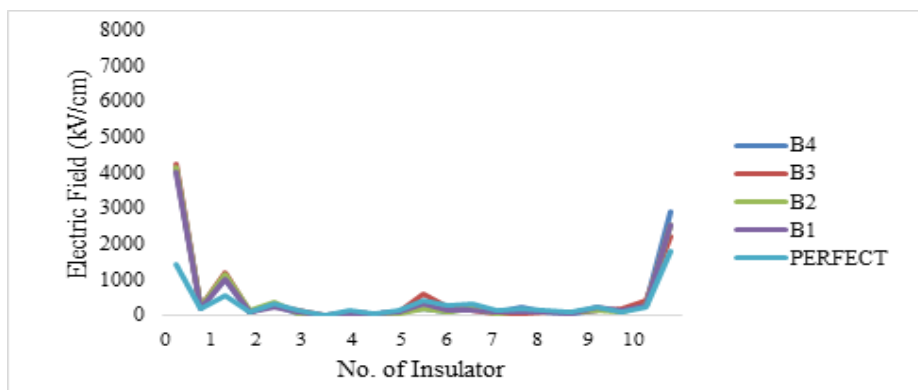
Figure 11. Electric field of broken insulator in string

Table 6 shows the electric field value in all cases of string insulator with and without broken porcelain insulator. The result shows that highest value of electric field distribution is found in the first insulator in Case B3 based on Figure 11. Meanwhile, highest value of electric field was found in case B4 at the tenth insulator as mentioned in Table 6.
