# MARINE FISHERIES INFORMATION SERVICE

No. 77

NOVEMBER 1987

## TIDAL WAVES CAUSE DAMAGES TO COASTAL VILLAGES IN KERALA\*

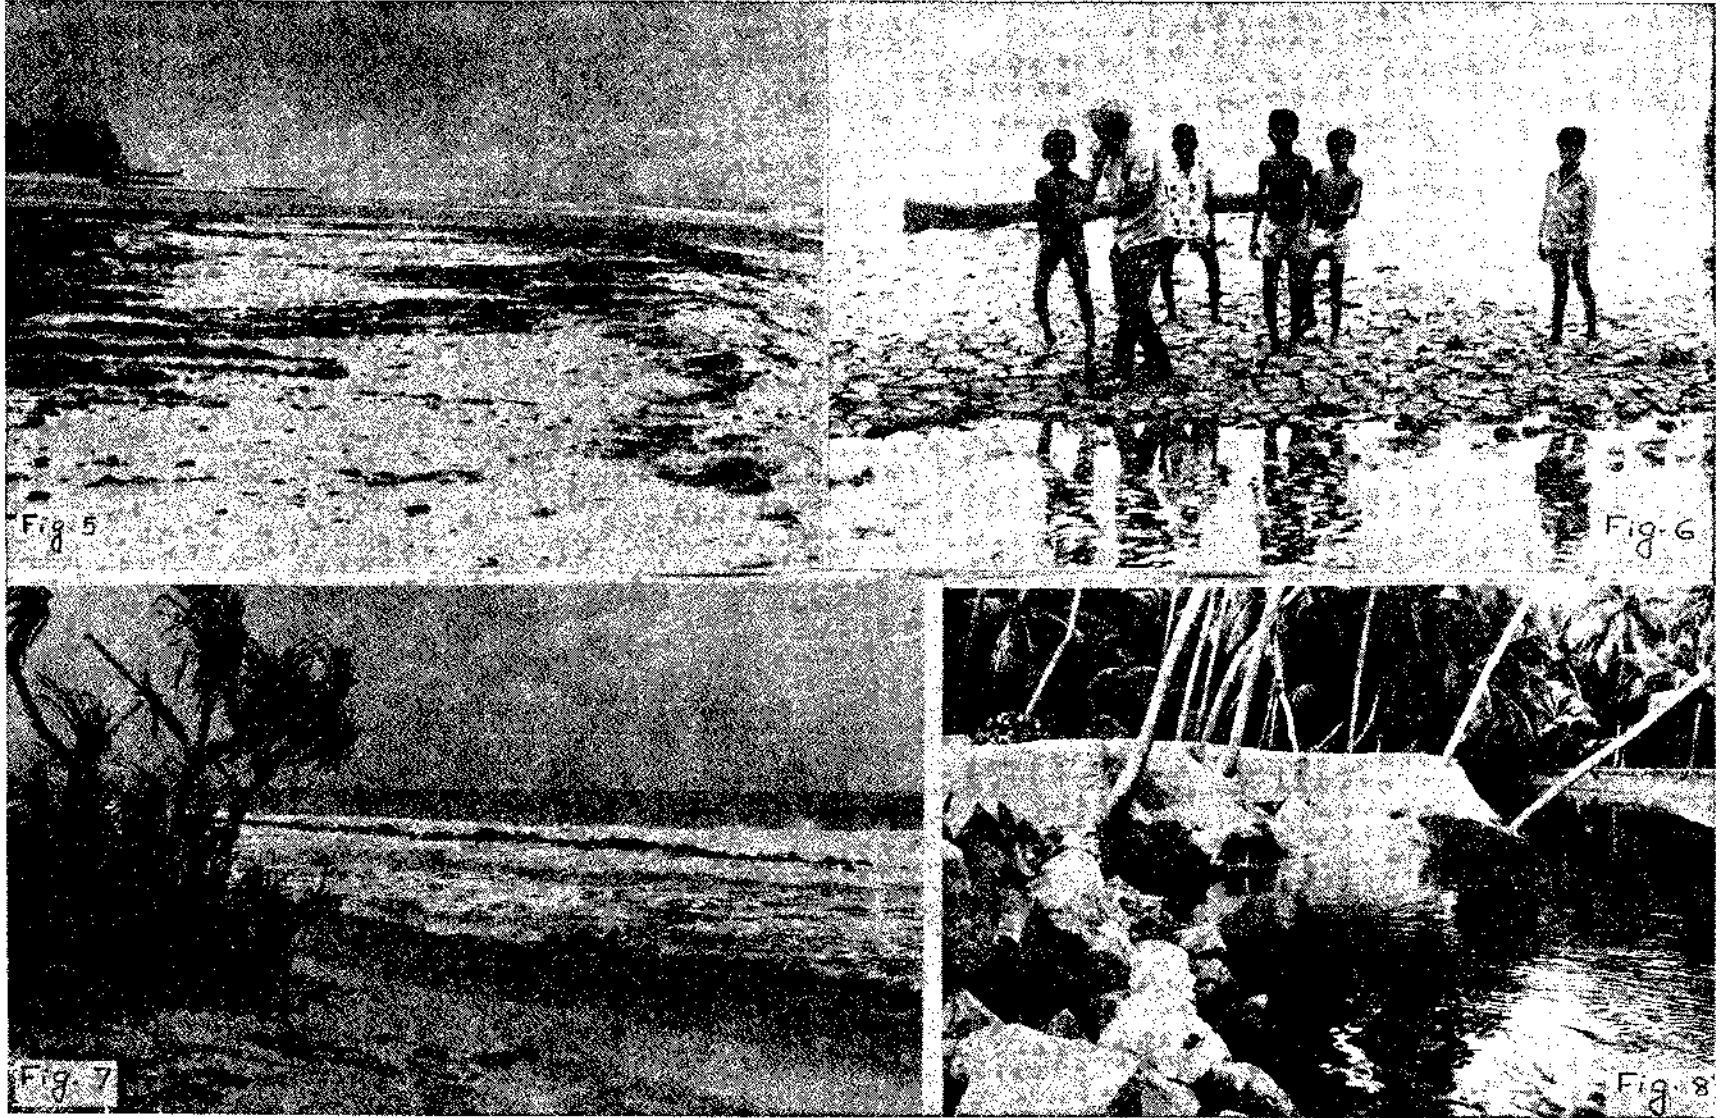
There have been earlier cases of such sudden changes in the sea. One such instance occurred in the mid-night of 29th August, 1980 when tidal waves rose over the beach between Alleppey and Quilon in the same manner as has happened at present. The waves swallowed considerable stretches of sandy beach. The greatest havoc was caused at the mud bank region in the Ambalapuzha-Thottappally area where tens of coconut trees were uprooted and seven houses were washed off leaving no signs of their existence. Two fish storage sheds built in bricks and cement were also completely destroyed at Ambalapuzha and heavy movement of sand occurred. Inundation of low lying areas also occurred.

The mud of the mud bank was completely dissipated over night and rough sea prevailed there. The dissipation of the mud bank aided by the tidal waves in 1980 was quite sudden and phenomenal unlike in the normal way which is a slow and gradual process. Part of the mud of mud bank was washed ashore along with fishes, shells and polychaete colonies and the rest was aggregated in the sea to form a platform of mud of about 3 km long and 0.5 km wide which could be seen above water level during the low tide. However, within 12 hours the aggregated mud was beaten away and thus the mud bank was completely dissipated causing rough sea in the area.

Fig. 5. Streaks of mud seen on the beach at Purakkad mud bank area. Major part of the mud is covered by sand(1980). Fig. 6. The mud thrown on to the beach at Purakkad after being baked in the sun (1980). Fig. 7. The sea has come far interior into the land. In the water is seen the sea wall which was no barrier to the roaring tidal waves. A scene at Ambalapuzha (1980). Fig. 8. Vast areas of unprotected beaches were eroded along the Alleppey-Quilon coast and the sea had come to the coconut plantations. A scene at Purakkad (1980).
