6TH APRIL 2009 L'AQUILA EARTHQUAKE, ITALY: REINFORCED CONCRETE BUILDING PERFORMANCE

Paolo Ricci, Flavia De Luca and Gerardo Mario Verderame

ABSTRACT

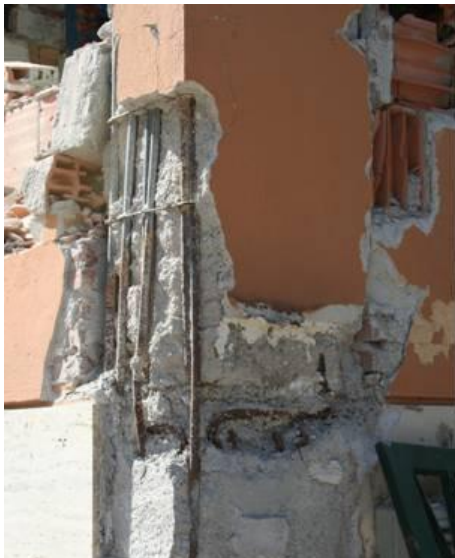
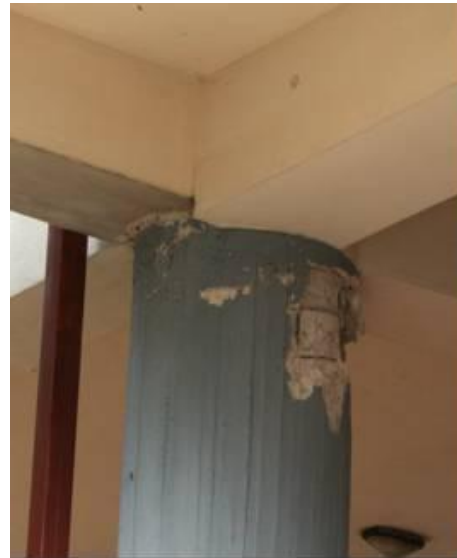
Figure 7. Column with smooth bars and poor transversal reinforcement (a); damage to a column due to axial force and bending moment (b)

Figure 7a presents a corner column of an RC building in the historical centre of L'Aquila, probably erected between 1950 and 1960. Damage occurred at the bottom end section of the element. The presence of smooth bars and a small hoop diameter (6 mm), closed with 90° hooks, can be observed, but the most significant detail is the absence of any transversal reinforcement in the first 30–40cm of the element immediately adjacent to the beam-column joint region. Figure 7b shows a circular column belonging to a building in the residential zone of Pettino, built in the 1980s: typical damage due to axial force and bending moment is recognizable; the concrete cover was crushed due to high compression strains and longitudinal bar buckling. In this case hoop spacing is, once again, not thick enough, as in the case of Figure 7a, but probably in this case the column was designed in accordance with code prescriptions at the time of construction.

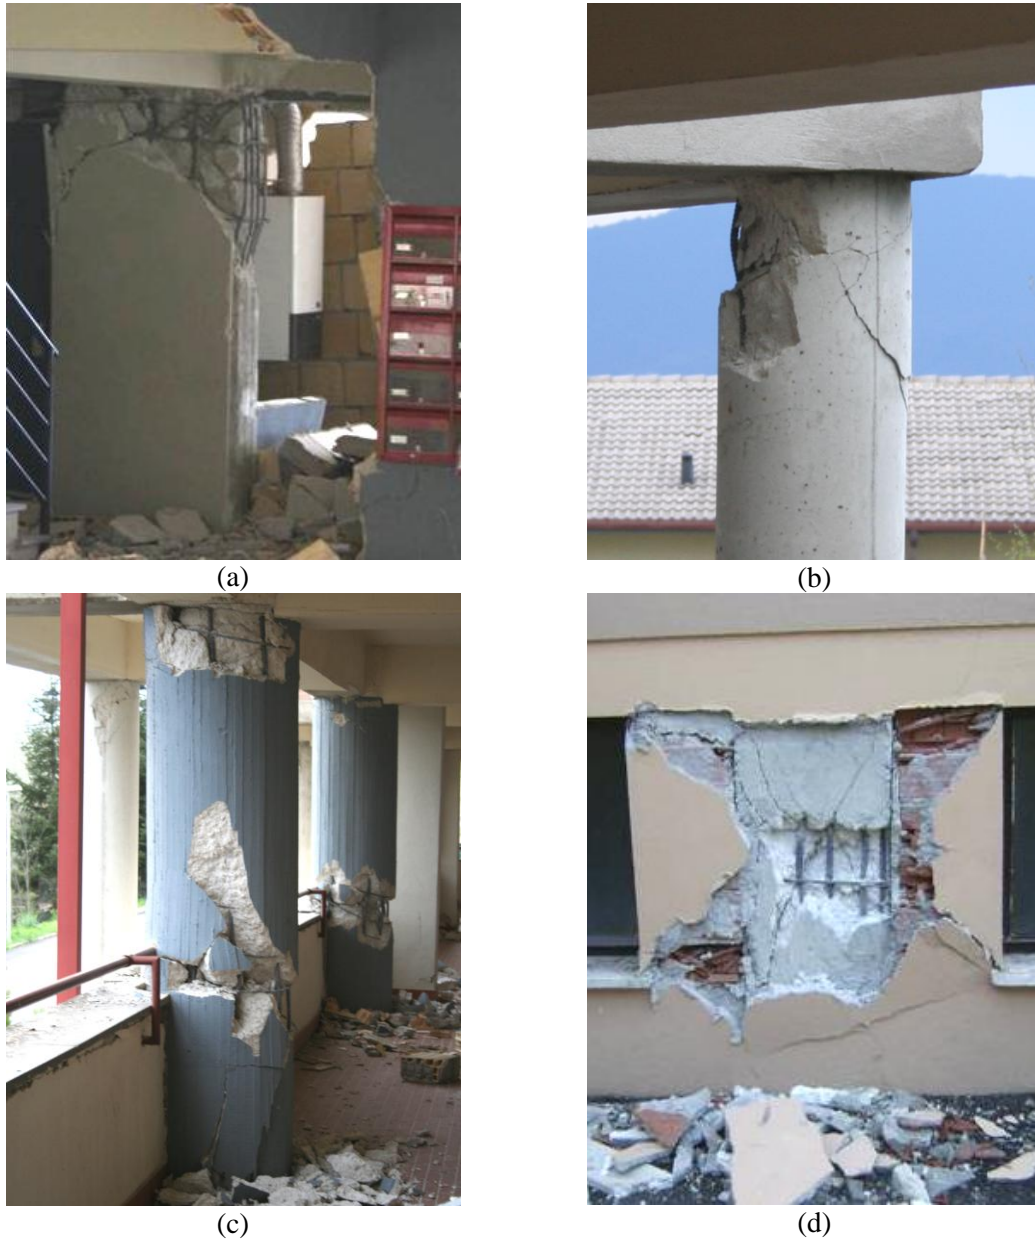
Figure 8. Shear failure of: (a) rectangular and (b) circular (b) columns, (c) column adjacent to partial infilling panels, (d) squat column adjacent to basement level concrete walls

With regard to the rectangular column in [Figure 8a](#), whose section is $30 \times 100 \text{ cm}^2$, belonging to a 1980s' building, shear failure is evident, involving the top end section. Transversal reinforcement has hoop spacing of approximately 15-20cm, and is definitely under-designed with respect to column section size, that is, with respect to the inertia of the section, thus leading to premature shear failure of the element. The brittle failure mechanism is highlighted by the crushing of the concrete within the reinforcement and the complete opening of the third and fourth hoops from the top end of the element.

[Figure 8b](#) shows shear failure of a 30cm-diameter circular column; in this case it is possible to recognize insufficient hoop spacing, which leads to the typical diagonal cracking characteristic of shear failure mechanisms and longitudinal bar buckling in the column.

In order to stress the non-secondary role played by column – infill interaction in determining brittle failures in the structural elements, [Figure 8c](#) shows the damage that columns present in these kinds of situation. It is possible to recognize the brittle failure in the column due to the local interaction with the concrete infill partially covering the bay frame, reaching 1/3 of the total column height. Partial infilling that effectively interacts with the column reduces the slenderness of the element and consequently produces a higher shear demand that exceeds column shear capacity. This kind of phenomenon involves all the columns interacting with the concrete partial infilling.

[Figure 8d](#) gives an example of a basement that is partially below the ground level. According to common building practice, basement levels are characterized by walls, often realized in concrete, aimed at a retaining function of the adjacent embankment; concrete wall height is limited with respect to column height to allow the fitting of windows. This structural solution leads to a strict reduction in column slenderness with a consequent increase in shear demand; moreover, decreasing shear span can modify the shear span ratio of the element up to a squat column behaviour. This situation is of no secondary importance since the shear resistance mechanism of a squat column differs with respect to the typical behaviour of a slender element. Differences between shear capacity formulations proposed in Eurocode 8 ([CEN 2005](#)) for existing buildings for

slender and squat columns testify to the difference between shear failure mechanisms. Hence, if local interaction between the column and concrete wall is not allowed for, premature brittle failure due to excessive concrete compression can often occur.

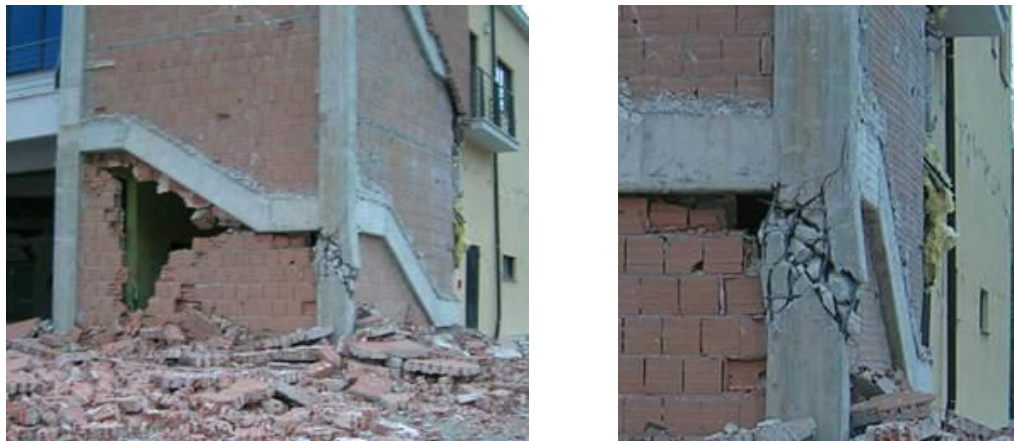
Figure 9. Shear failure in squat columns of the staircase

Figure 9 shows a staircase composed by inclined beams; the squat column in the corner has typical shear failure. Poor transversal reinforcement, both in terms of hoop spacing and diameter, can be recognized.

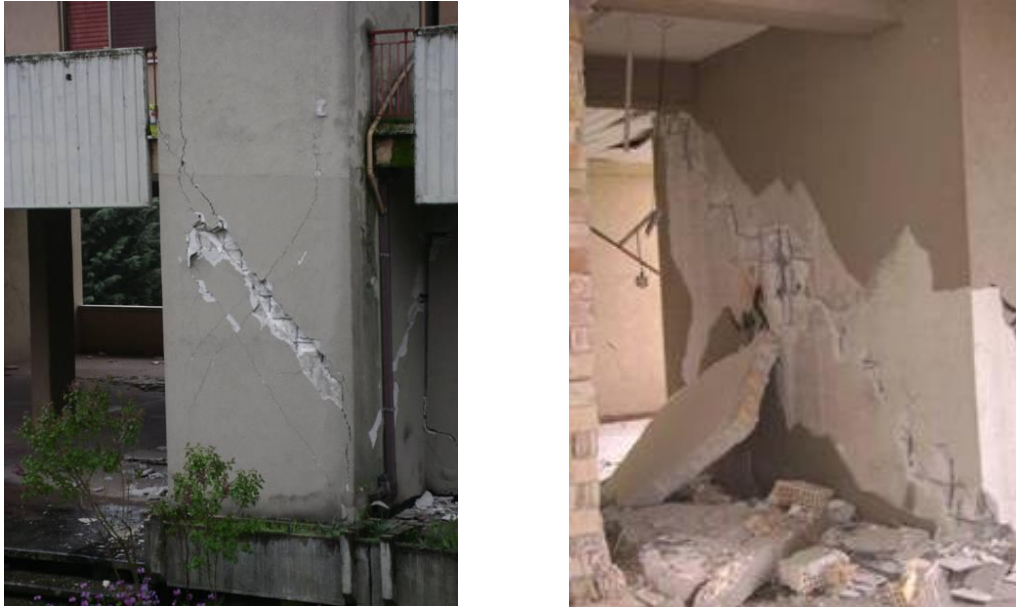
Figure 10. Failure in reinforced concrete walls

Shear failures were found in reinforced concrete as well. As an example, in Figure 10 two reinforced concrete walls, respectively with two different shape factors, are shown; damage consists of a spread diagonal cracking. Low longitudinal and transversal reinforcement percentages can be recognized, especially compared with minimum values prescribed by design codes based on capacity design approach.

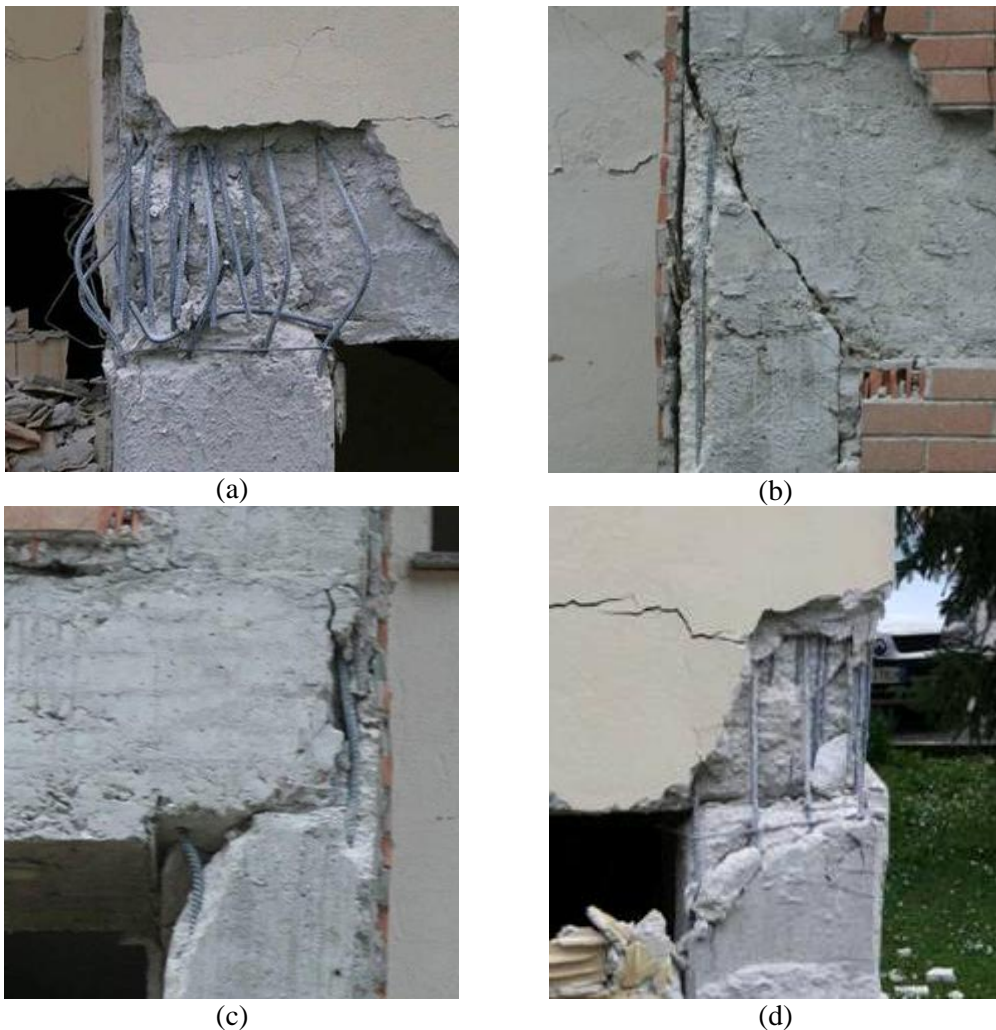
Figure 11. Joint failure with evident (a) longitudinal bar buckling and (b) diagonal cracking failure in concrete joint panel; (c) (d) failure mechanisms at joint – column interface surfaces

Damage from the 6th April 2009 earthquake clearly shows how hazardous failure of joints can be. [Figure 11a](#) shows an external beam-column joint, characterized by an extensive cracking in the joint panel. The absence of transversal reinforcement leads to local buckling of the longitudinal bars that consequently results in concrete cover spalling. Interestingly, the absence of proper transversal reinforcement in the joint also leads to a loss of anchorage in beam longitudinal reinforcement.

[Figure 11b](#) shows typical diagonal cracking failure in a concrete panel belonging to an external joint. Cracking begins at the intersection between the joint and upper column and ends at the intersection between the joint and lower column, producing the loss of monolithic connection. Absence of hoops, in this situation too, leads to buckling in the external longitudinal bars and involves lower column bars without transversal reinforcement in the first 30–40cm.

[Figure 11c](#) reports a brittle failure mechanism due to the lack of transverse and longitudinal reinforcement that led to loss of continuity at the intersection between the joint and lower column, being the probable final cause of the failure. [Figure 11d](#) shows a clear separation in concrete at the joint-column interface; in this case, due to a complete spalling of the concrete cover, the reinforcement in the element may be recognized and it may be noted that the first hoop in the column is partially open. The

lack of transverse reinforcement in the element made the separation at the joint-column interface critical.

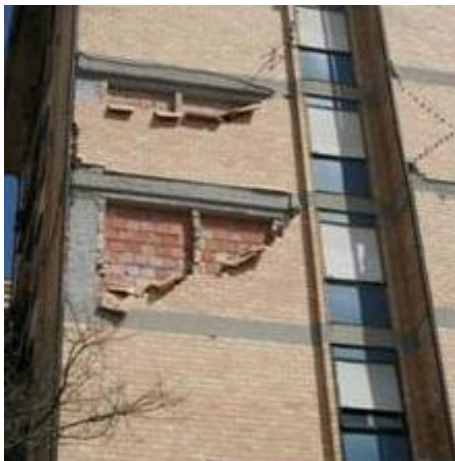
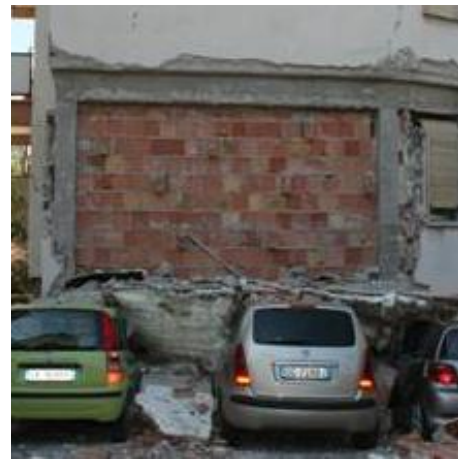
Figure 13. External infill panel failures without connection between layers (a) and with ineffective connection (b)

The great majority of external infill panels consist of double layer infill panels; internal layers are generally made with clay bricks, connections between the two layers by the interposition of brick elements discretely, or lined up. The low efficacy of this system is emphasized in Figure 13a.

Furthermore, in most of the observed cases, internal infilling layers are restrained at the four corners of the RC frame while external layers are constrained only by the upper and the lower beam by means of a small pawl. This constructive solution leads to a decrease in the interaction mechanism between RC frame and external infill panel, for

both in-plane and out-of-plane seismic forces. The low efficacy of the restraint applied to the external panel, coupled with the ineffective or completely absent connections between the two layers, leads to damage limited in most cases to the external infill panel which can easily show an out-of-plane failure due to seismic action in both directions, as can be observed in [Figure 13b](#). Both neither local nor global interaction effects between infills and the RC structure are negligible. As was previously emphasized, local interaction between infill panel and adjacent columns can lead to (i) a reduction in the effective height of the column, an increase in shear demand and a consequent brittle failure of the column when the infill panel partially occupies the frame bay; (ii) shear concentration demand at the end of the column and consequent brittle failure when diagonal compression is applied by the panel on the RC element.

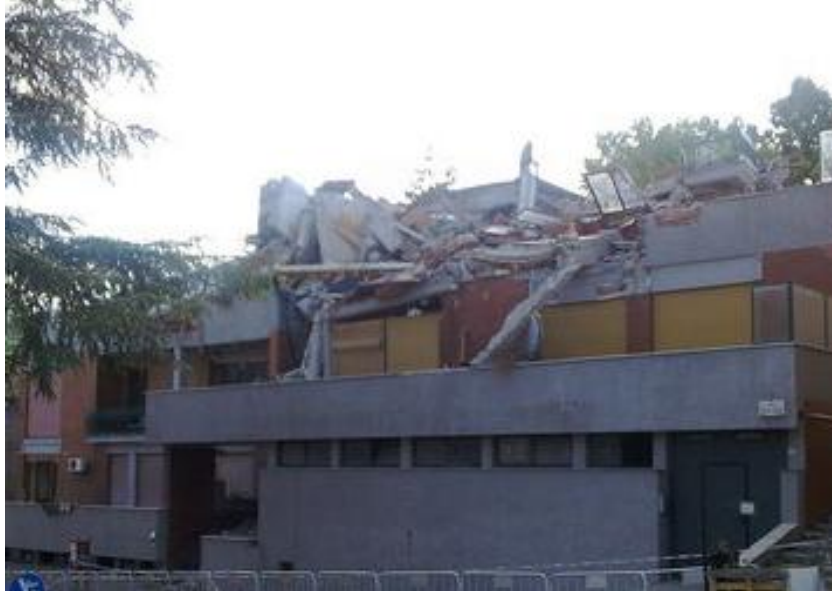
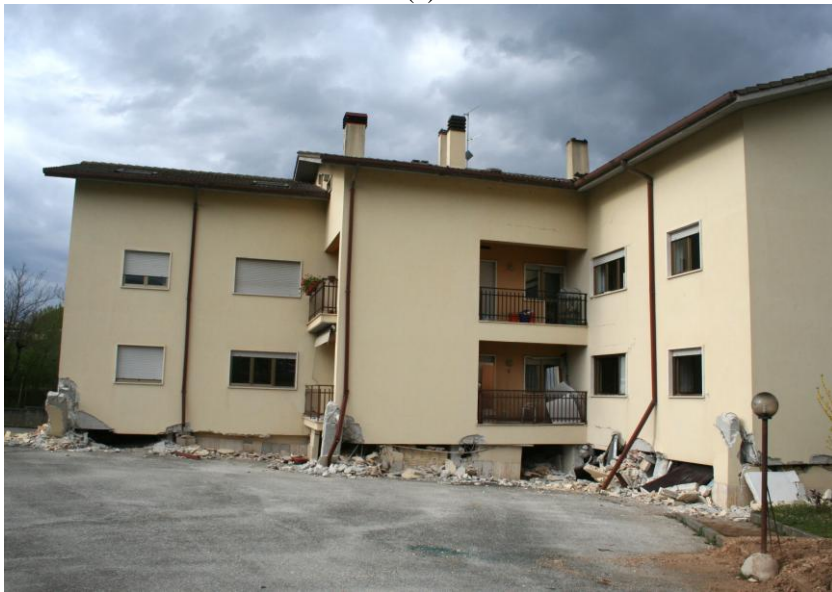
Figure 14. Soft storey mechanism examples in L'Aquila: (a) Via Porta Napoli, (b) Via Dante Alighieri (Pettino)

Some particular cases of structural failure after the L'Aquila event and mainly caused by irregularities in plan or elevation are reported in [Figure 14](#). The first structure (see [Figure 14a](#)) was situated in the centre of L'Aquila (Via Porta Napoli); it was irregular in elevation and the second storey had an evident discontinuity in terms of infill distribution; in the left wing of the building there was a sort of porch. In terms of

building collapse, damage was concentrated on the second storey, leading to complete failure of the upper levels.

can be explained by infill irregularities in elevation and by a local interaction between infills and adjacent columns, which probably led to a brittle failure of some columns at the first level, and consequently leading to the collapse of the whole building. An analytical study of this collapse can be found in [Verderame et al. \(2010\)](#).
