ESTHETIC AND FUNCTION REHABILITATION OF SEVERELY WORN DENTITION WITH PROSTHETIC-RESTORATIVE APPROACH AND VDO INCREASE. CASE REPORT

SUMMARY

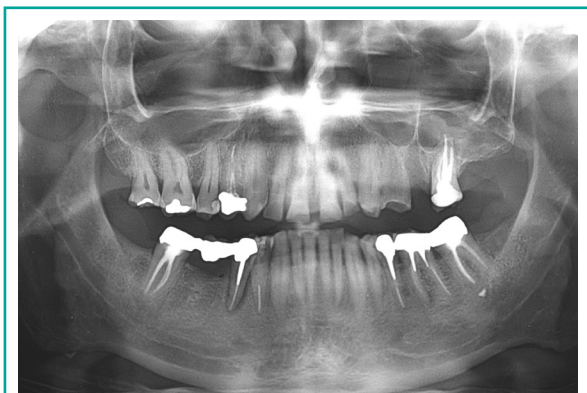
Figure 2
Pre operative rx opt.

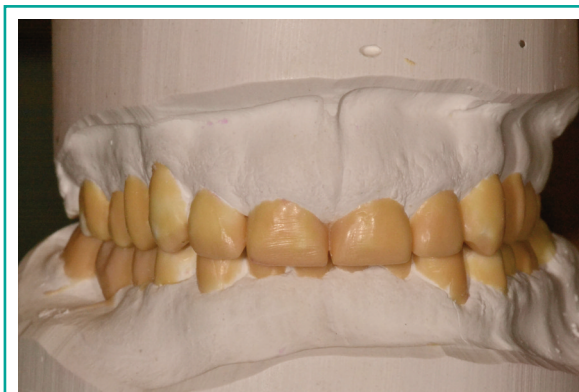
After clinical exam, impressions of maxillary and mandible arches were taken with alginate to obtain preliminary casts for diagnostic waxing to all maxillary and mandibular teeth and fabrication of all provisional crowns in acrylic resin for posterior teeth, and from the diagnostic wax-up were fabricated a silicone guide masks for anterior teeth (Fig. 3).

Figure 3
Diagnostic wax-up with alteration of the VDO 3mm anteriorly.

It was proposed to increase the incisal length of the maxillary anterior incisors, together with alteration of the VDO 3 mm anteriorly. These modifications were evaluated with a direct mock-up in the anterior segment using a flow-able composite resin material (Systemp Flow, Ivoclar Vivadent). The direct mock-up was subsequently removed.

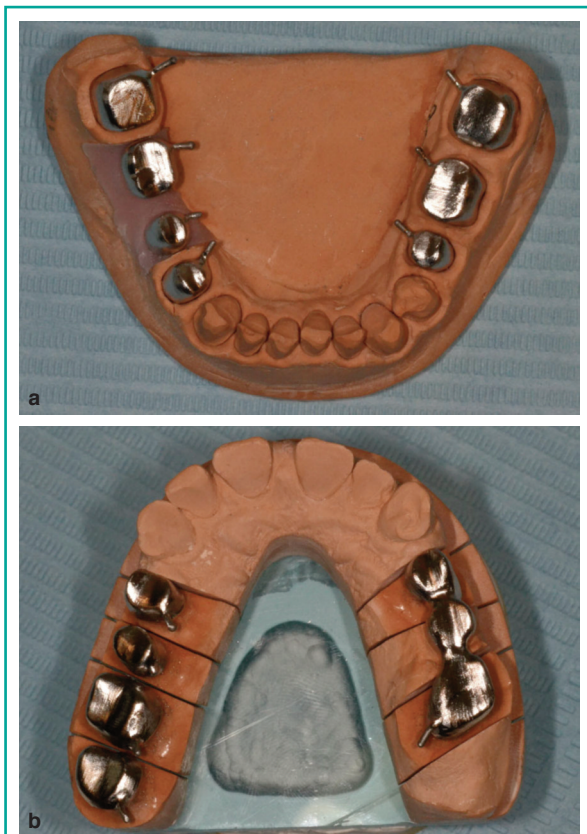
Figure 4 a, b
a) Lower master model and structures; b) Upper master model and structures.

For the recording of the beyond preparation have been used 2 different sizes of wires retraction: size "00" more deeply in the gingival sulcus and size "1" more superficial. The first wire was moistened with ferric sulfate at 25% of concentration and the second with aluminum chloride at 20% of concentration. After the test of the structure (Fig. 4 a, b) and the aesthetic valuation, the crowns were cemented with zinc oxide noneugenol cement.

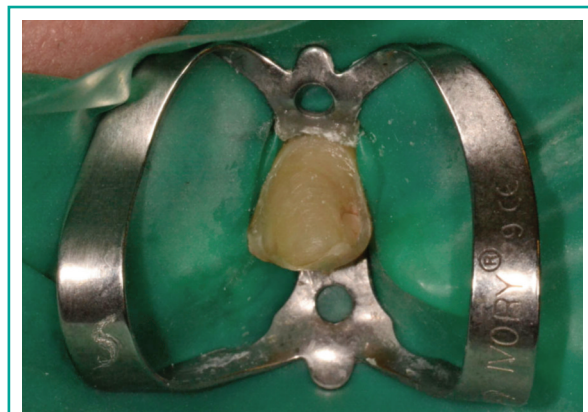
Figure 5
Veneers cementation saliva non contaminated.

Cementation followed a precise protocol (Fig. 5). Retraction cords were placed in the sulcus of every abutment to minimize the humidity from the crevicular fluid and to act as a barrier for the penetration of the resin cement to the base of the sulcus. The inner surfaces of the restorations were etched with hydrofluoric acid 4.5% (Ivoclar Vivadent) for 20 seconds, thoroughly rinsed with water, and put in an ultrasonic bath with distilled water for 3 minutes. After thorough air drying, the intaglio surface was silanized (MonobondS, Ivoclar Vivadent) and dried for 60 seconds. Tooth preparations were cleaned with pumice and rubber burs (Opticlean, KerrHawe), etched for 30 seconds on enamel and 10 seconds on dentin with 37.5% phosphoric acid (Ultra-Etch, Ultradent Products), rinsed, and dried. Both fitting surfaces, restorations, and teeth were coated with the adhesive system (OptiBond FL, Kerr Italia s.r.l. Scafati, SA), and a dual composite resin cement (Relyx Unicem 2, 3M ESPE, Neuss - Germany) was selected to lute the veneers.

All the bonding procedures were carried out using rubber dental dam (Fig. 5).
