Grzegorz Krolczyk
Stanislaw Legutko

INVESTIGATIONS INTO SURFACE INTEGRITY IN THE TURNING PROCESS OF DUPLEX STAINLESS STEEL

Summary

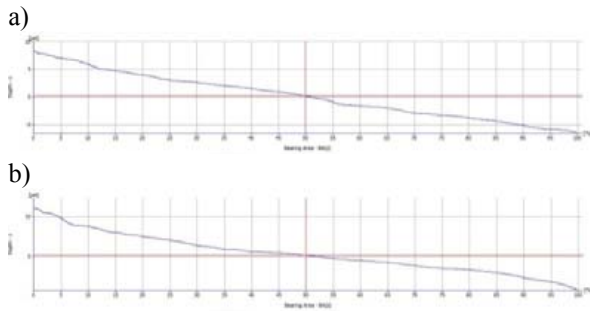
Fig. 3 Load capacity curves after turning a) T1 tool point b) T2 tool point

The shape of the load capacity curve mainly depends on the shape of irregularities in the direction perpendicular to the reference surface. A comparison of the load capacity curves depending on the cutting speed can be seen in Figure 3. Nielsen [19] found that the honing process can be controlled by Rk parameters. According to Sedlacek et al. [20], the Rvk and Rpk parameters could have an influence on friction. The representative measured values of roughness parameters and material ratio parameters (Rk parameters group) are listed in Tables 3 and 4 (the results are presented in the table as the arithmetic mean of three measurements). The contact angle was recorded at least thrice for each sample and at least two samples for each experimental condition were prepared. The biggest differences in the surface parameters due to the change of the cutting wedge were observed for the Rvk parameter. The Rvk parameter is a measure of the valley depths below the core roughness. By comparing the various parameters one may assess the uniformity of the surface peak and valley distributions relative to a particular direction. The Rvk parameter (Reduced valley height) is a parameter which is found from a measure of the valley depths below the core roughness. Rvk is a measure of the valley depths below the core roughness and is related to debris entrapment and lubricant retention.

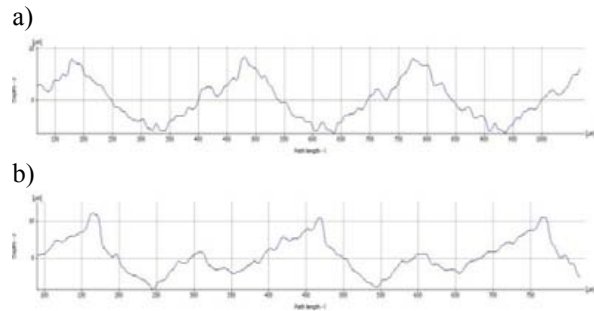
Fig. 4 Surface roughness profiles after turning a) T1 tool point b) T2 tool point

Figure 4 shows the differences in roughness profiles of both analysed cases. The roughness profile of the duplex stainless steel surface after the turning with the T2 wedge has slightly deteriorated, which can be seen through tribological disturbances or through the wear of the cutting tool point. The higher values of the Rt , Rp , and Rv parameters on surface after the turning process using T2 wedge cause the occurrence of a sharp spike or burr on the surface. The sharp spike and burr cause damage to the seals and can cause cracks.

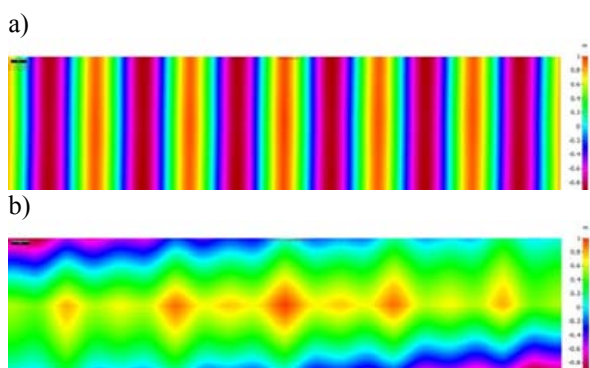
Fig. 7 Auto correlation of primary model after turning a) T1 tool point b) T2 tool point

The surface texture analysis has been performed by means of an Infinite Focus Measurement Machine. The geometrical structures of the surface shown below have been observed after longitudinal turning. Fig. 7a shows the preferential direction of a periodically iterated surface structure whereas Fig. 7b shows the surface dominated by low frequencies. *Sal* parameter (Table 5) after the turning with the T2 wedge has a higher value. *Str* and *Stdi* parameters have higher values after the turning with the T1 wedge; therefore, Fig. 7a presents the surface without the dominated preferred direction.

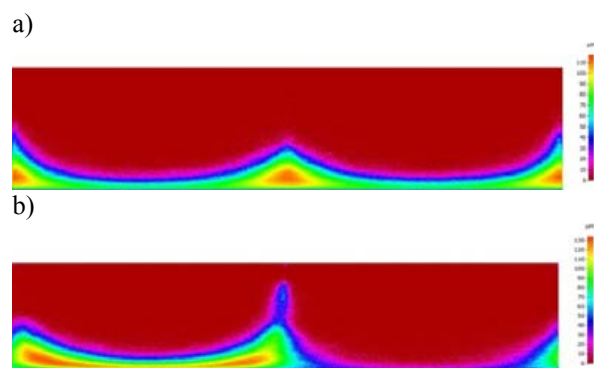
Fig. 8 Gradient distributions of primary model after turning a) T1 tool point b) T2 tool point

Fig. 8 shows the gradients of the surface of ISO Gradient Distribution. Both samples exhibited surfaces with steep gradients.

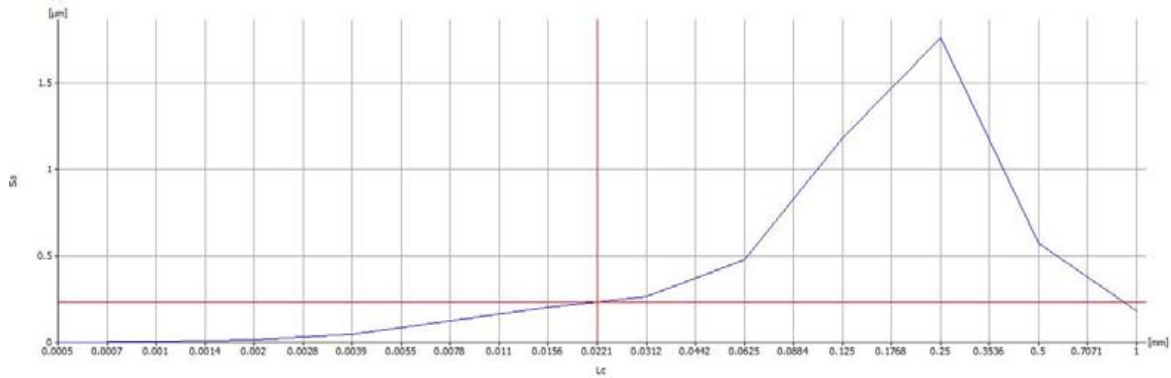
Fig. 9 Spectrum of sample after the turning with the T1 tool point of primary model

Figs 9 and 10 show two views of spectral distributions (Surface Texture Spectrum) of the selected region. The selected parameter was the Sa parameter (average height of selected area). Figs 9 and 10 show the selected parameter Sa in certain wavelength ranges. Due to the same machining parameters, the analysed surfaces have similar wavelength ranges but the sample turned with the T2 wedge is characterized by steep slopes.
