OPTIMIZATION OF TIMELY REPLACEMENT OF SECTIONAL FURNACE REFRACTORY LINING

The goal of the study is to establish the influence of temporal wearing of refractory lining on energy losses of the furnaces by conducting heat through the furnaces walls. Object of the study were sectional furnaces, type SELAS, situated in the seam tubes production line in Željezara Sisak, Croatia. In order to reduce production costs, it was attempted to define the timely replacement of refractory lining by the criteria of comparing the costs resulted by heat loss through the furnace lining with the costs of refractory lining replacement. Data for the calculation of heat losses was obtained by use of the infrared camera.

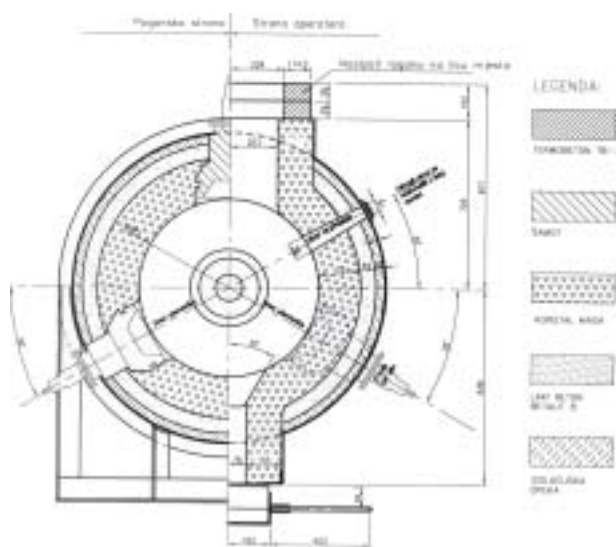
Figure 1. Cross-section of sectional furnace
Slika 1. Poprečni presjek segmentne peći

Each section of the SELAS furnace is equipped by circumferentially positioned burners as well as the open-

ings for tube transport and visual control of the section interior, an opening for discharge of scaling loss and channel for venting of waste gases (Figure 1.). The furnace is fired by natural gas that burns in non-preheated air.

A refractory material used for inside layer in the sections is a KONSTAL 39 ramming mixture of Zagorka Silex type. The middle layer is thermo concrete BETALIT 8. The thermo concrete TB-7 is used for covering of the section sides. Outer layer is made of OL-18 chamotte isolation bricks. Characteristics of refractory used are given in Table 2. [1].

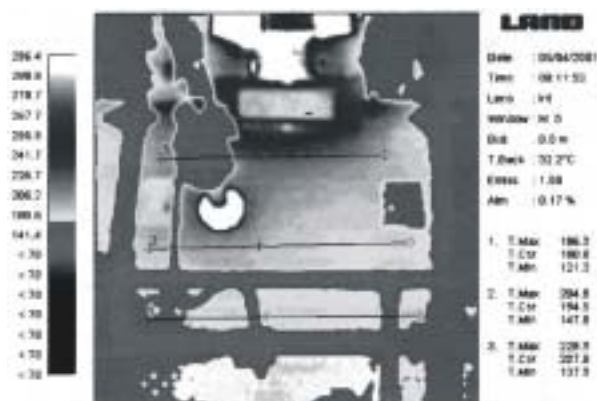
Figure 2. Thermal image of the 8th zone section with worn-out refractory lining
Slika 2. Termička slika segmenta 8. zone sa istrošenom vatrostalnom oblogom

a) with worn-out refractory lining (Figure 2.);

peratures were approximately 30 °C higher on furnace section with partially wear-out refractory lining but considerably higher temperatures were observed around flue opening (to 280 °C). Temperature of the inside surface of lining, which was calculated earlier on the basis of measured temperatures of the section outer surface was also controlled (Figure 4.). Measured temperature (around 1200 °C) shows very good agreement with the values obtained by calculation.

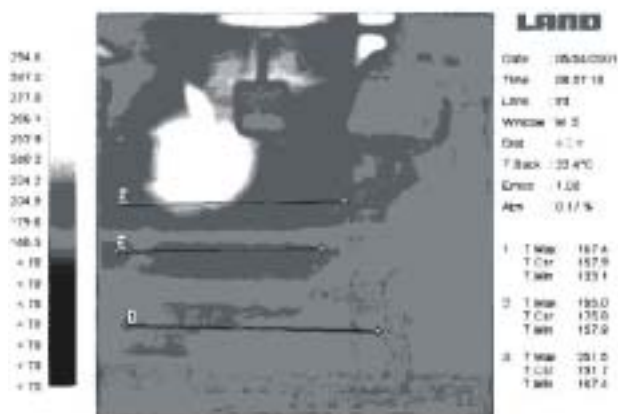
Figure 3. Thermal image of the 8th zone section with renewed refractory lining
Slika 3. Termička slika segmenta 8. zone s novom vatrostalnom oblogom

b) with renewed refractory lining (Figure 3.).

The results show more uniform temperature distribution of temperatures over the outer surface of the section with newly installed refractory lining (130 - 210 °C). Tem-

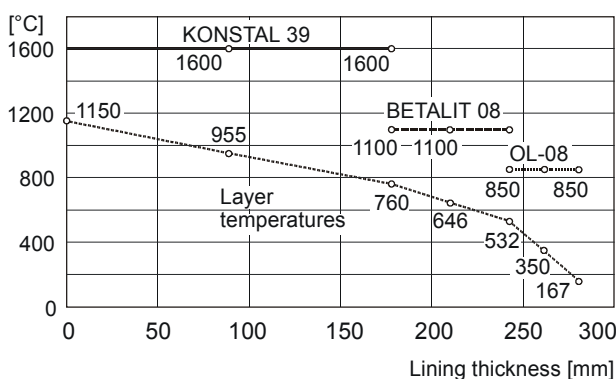
Figure 4. Diagram of temperature distribution in furnace lining
Slika 4. Dijagram temperaturnog rasporeda u zidu peći

For analysis of results it is necessary to know the temperature distribution through furnace lining so it can be ascertained whether the real temperature exceeds allowed temperature for the material of each lining layer. The temperature distribution curve is defined on the basis of measured temperature of the section outer surface and the manufacturer information about thermal conductivity of each refractory material. Calculated temperature of inside surface lining was compared with values measured with thermo camera through the transport opening of the section.
