Article

Design and Construction of a New Metering Hot Box for the In Situ Hygrothermal Measurement in Dynamic Conditions of Historic Masonries

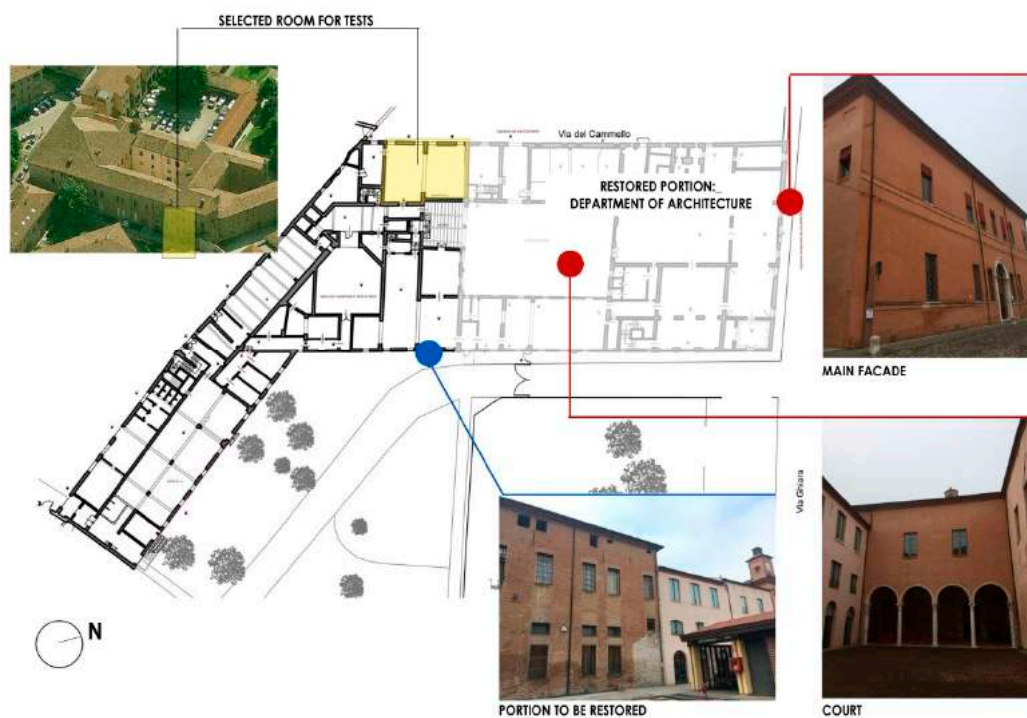
Figure 1. Ground floor plan of Palazzo Tassoni and location of the room where the experiment is carried out. External views of the surrounding buildings.

The room (700 m³) and the wall under-study are part of this complex and are located on the ground floor of an area that has not been refurbished yet, currently unoccupied and without any HVAC system (Figures 1 and 2).

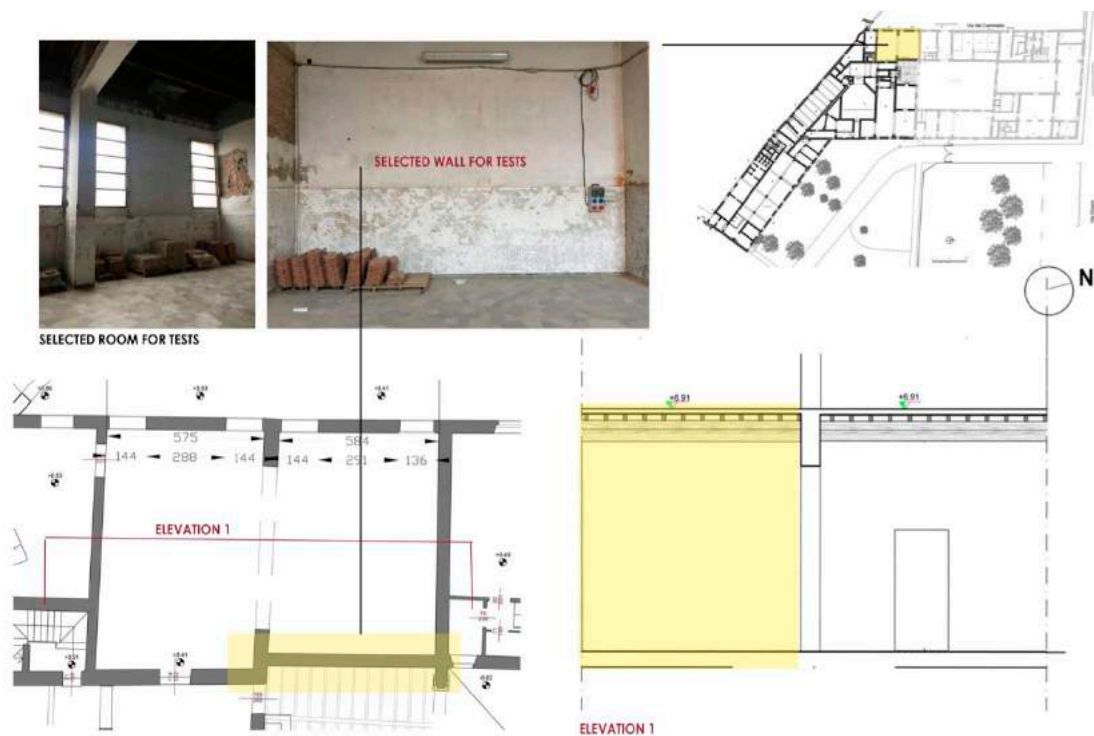
Figure 2. Ground floor plan of Palazzo Tassoni and signaling of the location of the room and wall on which the experiment is carried out (in yellow). Internal views of the room. Inside elevation of the wall (in yellow).

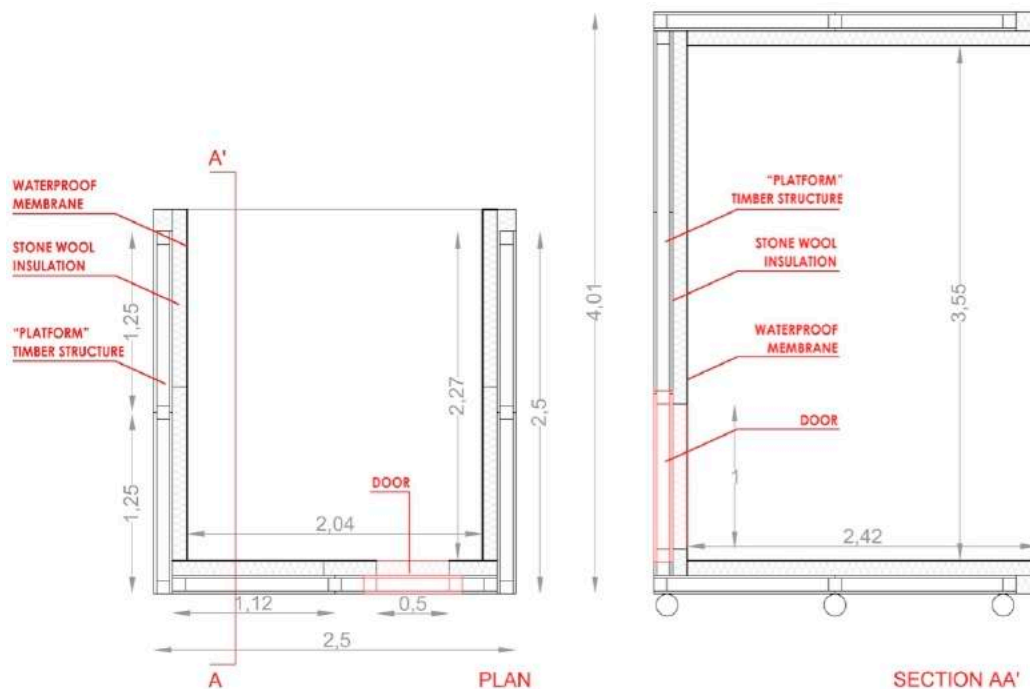
Figure 3. Drawing of the metering box (horizontal plan and vertical section). Measurements expressed in meters.

The newly developed metering hot box used to perform the hygrothermal tests is depicted in Figure 3. This gross box size is 2.50 × 2.50 × 4.01 m, built with ‘platform system’ circa 0.13 m thick walls composed by two 0.018 oriented strand board (osb) panels mounted on a timber structure made of elements 0.09 × 0.09 m. To avoid thermal losses and maintain the setup temperature and humidity values, the 5 walls faces (including the pavement) were provided of 0.10 m high-density stone wool insulation material, then protected with a vapor barrier. The net size was 2.04 × 2.42 × 3.55 m (volume of the chamber).

Box dimensions were determined not only by the anticipated study of probable vertical heat stratification common in historic buildings often with high ceilings (see also Section 5.1), but also due to the favoured and anticipated study of at least 2 insulation systems put in parallel, as depicted in Figure 4, alike the experimental study developed by Kloseiko et al. [93]. In [93], the hygrothermal performance of an internally insulated brick wall was studied, with different insulation systems, measuring 1.00 m width each (this way, by placing sensors in the middle, a 0.50 m distance from each material border was assured).

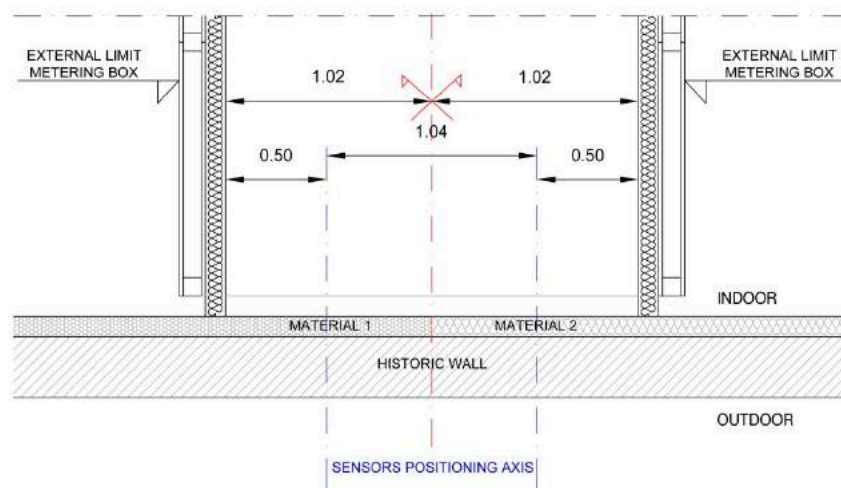
Figure 4. Metering hot box positioning (plan). Relation between the box and sensor location if two insulation materials are tested.

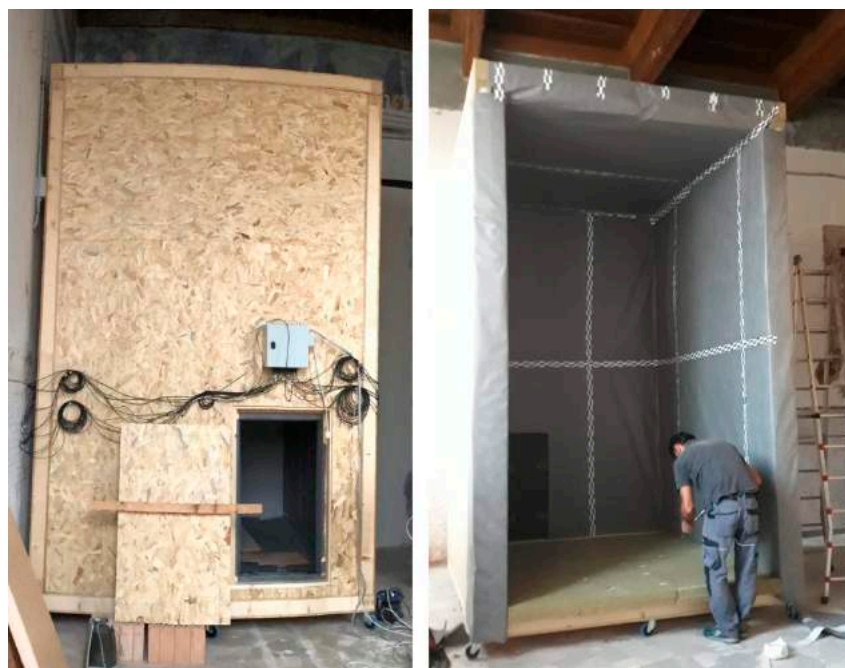
Figure 5. Box finishing: Thermal insulation and vapor barrier application.

One of the main objectives of the HeLLo project, besides the general scientific final goal to make actors of buildings sector aware of strengths and weaknesses of the most common energy retrofit technical solutions when applied to historic buildings [32], was the development of a very wide and structured program of dissemination. The idea was to open the door of the laboratory to other different stakeholders and involve them in the project activities. Among this open Labs program, in the one called SchoolLab activity, in a unique didactical approach, students of the 2nd year of the Degree of Architecture were involved in the activity of the box constructing—Figure A1 in Appendix A unveils some of the steps of the box construction. During this phase, only the ‘outer-shell’ was executed (the platform frame structure), being later internally coated with 10 cm high-density stone wool, covered by a vapor barrier, Figure 5.

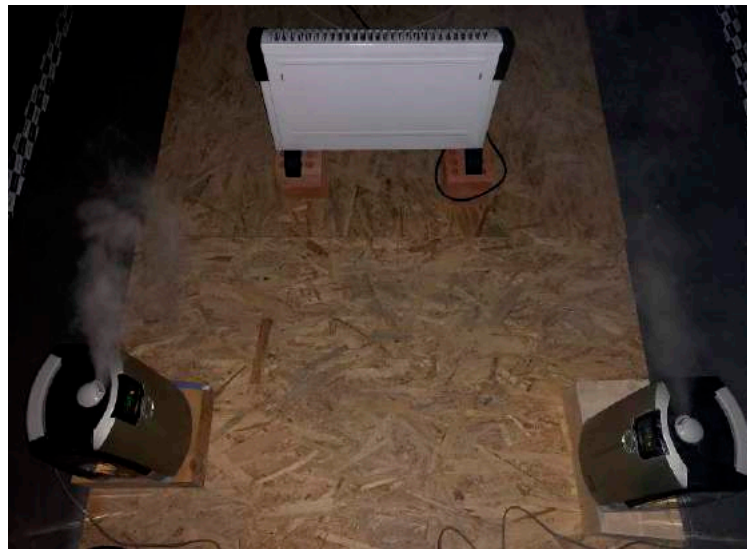
Figure 6. Box indoor hygrothermal control equipment.

The metering box was provided with a 2000 W heating convector (with 3 power levels), locally controlled by its own sensor (PID, as described below) and 2 ultrasonic humidifiers, (argo HYDRO digit), 30W/each, self-regulated, which guaranteed indoor air parameters at the desired setup conditions ($T \approx 20\text{ }^{\circ}\text{C}$, $\text{RH} \approx 55\%$), Figure 6.

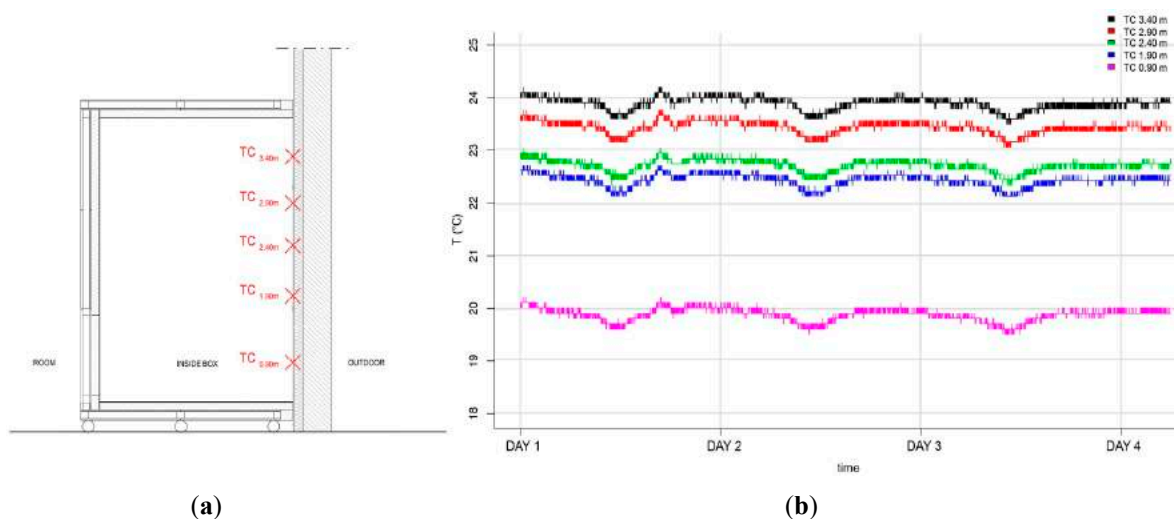
Figure 7. Results of the simplified test to evaluate the heat stratification inside the box: (a) Vertical section of the metering box with the position of the TCs; (b) plot of the monitored T value of the five survey points (TC).

A simple test was performed to control vertical heat stratification inside the box. Five hand-made thermocouples (TC) with an accuracy of $0.5\text{ }^{\circ}\text{C}$ (calibrated in the laboratory), were placed on the surface of the historic wall, between 0.90 m and 3.40 m from the floor to circa 0.50 m from the box boundaries (Figure 7a), during a four-day monitoring period. As shown in Figure 7b, between the highest TC ($h = 3.40\text{ m}$, in black) and the lowest one ($h = 0.90\text{ m}$, in pink) there was an average difference of $4\text{ }^{\circ}\text{C}$. This simple test has confirmed the anticipated heat stratification, common in historic buildings, justifying the height of the box.

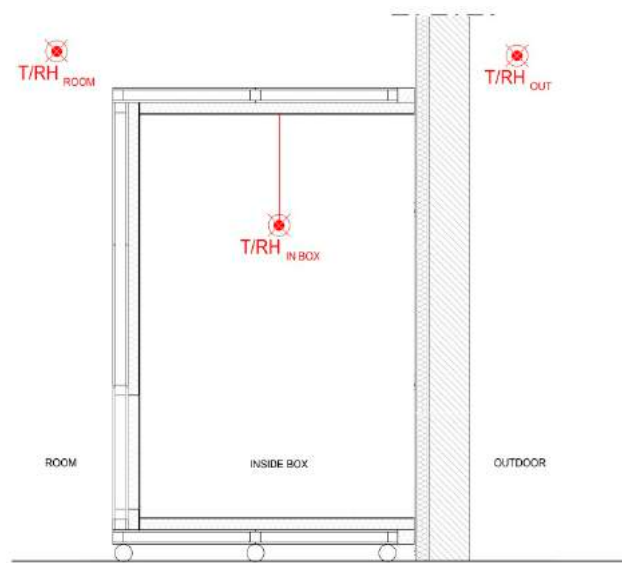
Figure 8. Vertical section of the metering box with the position of the T-RH combined sensors.

Figure 8 shows the distribution of the T-RH combined sensors (see Section 4.4) for the monitoring of the following environmental parameters (T_a and RH):

- Of the outdoor climate conditions (T/RH_{OUT});
- Of the non-refurbished and not heated room in which the box is located (T/RH_{ROOM});
- Inside the metering box ($T/RH_{IN\ BOX}$), placed in the center at circa 1.0 m from the top of the box.

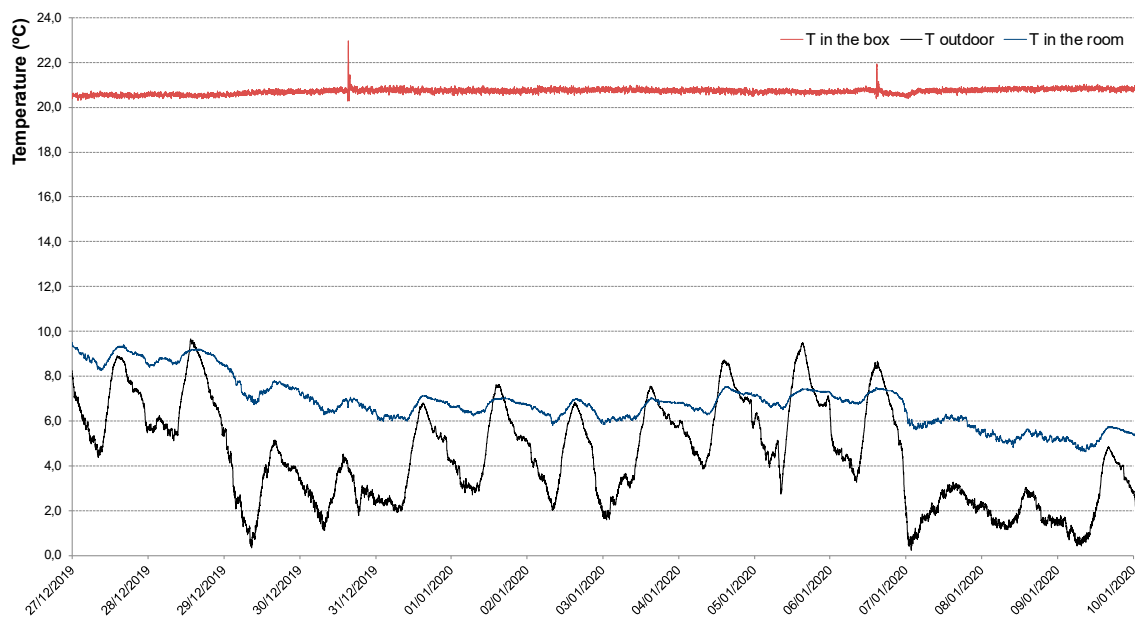
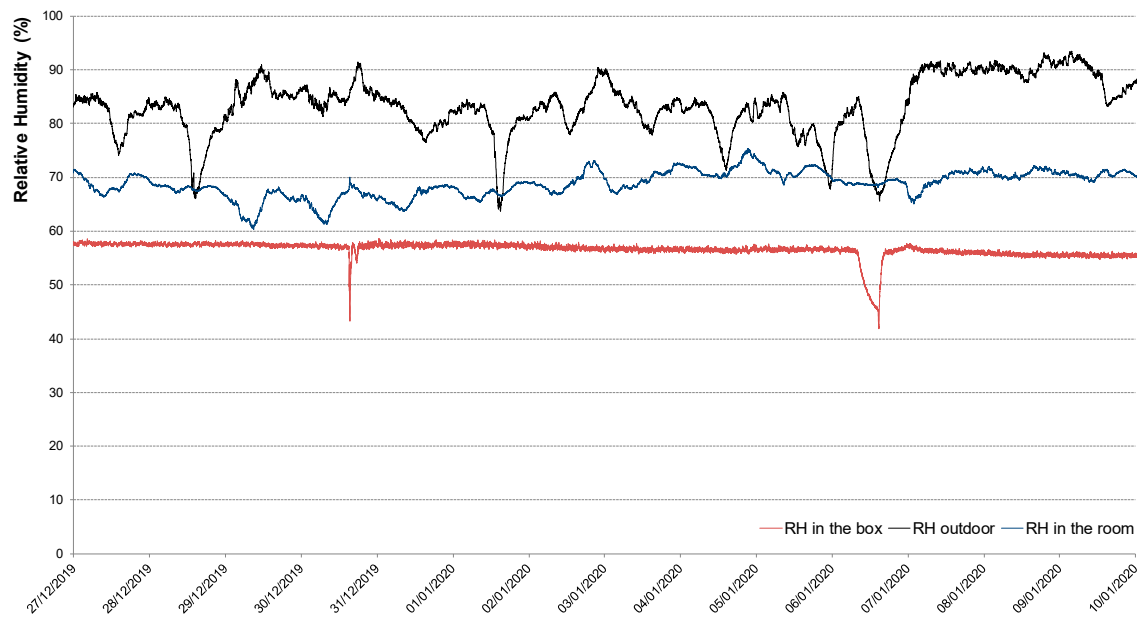
Figure 9. Graphical representation of the monitored parameters [T (°C) and RH (%)] values between 27 December 2019–10 January 2020.

The validation of the maintenance of the desired setup conditions was reached after the first period of tests and tuning (27 December 2019–10 January 2020). Figure 9 shows a recently monitored two-week period of a very stable indoor environment. Moreover, in the figure, two small peaks can be observed, brief in time and amplitude, corresponding to the moment of maintenance procedures of the monitoring campaign. In other words, the moments when the door of the box was opened, and the conditions of the air inside the box naturally mixed with those of the room. The insignificance of these events can be further observed in detail in Figure 10.

As shown in Figure 9, the outdoor climate in this winter period is quite varied. The same goes for the conditions of the room where the box is placed, which, as expected, were close to the outdoor conditions, less the thermal influence of the inertia of the historic building envelope. For the entire monitoring period (27 December 2019–10 January 2020), the conditions in the box were definitely stable, average $T = 20.7$ °C, average $RH = 56.5\%$.

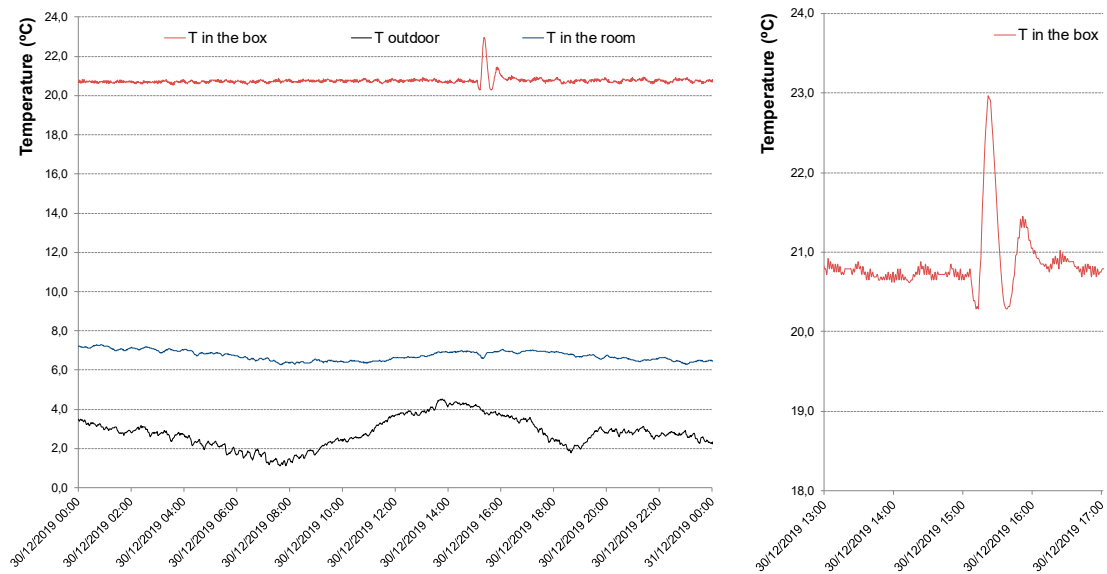
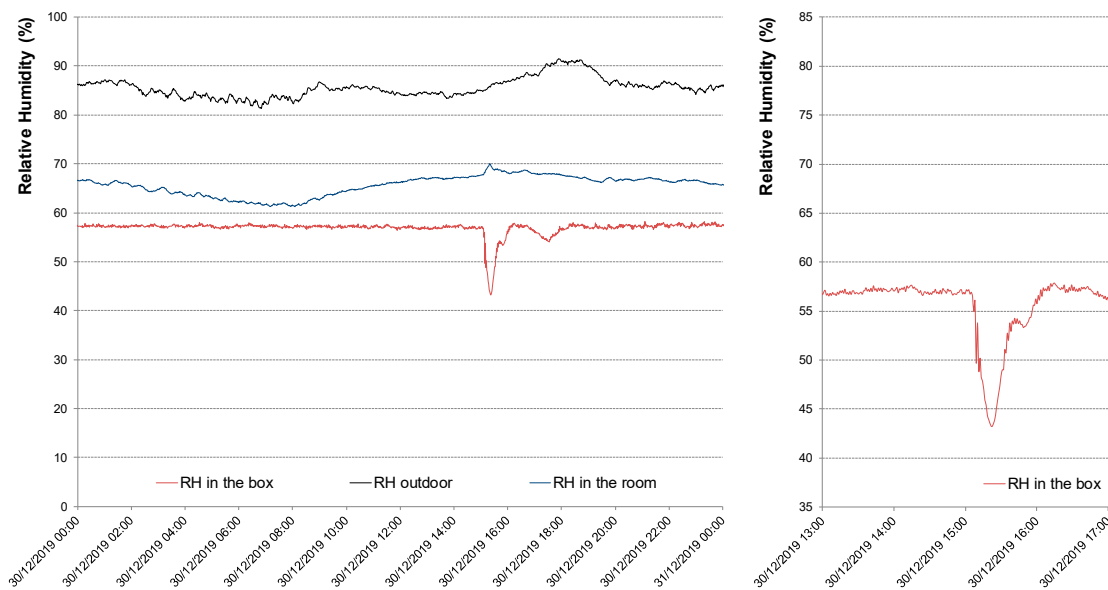
Figure 10. Graphical representation of the monitored parameters [T (°C) and RH (%)] values on 30 December 2019.

As declared, the door of the box was opened twice during this period, on the 30 December 2019 and 6 January 2020, i.e., the experiment might need to be controlled on-site up to once a week. Nonetheless, this action interferes with almost nothing with the continuity and stability of the indoor conditions. Looking at the most noticeable peak, registered on the 30th December, Figure 10, from the moment the door was opened, the indoor temperature suffered a maximum variation of 2.7 °C. Likewise, $RH \Delta_{max} = 15\%$.

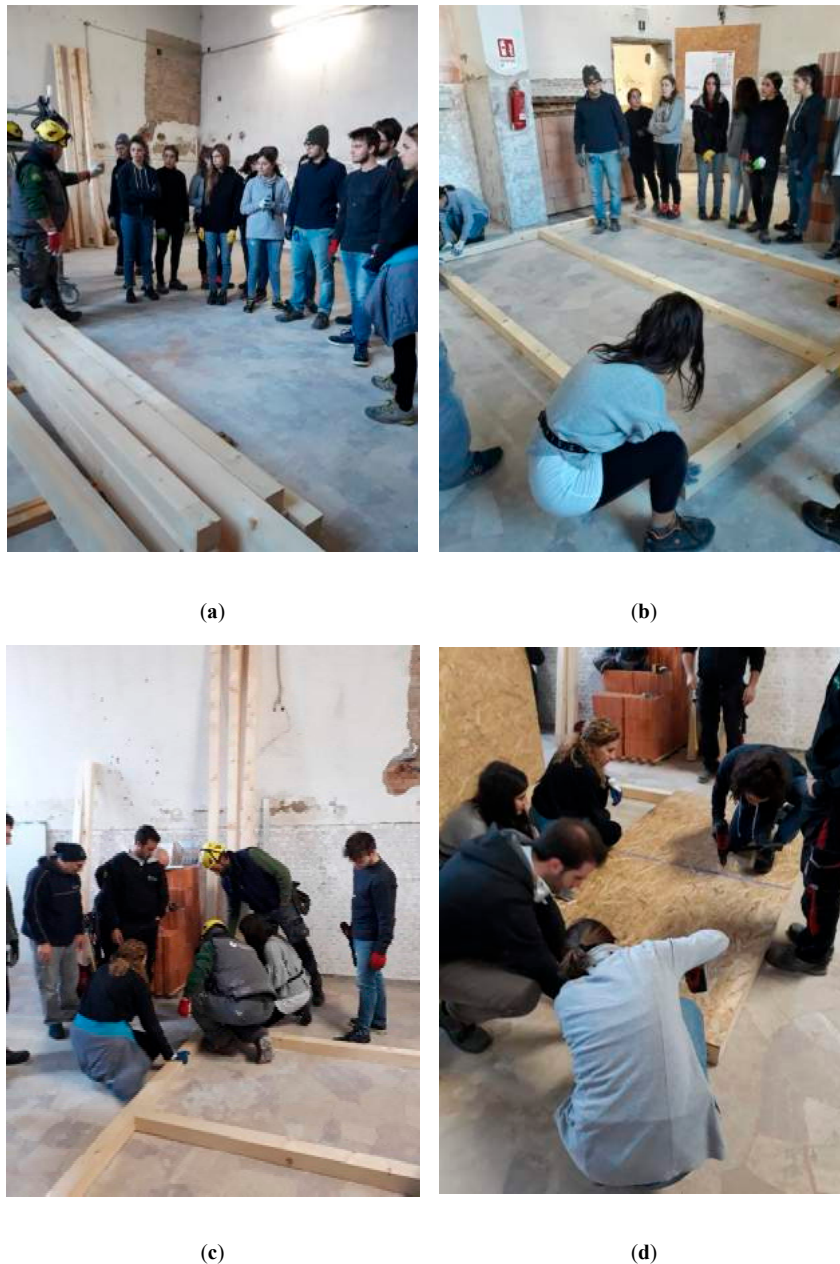
Figure A1. Box construction during SchoolLab activity with students (HeLLo [32]).
