EFFECT OF FIRE ON NATURAL STONES

András Biró, Viktor Hlavička, Éva Lublóy

Budapest University of Technology and Economics, Department of Construction Materials and Technologies, H-1111, Budapest, Műegyetem rkp. 3. Hungary

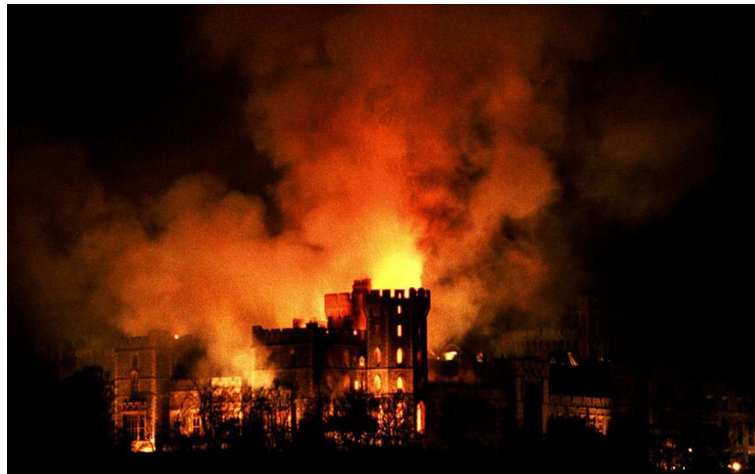
Figure 1: Fire of the Windsor Castle [1]

Stonemasonry (limestone in this particular case) was affected by the fire of the Windsor-Castle (which is a property of the royal family in the United Kingdom) on November 20th in 1992 (*Figure 1*), when a private chapel set ablaze in the Chester Tower on the first floor, which is located in the north-eastern side of the castle. At the beginning photographers noticed a burning carpet. Later experiments confirmed, that a lamp caused the fire, which set several chemicals ablaze and the fire spread to the carpets only after. The high heat and fire damaged the St George's Hall and destroyed the Brunswick Tower. The natural stone was damaged by fire, smoke and even by the water used during the fire extinguish [2].

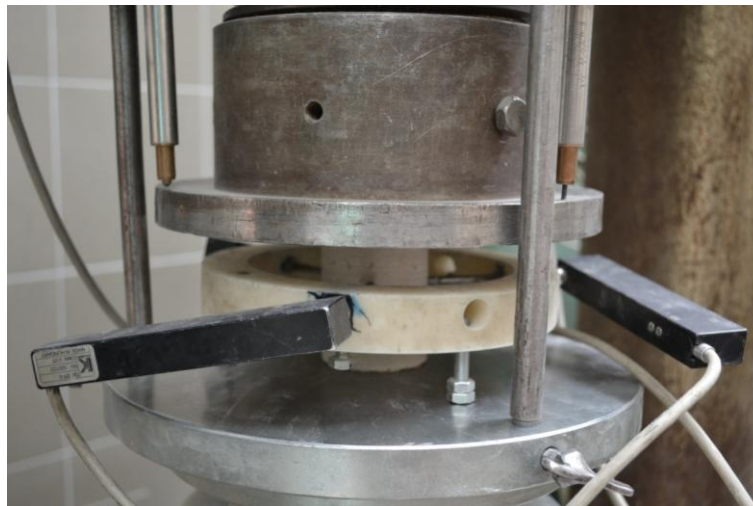
Figure 2: Experimental setup for uniaxial compressive strength test

We measured the compressive strength on cylindrical specimens (h=60 mm, d=50 mm) (*Figure 2*). During the tests we measured the axial and lateral deformations, by three-three electronic transducers (10 mm measuring limit). The device used for the test was displacement controlled. The loading speed was 0.01 mm/s.

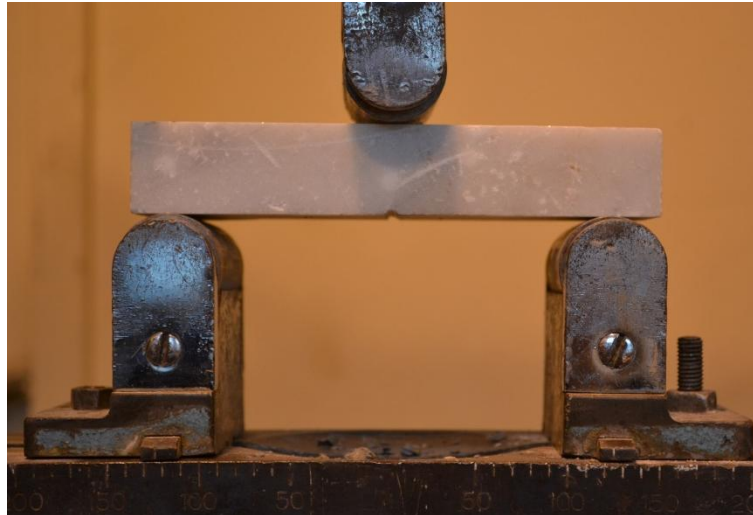
Figure 3: Experimental setup for flexural strength test

Flexural strength was also measured. The geometry of the specimens was: 25×50×150 mm. The applied support distance was 125 mm. The experimental setup can be seen in *Figure 3*. The force which caused the failure of the specimen was measured. The device used for this test was force controlled. The loading speed was 0.5 MPa/s.

There was small groove on the specimens (*Figure 3*). These grooves made sure that the failure happened at the middle of the specimen and made possible to also evaluate the results by fracture mechanics methods. This evaluation is not the subject of this research.

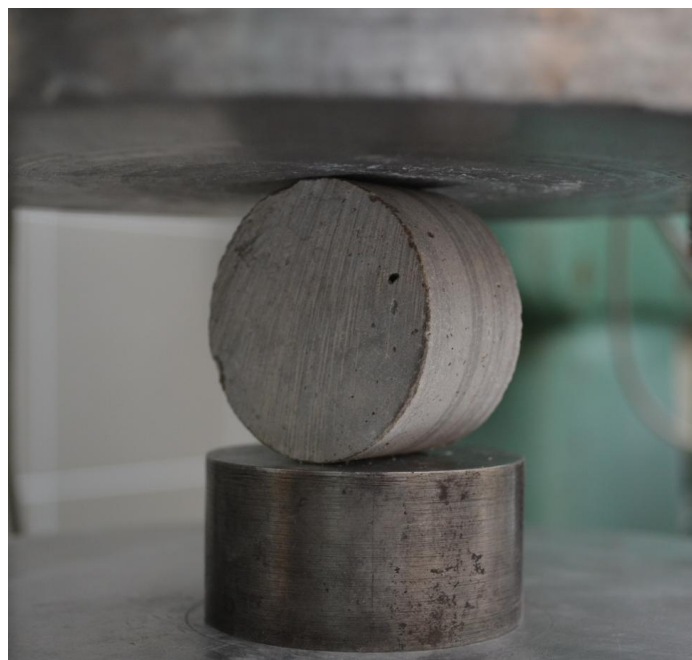
Figure 4: Experimental setup for splitting strength test

Splitting (tensile) strength was measured on cylindrical specimens ($h=30$ mm, $d=50$ mm) (*Figure 4*). The force, which caused the failure of the specimens was detected. The device used for the test was force controlled. The loading speed was 1 kN/s.

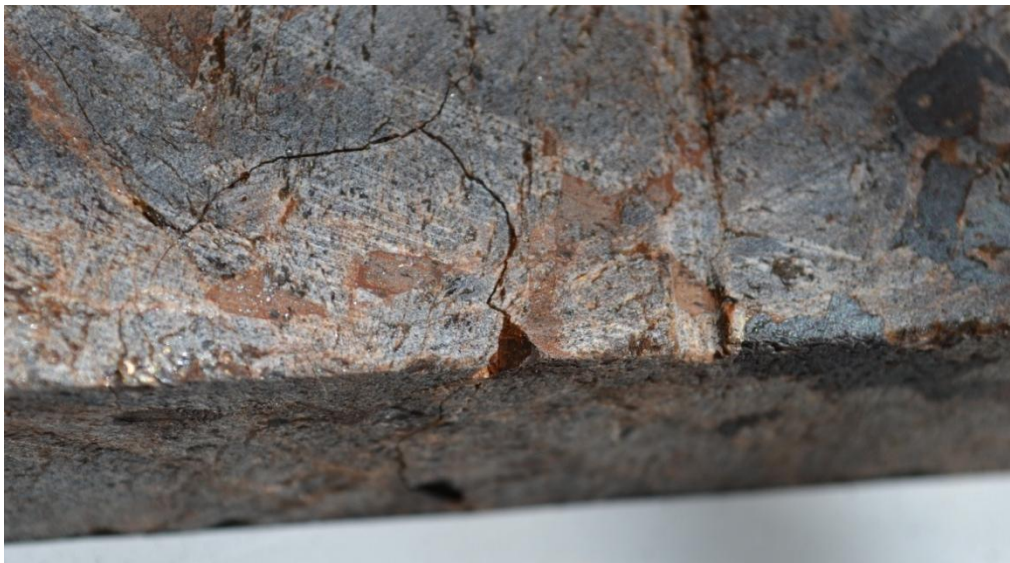
Figure 5: Cracks on 800°C temperature loaded labradorite specimen

- Slight cracks appeared on the granite and labradorite specimens at 500 °C and even more and wider cracks appeared at 800 °C (*Figure 5*). It is assumed that the cracks also affect the strength values unfavourably, which makes the further applicability of these rocks questionable.

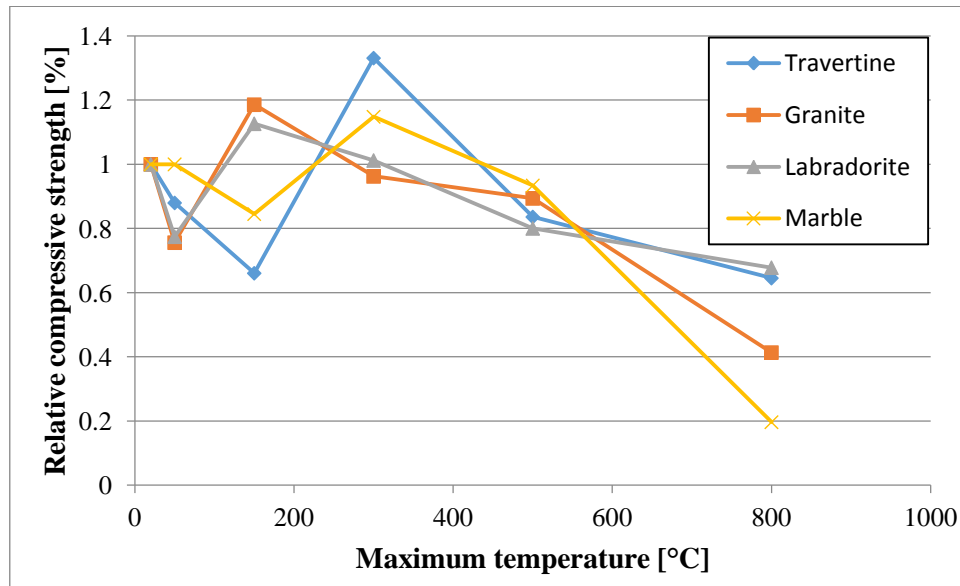
Figure 7: Relative compressive strength (each point is the average of 3 measurements)

For strength test results we gave the results relative to the measured strength of the reference specimen (20 °C). The relative compressive strength after temperature loading (each point is the average of 3 measurements) is shown in *Figure 7*.

The reference values were 63.58 MPa for the travertine, 81.34 MPa for the granite, 61.51 MPa for the labradorite and 59.09 MPa for the marble.

The test results were grouped based on the origin and the base components of the stone. The results of the marble specimens were compared to those of the travertine (CaCO_3 and MgCO_3 based rocks) and the results of the labradorite specimens were compared to those of the granite (igneous rocks).

The granite behaved favourably up to 500 °C. After being subjected to 500 °C heat load, the decrease in its compressive strength was only 9.6%, but after 800 °C heat-load only 41% relative strength remained. This significant decrease was predictable during the observations as we saw that a lot of cracks appeared at 800 °C. This was a result of the high quartz content of the granite, as the inversion of the α quartz to β quartz happens at 573 °C and it is accompanied by a linear expansion of 0.45%. A local maximum of relative compressive strength can be seen for the granite at 150 °C. Presumably it is due to the release of the absorbed water. The granite had the highest absolute compressive strength values at 20 °C, 50 °C and 150 °C. We observed that the failure always happened on the crystal boundaries. The fracture pattern changed with the increase of the temperature load. When the surface of the specimen was matt, we found that the fracture surface was matt as well.

The labradorite behaved similarly to the granite up to 500 °C, its compressive strength was 80% of the reference value. Similar local maximum can be seen at 150 °C, and it is caused by the release of the absorbed water. There was a significant difference however, the cracks were fewer and thinner than in case of the granite at 800 °C due to the lower quartz content. Therefore, the cracks did not drastically reduce the relative residual compressive strength. In this case the residual strength was 67%. Failure always happened at the crystal boundaries.

The decomposition of the CaCO_3 to CaO and CO_2 only occurs between 700 and 800 °C, which explained the favourable behaviour of the travertine up to 500 °C. As we saw on the specimens after the 800 °C temperature load only a layer fell off, the chemical reactions did not happen in the inner parts of the specimens. The manner how the structure of the rock affects the speed of these chemical

reactions should be further investigated. It is important that the decrease in strength after temperature loading with 150 °C and the increase after temperature loading with 300 °C were bigger for the travertine than for the marble.

According to the compressive strength test results, the marble was the most sensitive of the rocks to 800 °C temperature load. The relative residual compressive strength was only 20%. The 500 °C test result was 93%, which was 77% in previous studies [3]. This could happen due to the differences of the mineral structure and different chemical composition. The CaCO₃ crystals had a more homogenous structure in the marble than in the travertine, which led to more CaCO₃ decomposition over the same period of time so the decrease in compressive strength was more significant.

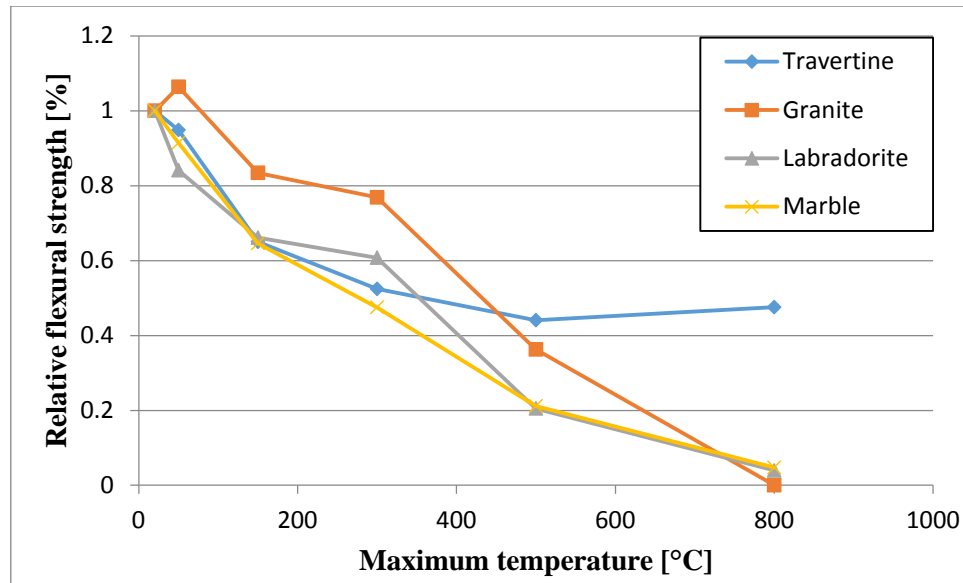
Figure 9: Relative flexural strength (each point shows the average of 3 measurements)

The relative flexural strength results are shown in *Figure 9*.

The reference values were 4.02 MPa for the travertine, 3.41 MPa for the granite, 4.27 MPa for the labradorite and 4.82 MPa for the marble.

Marble had the highest reference flexural strength but the changes in its inner structure resulted in the fastest and most significant absolute decrease.

The initial flexural strength of granites was lower than of the marbles and the relative residual flexural strength was near 0% after the 800 °C temperature load. However, from 50 °C to 300 °C it had the best relative performance of the four rock types and only the travertine had better relative results after temperature loading with 500 °C.

Concerning the rocks that we examined, the travertine had the best overall performance in flexural strength, approximately 50% of the reference value remained at 800 °C. As we mentioned above, the main reason for this was the duration of the heat-load. The inner structure of the limestone was damaged (discoloration, darker surface), but only an outer layer reacted with oxygen completely, and fell off after. Surprisingly we experienced a slight increase in strength from 500 °C to 800 °C, but this can be explained by the low number of samples (the standard deviation was also higher at 800°C).

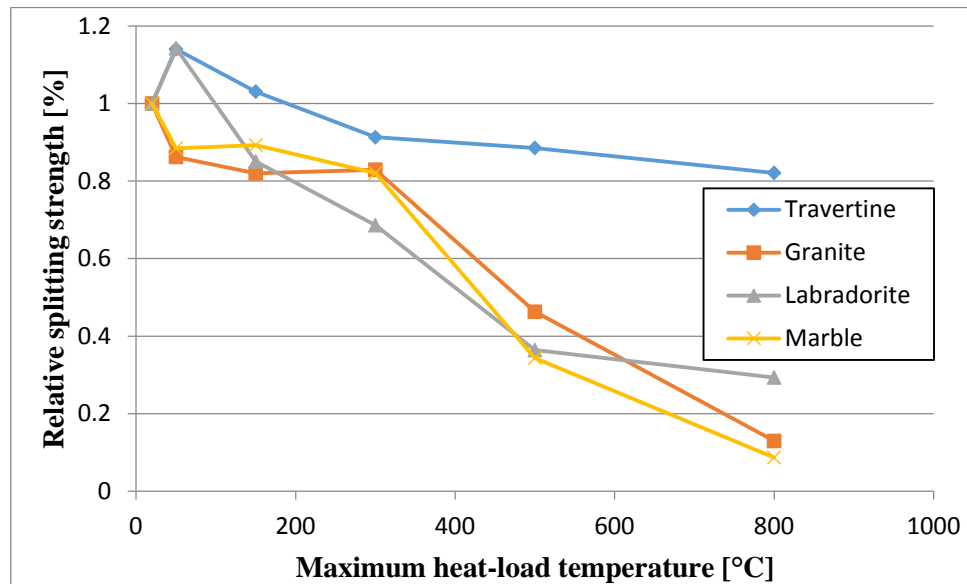
Figure 10: Relative splitting strength (each point shows the average of 3 measurements)

The relative splitting strength test results are shown in *Figure 10*.

The reference values were 6.02 MPa for the travertine, 10.29 MPa for the granite, 8.32 MPa for the labradorite and 6.79 MPa for the marble.

The splitting strength test results showed similar trends to the flexural strength test results. The main differences were the following:

- The granite did not have a better performance at lower temperatures.
- The strength of the travertine and of the labradorite had a local maximum at 50 °C.
- The relative residual values were at each case higher than the ones measured during the flexural strength tests.

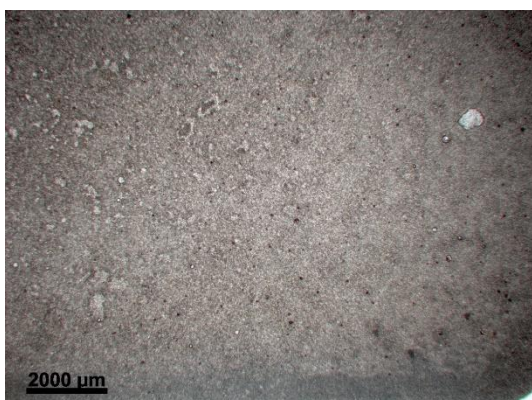
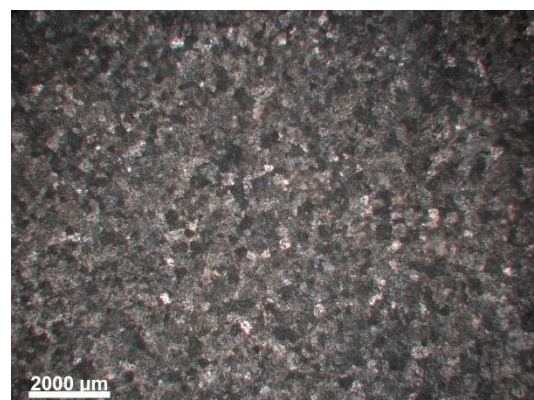
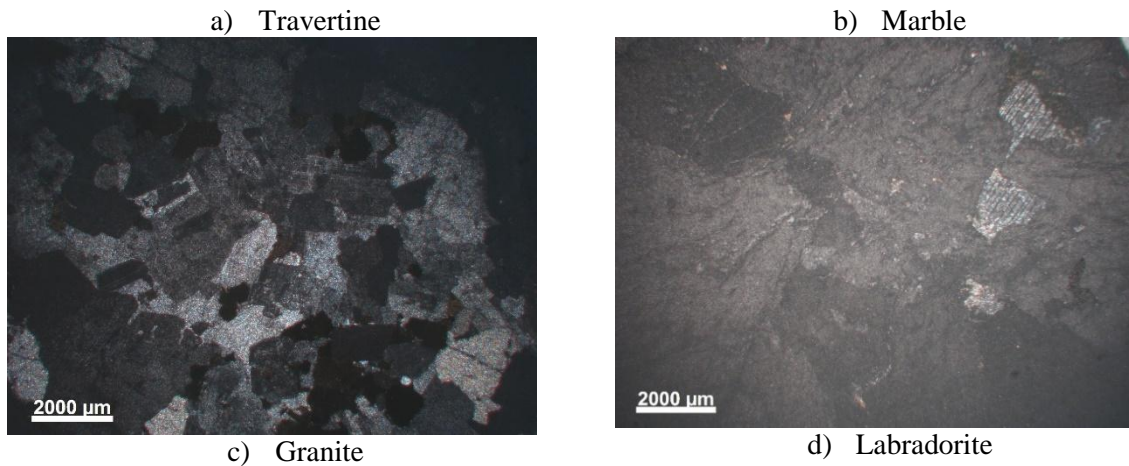
Figure 11: Microscopic pictures taken with two polarization filters (reference temperature)

We took pictures of the thin sections with one polarizing filter and two polarizing filters as well (*Figure 11*). One can see the crystal structure in the pictures taken with one polarizing filter and the mineral composition in the picture taken with two filters.

The homogenous, porous texture with scattered calcites could be seen for the travertine.

The marble had a microcrystalline texture with small, not crystallized parts.

The quartz crystals in the granite were loosened, but there were various plagioclases and coloured envelopes.

Images of the labradorite showed an orientation in the minerals. There were big plagioclases (compared to crystals of the other rocks) and scattered coloured envelopes. It was very compact, its pore content was very low, loosening was not visible.

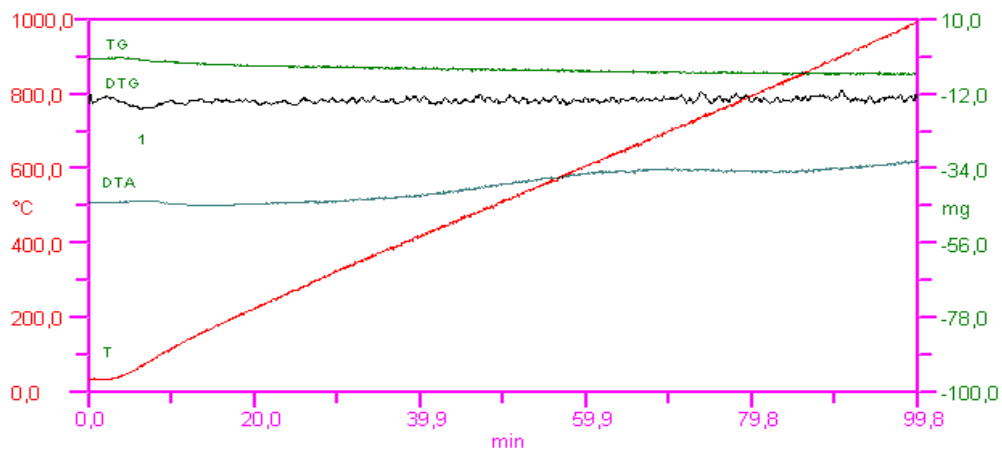
Figure 12: Derivatogram of the granite

The derivatograms of the granite and the labradorite were typical for igneous rocks. There was only one thermal decomposition peak for the granite and the labradorite, which was the release of the absorbed water.

Milled samples were tested by Q-1500D type derivatograph. The results are shown in *Figures 12, 13, 14 and 15*.

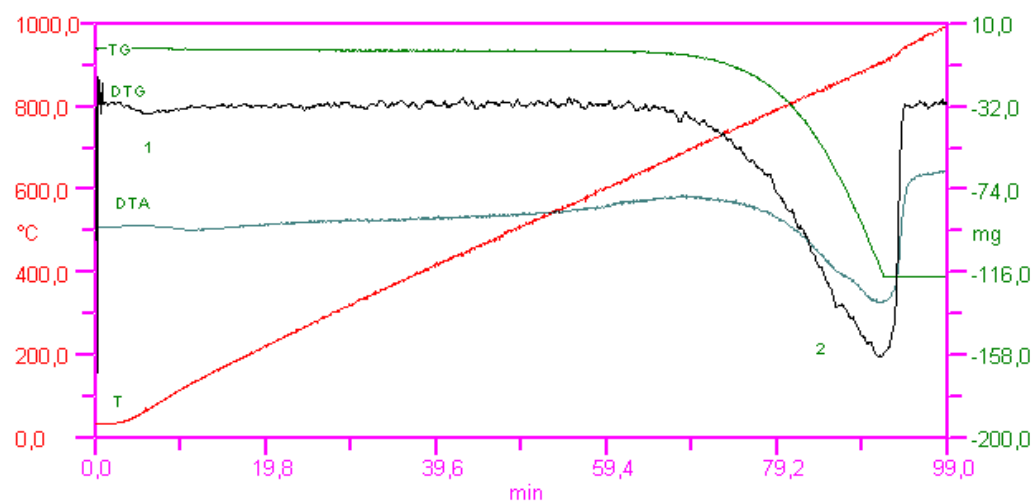
Figure 14: Derivatogram of the marble

The marble and the travertine showed similarities on their derivatograms. The derivatograms of the marble and of the travertine had two thermal decomposition peaks each:

- Peak 1: Release of absorbed water
- Peak 2: Decomposition of CaCO_3 ($\text{CaCO}_3 \rightarrow \text{CaO} + \text{CO}_2$)

According to the weight evaluation of the marble and the travertine, the emission of CO_2 was higher for the travertine, suggesting that the CaCO_3 content of the travertine sample was higher. This was predictable because marble may contain MgCO_3 as well. The decomposition of MgCO_3 only happens at higher temperatures. The same result was shown by the weight of the spalling material after the 800 °C heat-load.
