## PHOTOGRAMMETRIC DEFORMATION MONITORING OF THE SECOND BOSPHORUS BRIDGE IN ISTANBUL

Özgür AVŞAR<sup>a, b, c</sup>, Devrim AKCA<sup>b</sup>, Orhan ALTAN<sup>a</sup>

<sup>a</sup> Department of Geomatics, Istanbul Technical University, Istanbul - (avsarem, oaltan)@itu.edu.tr

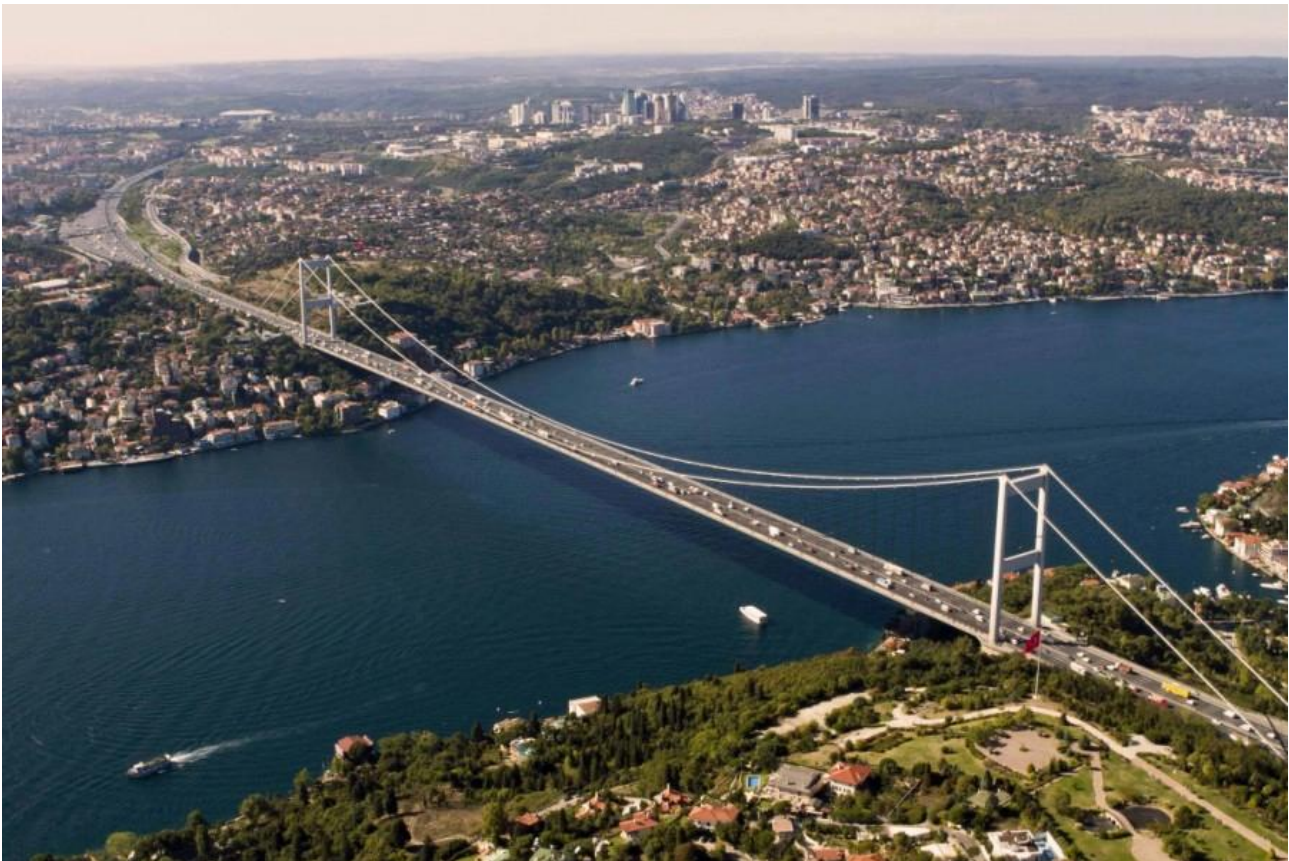
Figure 1. The second Bosphorus Bridge in Istanbul

The second one, the Fatih Sultan Mehmet Bridge, is a modern type of suspension bridge (Figure 1). It is the 19<sup>th</sup> longest suspension bridge of the world. It started the public use in 1988. An immense level of transportation load comes to this bridge, since it lies on the “arteries” of the Turkish transportation net. The daily traffic of the bridge is approximately 180.000 vehicles. It spans 1510 meters from bank to bank. The distance between the two pairs of suspension towers is 1090 meters and towers are 105 meters above the roadway. The distance from the

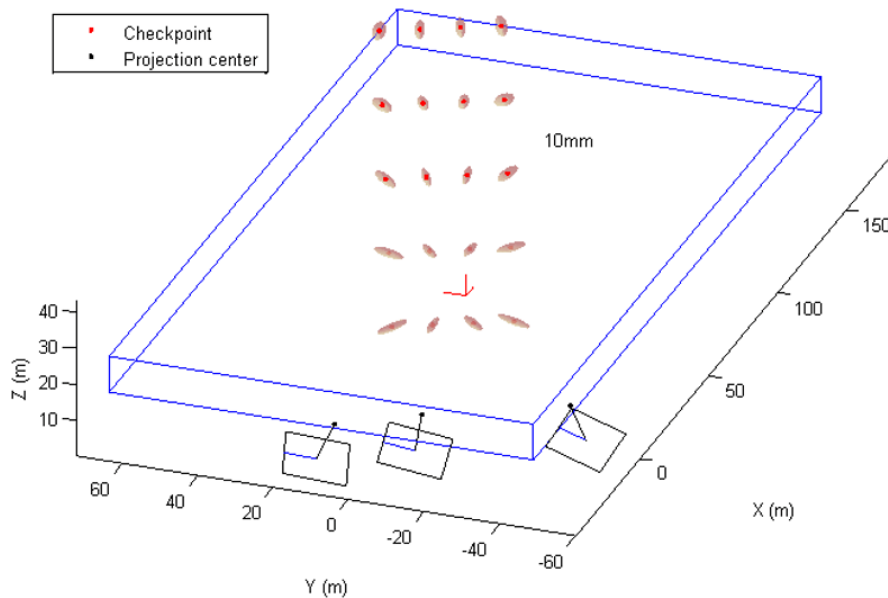
Figure 2. The a priori estimated error ellipsoids of some representative signalized points attached below of the bridge body

Three-camera based convergent multi-image acquisition geometry was adopted to provide adequate photogrammetric coverage of the experiment area. The a priori point positioning precision of the signalized targets was estimated to be  $\pm 46.0$  mm,  $\pm 26.9$  mm and  $\pm 2.5$  mm along the X, Y and Z directions respectively (Figure 2). The a priori standard deviation of the image point observations was assumed to be  $\pm 0.1$  pixel. The design consideration for the project is to track the signalized points within a positional accuracy of  $\pm 5$  to 6 cm.

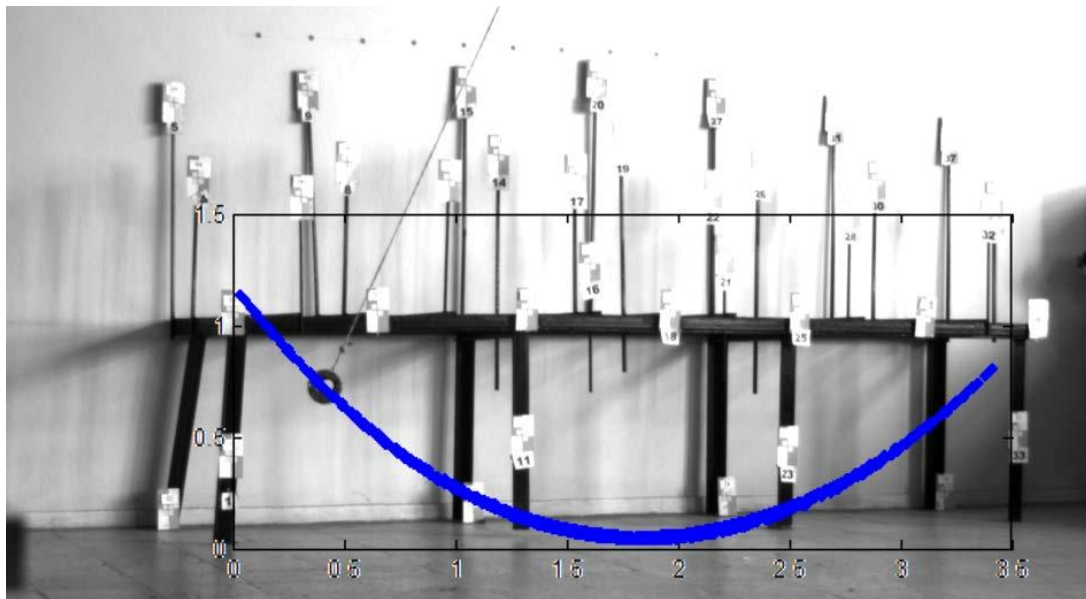
Figure 3. The pendulum setup

Additional in-door tests were performed using a pendulum setup (Figure 3) which was established at the photogrammetry laboratory of the Geomatics Engineering Department of Istanbul Technical University (ITU). The oscillation of the pendulum was monitored by the three cameras with an image acquisition frequency of 24 fps. Only an area of interest of 1200 x 880 pixels over the full image format is recorded thanks to the windowing capability of the CMOS sensor. The in-door pendulum test gave us useful information about the synchronization error and the point positioning error prior to the out-door tests.

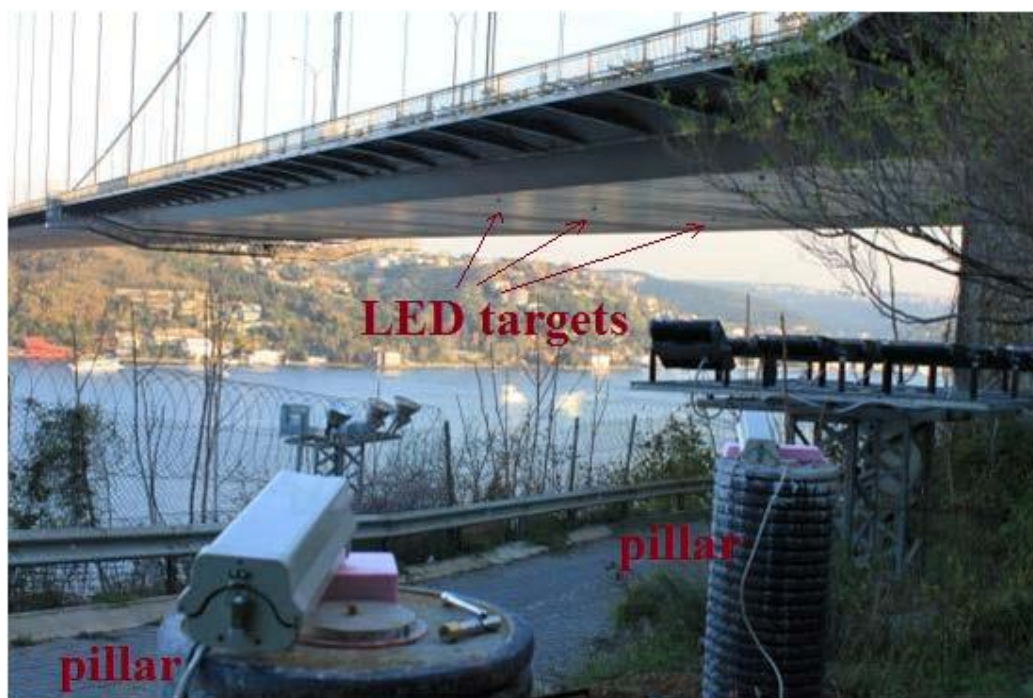
Figure 4. The two of the total four pillars

Four pillars out of three for the cameras and the remaining one for an image assisted total station were constructed at the field. The total station simultaneously collected the geodetic measurements which were used as validation data later. The X, Y and Z coordinates of the pillars were measured with static GPS observations. A part of the field constellation is shown in Figure 4.

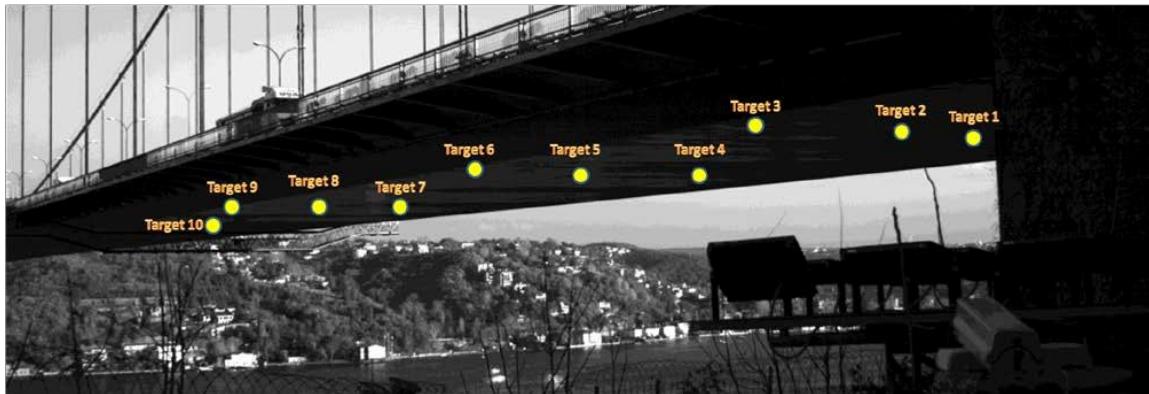
Figure 5. (a) Location of the 10 LED targets under the bridge surface. (b) The total displacement of Target 2 and 4.

A total number of 12 LEDs, equipped with 12 volt accumulator for the energy, cable for flowing energy from the accumulator to the target, and cable for charging the accumulator, were used as signalized target points. They were affixed with chemical
