The influence of the physical environment on self-recovery after disasters in Nepal and the Philippines

S. Sargeant¹, A. Finlayson, T. Dijkstra, B. Flinn, H. Schofield, L. Miranda Morel, J. Twigg, E. Lovell, V. Stephenson and B. R. Adhikari

Abstract

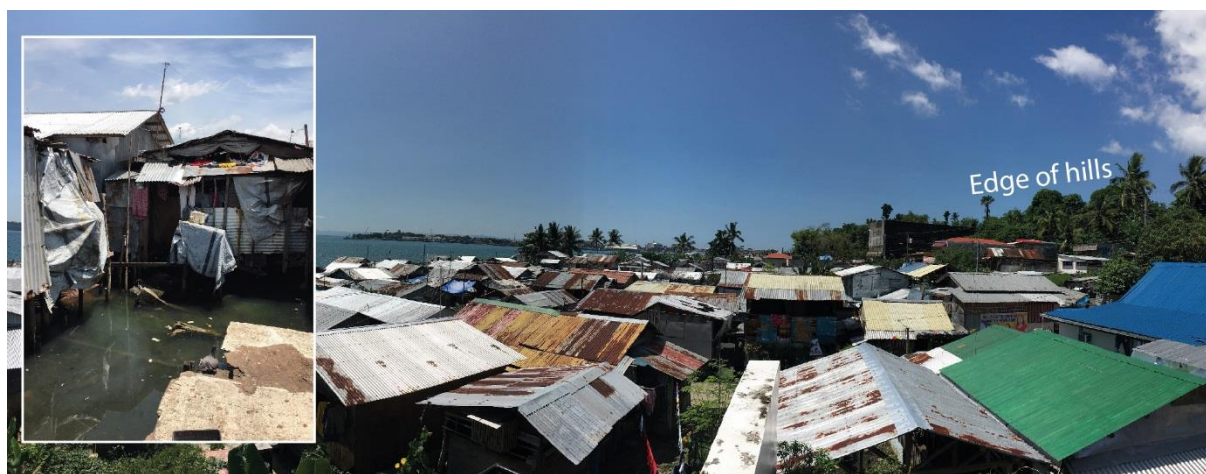
Figure 3. Photograph illustrating context for the community of Anibong, Tacloban. Closely spaced houses are located between the sea and a group of outlying hills. Inset: Shelters encroaching into the sea and are vulnerable to frequent low severity tidal flooding. British Geological Survey (c) UKRI 2020.

outlying hills with slopes up to 30° (composed of weathered sedimentary rocks) all occur in very close proximity (Fig. 3). As a result, a number of shelters encroach out into the sea. At the opposite, south-eastern side of Tacloban City, the barangay of San Juan (Brgy 88) is located on a coastal sand spit where the ground surface rarely rises above a few meters above sea level, and everywhere is within 500 m of the coastline. Both Anibong and San Juan are located in areas where published maps indicate a high storm surge hazard level – and are now classified as no-dwelling zones (Ong et al., 2016; NOAA, 2018). Anibong also includes areas exposed to flood hazard from the Mangonbangon River and a landslide hazard from the hills that the community backs onto. Barangay 83-C is located along the banks and close to the mouth of the Burayan River, and is also exposed to river flooding.

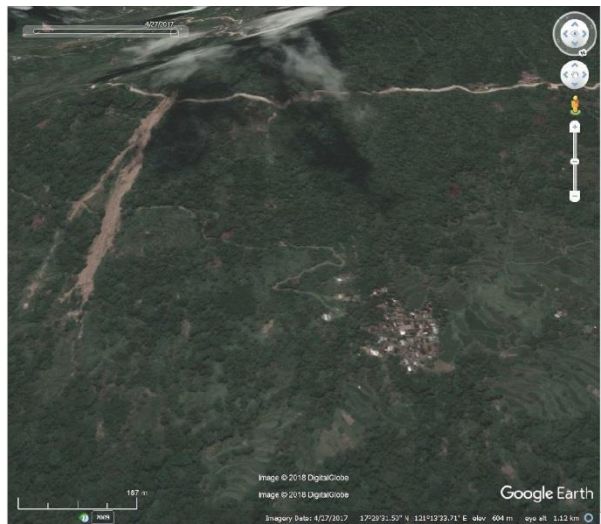
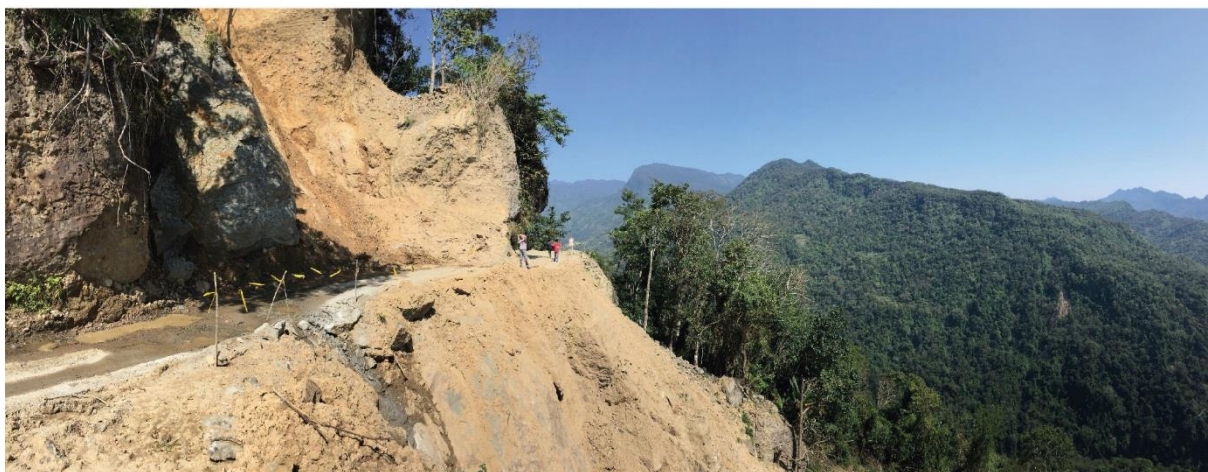
Figure 4. (A) Digital Globe Image (25th February, 2009) courtesy of Google Earth illustrating the context for the community at Sitio Bolo. (B) Digital Globe Image (5th February 2017) courtesy of Google Earth showing the extent of a debris flow adjacent to the community, that was triggered by heavy rainfall during Typhoon Haima. (C) Photograph illustrating conditions on the only access road in March 2017, 6 months after the typhoon. A large landslide scar is clearly evident and unstable blocks remain above the road. Local people spoke of concerns about the continued threat of landslides here. British Geological Survey (c) UKRI 2020.

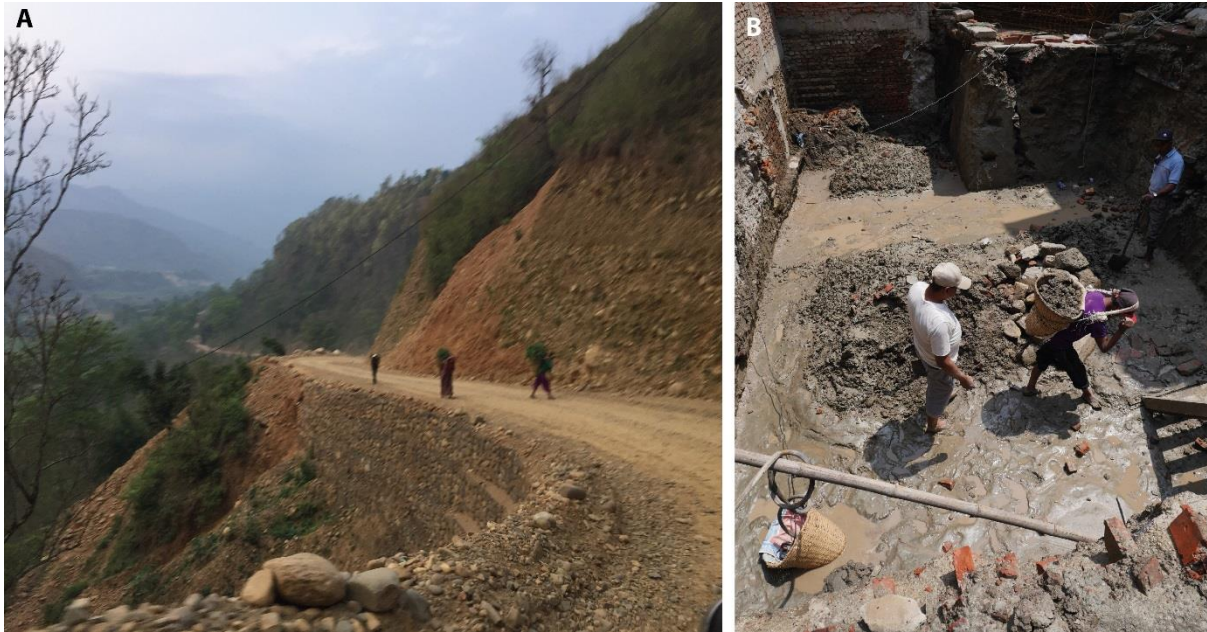
Figure 7. (A) The road that accesses communities on the Salyantar terrace is cut into a steep escarpment that is vulnerable to instability during monsoon rains. (B) Excavation in silts and fine sands with a sump pump, for building foundations in Bhaktapur in April 2018. Evidence for liquefaction below the feet of the construction workers. Local people reported that this stage of reconstruction is not possible during the monsoon.

The clayey and silty nature of the sediments under Bhaktapur make foundation excavation particularly challenging in wet conditions (Fig 7B). Another interviewee in Bhaktapur also described how the occurrence of dry spells can have an impact on rebuilding when mixing mortar: *“Water is scarce here but it is important for the building”* and people had to buy water from tankers to use in housing reconstruction, which increased the cost of rebuilding. The limited weather-controlled ‘windows’ for different building stages compounded delays caused by blocked roads and access difficulties, further slowing down peoples’ recovery.
