Citation: Binici, Hanifi, Binici, Fatih, Akcan, Mehmet, Yardim, Yavuz, Mustafaraj, Enea and Corradi, Marco (2020) Physical–Mechanical and Mineralogical Properties of Fired Bricks of the Archaeological Site of Harran, Turkey. *Heritage*, 3 (3). pp. 1018-1034. ISSN 2571-9408

Physical–Mechanical and Mineralogical Properties of Fired Bricks of the Archaeological Site of Harran, Turkey

Keywords: brickwork; mechanical testing; cultural heritage conservation; structural analysis

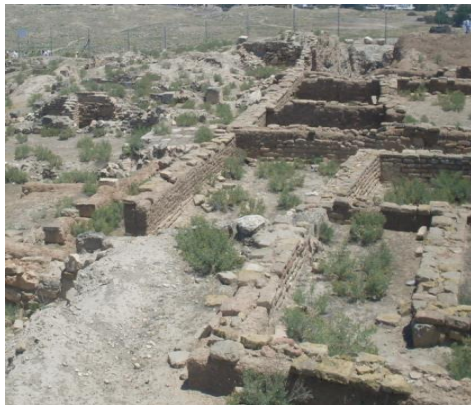
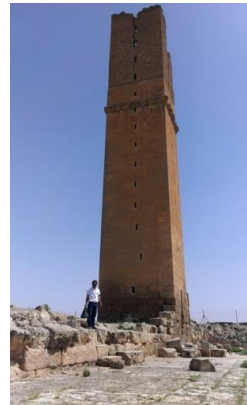
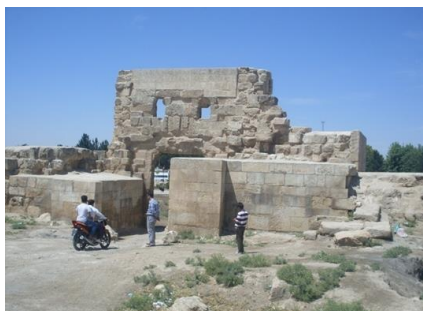
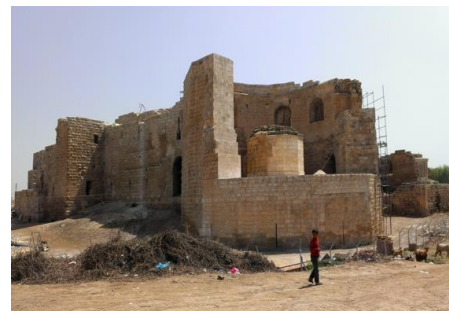
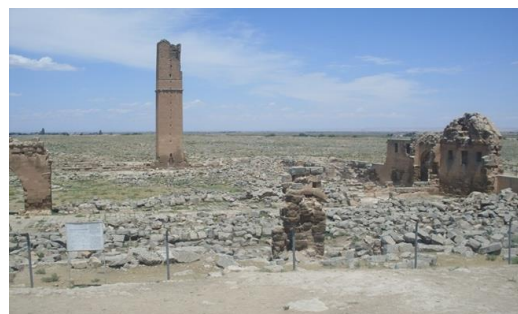
Figure 3. Iconic monuments in the historic city of Harran: (a) burial mound, (b) university, (c) city walls, (d) castle, (e) great mosque.

Five brick samples were taken from different historical ruins of the city: the burial mound, the university, the city walls, the castle and the great mosque, from undisturbed parts of these buildings. While extracting the brick samples, special attention was paid not to spoil the unique structures of the bricks and photos of places from where the samples were taken, and photos of the taken brick samples were filed. The five selected buildings are shown in Figure 3. A detail of a wall of the burial mound is given in Figure 4.

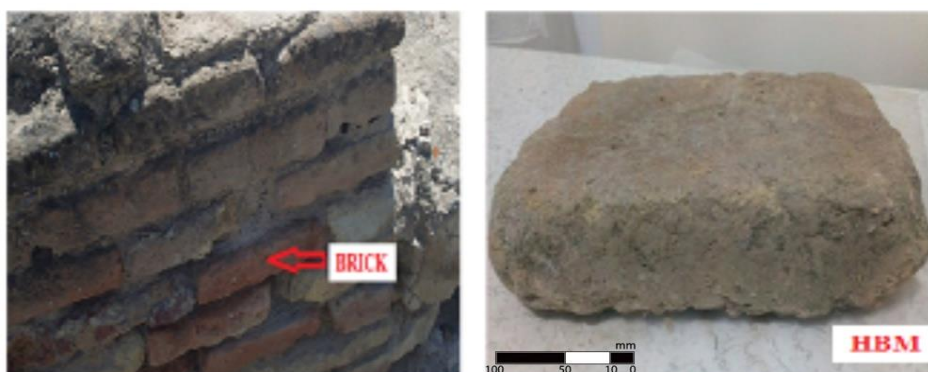
Figure 4. Brick sample taken from the burial mound (HBM).

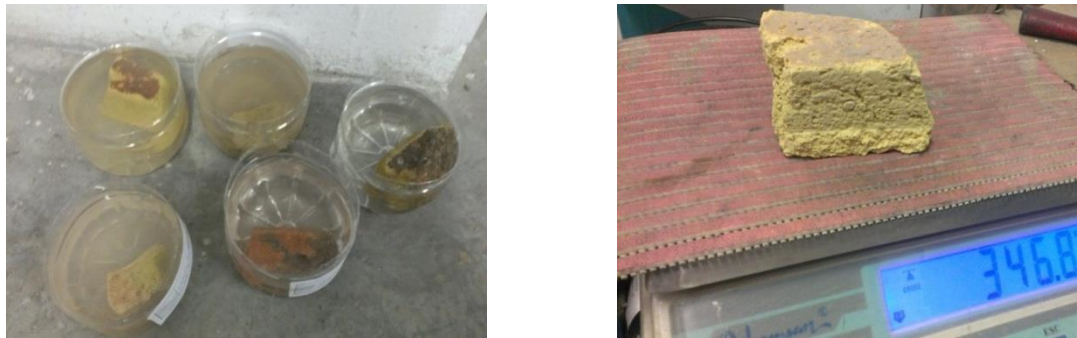
**Figure 6.** Water absorption tests.

Physical analyses allowed us to determine the water absorption rates by weight and by volume of the brick samples. Apart from the compressive strength, it is well-known that water absorption is an important property in brickwork masonry. This property can affect the quality of the brick itself and the bond strength between the brick and mortar in masonry structures and can result in reducing its strength properties. The authors [25] have previously conducted an experimental investigation to assess the physical, mineralogical, and chemical properties of the lime mortars used in the monuments of Harran. The test results carried out on the lime mortar and on the units (i.e., the bricks) could be critical for any future conservation measure and assessment of the structural safety of the masonry structures of the site of Harran: this could highly facilitate the estimation of the mechanical properties of the brickwork masonry. Water absorption rates by weight and by volume of the samples are given in Table 3. Figure 6 shows the tested specimen during soaking in water.

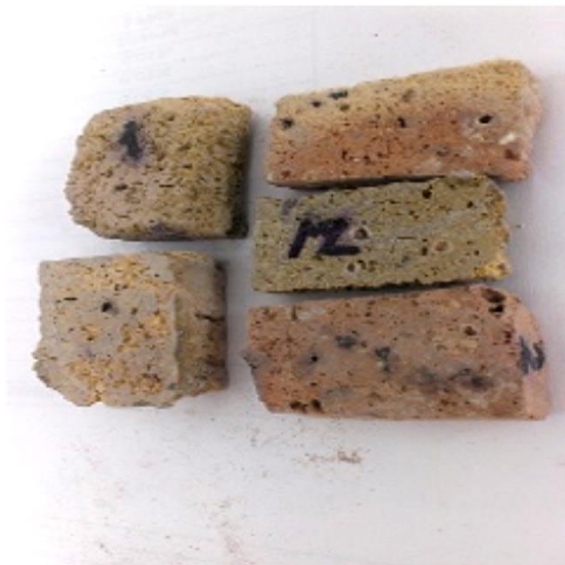
Figure 11. Detail of the brick cross-section.

The sample with the lowest compressive strength value is the one taken from the city walls. According to previous studies [58], it is possible to say that the compressive strength values of the brick samples are very similar and in a limited range (6.69–7.95 MPa). This could suggest that the Harran monuments, constructed in different periods of time, have been manufactured using a similar or non-time-varying technology, labor, resources, and environmental conditions. This could strengthen the hypothesis that local skills, construction materials, and methods were passed down from father to son for generations in family brick companies, also considering the frequent changing of rulers (from Parthians to Romans, from Byzantines to Arabs, and finally to the Mongols and Turkish). The thin-section images of the five brick samples taken from the historical structures are quite similar to each other (Figure 11).
