Geohazards in the Lanzhou loess region

Geohazards in the mountains of south Gansu and Sichuan

The thematic set on Geohazards in Central China

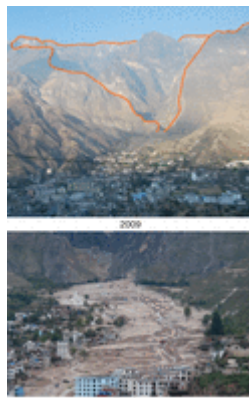
Fig. 4.

The town of Zhouqu in 2009 before the debris-flow disaster, and in October 2010, 2 months after the disaster. The grey line in the 2009 photograph indicates the outline of the Sanyangyu watershed. (photographs T. Dijkstra).

In this mountainous terrain, limited vegetation cover, high-relief steep slopes and narrow valleys draining large catchments result in a rapid response of river flow regimes to rainfall inputs. This was the case in the night of 7–8 August 2010 in Zhouqu, in south Gansu. Only 30 min of very intense rainfall (>70 mm h⁻¹) was sufficient to mobilize material discharging at more than 1300 m³ s⁻¹ and reaching an estimated 10 m s⁻¹ peak flow velocity ([Tang *et al.* 2011a](#)). The town is located on a fan structure that was formed by previous events and the small channel through the town could not contain the material that was delivered, and, as a consequence, the debris flow created a new wider path, leaving a trail of destruction and causing the deaths of more than 1700 people ([Tang *et al.* 2011a](#); [Dijkstra *et al.* 2012](#); [Fig. 4](#)).

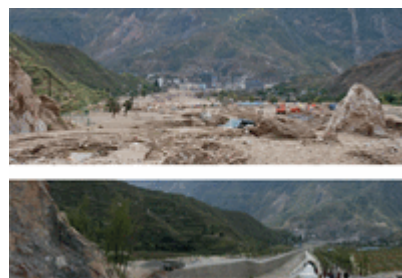
Fig. 5.

The main discharge channel of the Zhouqu debris flow in October 2010 (top) and September 2012 (bottom) (photographs T. Dijkstra).

The Zhouqu disaster triggered substantial investment in research, disaster relief and hazard management. It has also resulted in the construction of substantial debris-flow control structures. These appear sufficiently robust to halt, or at the very least slow down, large future debris flows in this valley and provide a measure of protection for the town of Zhouqu ([Figs 5 and 6](#)). However, elsewhere in the region, poorly constructed dams still exist and these continue to pose a potential danger for those living downstream, both in terms of a complacency creep (i.e. a gradual loss of awareness of geohazards occurrence when small events are successfully captured upstream) and impact magnification (as deposits of small debris-flow events accumulate in upland catchments; one large event may mobilize much of this stored material). In a broader context the question needs to be addressed whether an approach to constrain or even halt the progress of natural processes in such a dynamic terrain is a sustainable long-term strategy.

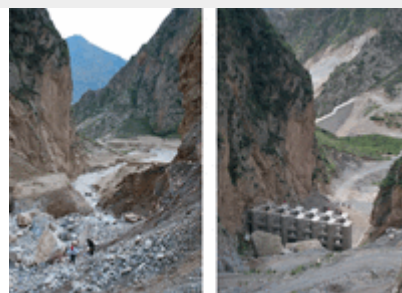
Fig. 6.

Engineered interventions in the discharge channels of the Sanyangyu valley where the Zhouqu debris originated; October 2010 (left) and September 2012 (right) (photographs T. Dijkstra).
