# **RIVER KENNET REPORT JULY 1996**

**M Ladle PhD**

Report To: Thames Water plc  
CEH Project No: T11064B7  
IFE Report Ref.No: RL/T11064B7/3

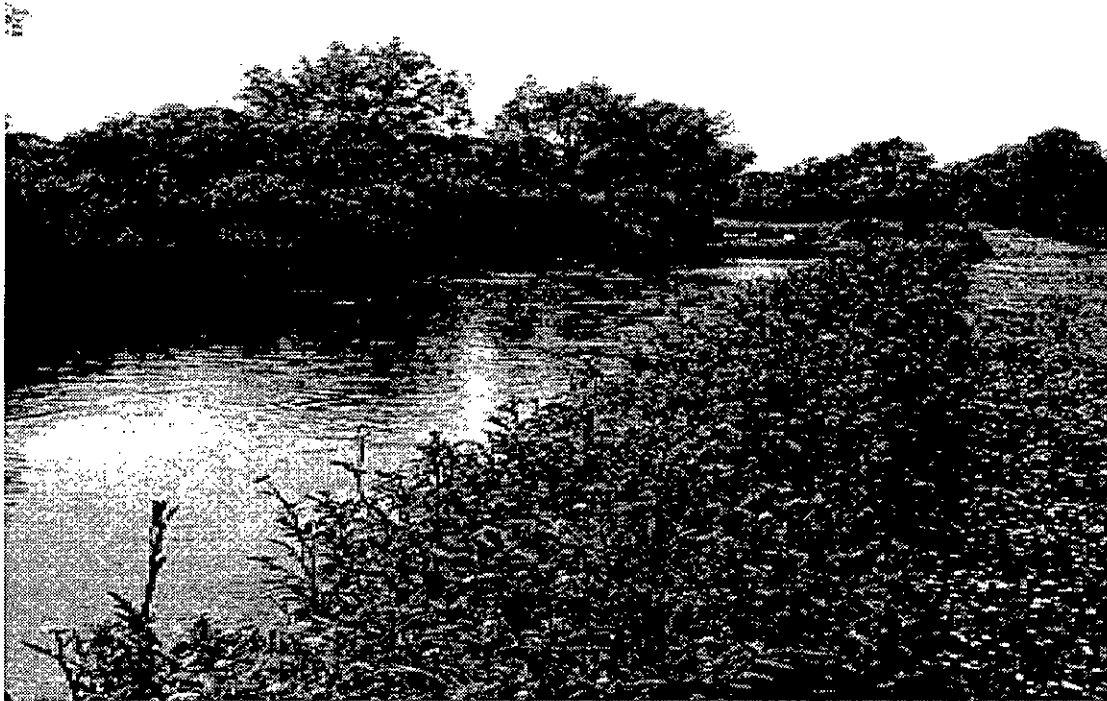
*Axford upstream SU 239 698*

The bed of the river was entirely visible and the site was surveyed from the left bank. The floodplain was symmetrical with a straightened, probably resectioned channel. The banks were steep, about 0.8 m high and essentially of earth with no recent modifications or features. The substratum was of irregular flint gravel and the water was 0.3 m deep with a rippled (upstream) or smooth (downstream) flow pattern. The left bank was uniformly covered by tall herbs and occasional trees (see below) and behind the bank top was a broad mown path to improve access for anglers. The right bank was fenced and inaccessible being overgrown with a simple semi-continuous mixture of scrub and small trees, creating a certain amount of shade; at the downstream end there were mostly tall herbs. Behind the left bank was rough pasture and behind the right bank, extensive fen.

"Axford upstream" was a well kept trout fishery with a broad bankside cover of tall herbs including *Mentha*, *Epilobium hirsutum*, *Filipendula ulmaria*, *Agrimonia eupatorium*, *Myosotis*, *Valeriana*, *Cirsium*, *Veronica*, *Lycopus* etc. and a closely mown walkway along the banktop. The instream plants consisted of *Zannichellia* and some clumps of *Callitriche*. *Ranunculus* was seemingly absent from the study reach. The calculated BMWP score was 87 and the corresponding ASPT 5.4. The most abundant invertebrates were again *Gammarus pulex* and *Ephemerella ignita*. Four families of mayflies were noted to be present. Large trout were again observed to be present at high density. Birds noted included coot, moorhen, mute swan and sedge warbler. A number of butterflies were present on the bankside herbs.

**Assessment - The channel had undoubtedly been straightened at some time and the left**

bank had been cleared of trees close to the water's edge and regularly mown in order to provide easy conditions for fly fishing. The dense mat of *Zannichellia* with clumps of *Callitriche*, on the bed of the channel, had trapped silt leaving the gravel runs reasonably clear with relatively fast flow. The presence of the above plants tends to indicate weak flow (poor flushing properties) and/or mild organic enrichment. *Zannichellia* often replaces *Ranunculus* in chalk streams where conditions of reduced flow and organic enrichment prevail. Heavy stocking with farmed fish had taken place and the input of excretory products from these animals must contribute, in some slight degree, to improving the habitat for *Zannichellia*. The section of river containing the *Zannichellia* did not appear to be unduly influenced by the presence of a sluice some distance downstream. As at other sites the impact of this stocking on native fish populations must also be considerable. The general impression was that more water in the summer months would be beneficial to both plants and fauna. It is difficult, if not impossible, to separate the various components of the discharge pattern (cross sectional area changes, maximum:minimum discharge ratio, mean velocity) as being responsible for changes in biotic characteristics because of the spatial and temporal interaction of physical characteristics with biological aspects (backing up of flows, channel cross section restriction).

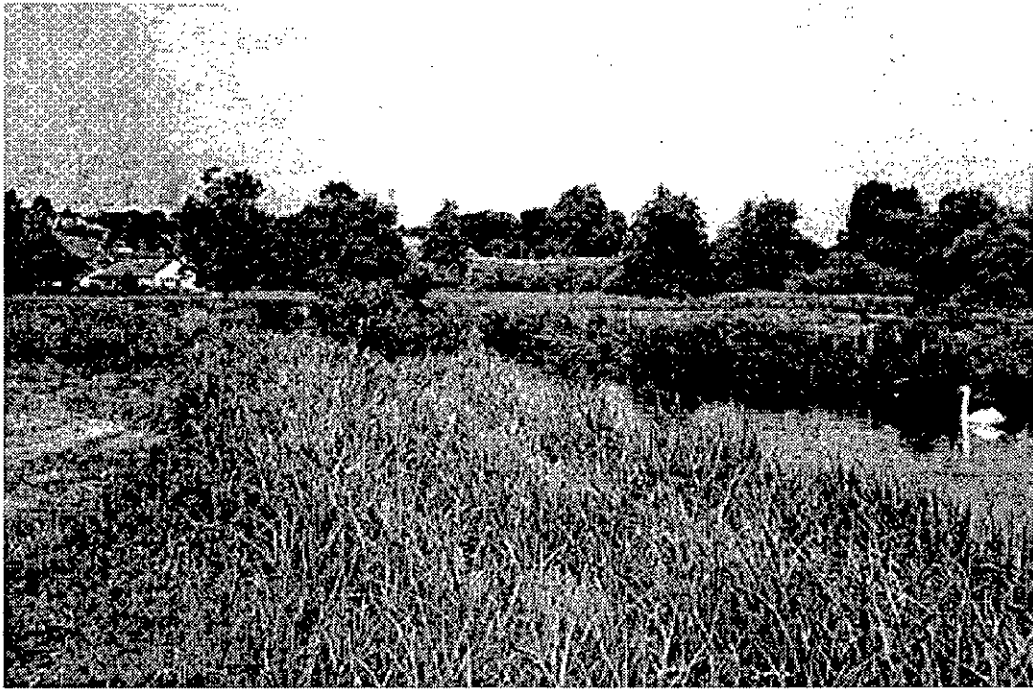
This section was about 14-16 metres in width with earth banks of about 1 m in height. The left bank was a sloping heavily overgrown strip of sedges giving way to a thickly silted river bed, behind the sedges was rough pasture. The right bank was a steep earthen face at the margin of a rough pasture. Ten metres of the right bank was overlain (rather than reinforced) by timbers. There were no trees along the right bank and the left bank had sparse isolated tree cover. The water depth was  $>0.4$  m and the loosely packed gravel bed was overlain by a film of silt. The flow was smooth and the channel may at some time have been widened. Small areas of marginal dead water were present.

This site at Ramsbury was somewhat wider than many of the others but the flow was still reasonably strong. There was no shading and no appreciable poaching of the banks by animals but deep silt deposits, which gave off methane bubbles, were present close to the left bank in the downstream part of the reach. There were no water plants and the stream bed gravels were coated in silt. A broad marginal cover of *Carex* was present along the whole of the left bank. The recorded BMWP score at this site was 53 only (presumably low because of the uniform habitat) and the ASPT was 4.8. The most abundant invertebrates were, *Gammarus pulex*, *Micronecta* and *Caenis* (a silt loving mayfly). Stocked trout were numerous and a juvenile *Cottus* was taken in the pond net sample.

**Assessment -** The impression was that the channel at this point had been artificially widened at some time in the past. The absence of plant growth, even though there was minimal shading, reasonable velocities and, at least for part of the channel, a firm gravel substratum, suggests that some periodic factor had been operative in removing plant growth and preventing recolonisation at a later date. This factor does not appear to be competition with filamentous green algae, as may sometimes be the case. The most likely reason for the existing absence of macrophytes is bed disturbance or exceptionally

low flows at some time in recent years causing. Subsequently, variable discharge regime or low summer flows, aggravating the effects of siltation, could have prevented reestablishment of plants. Even in this open and featureless stretch of water stocked trout were rising regularly. Initially the channel probably requires a good scour out by high flows. Some narrowing would also be beneficial.

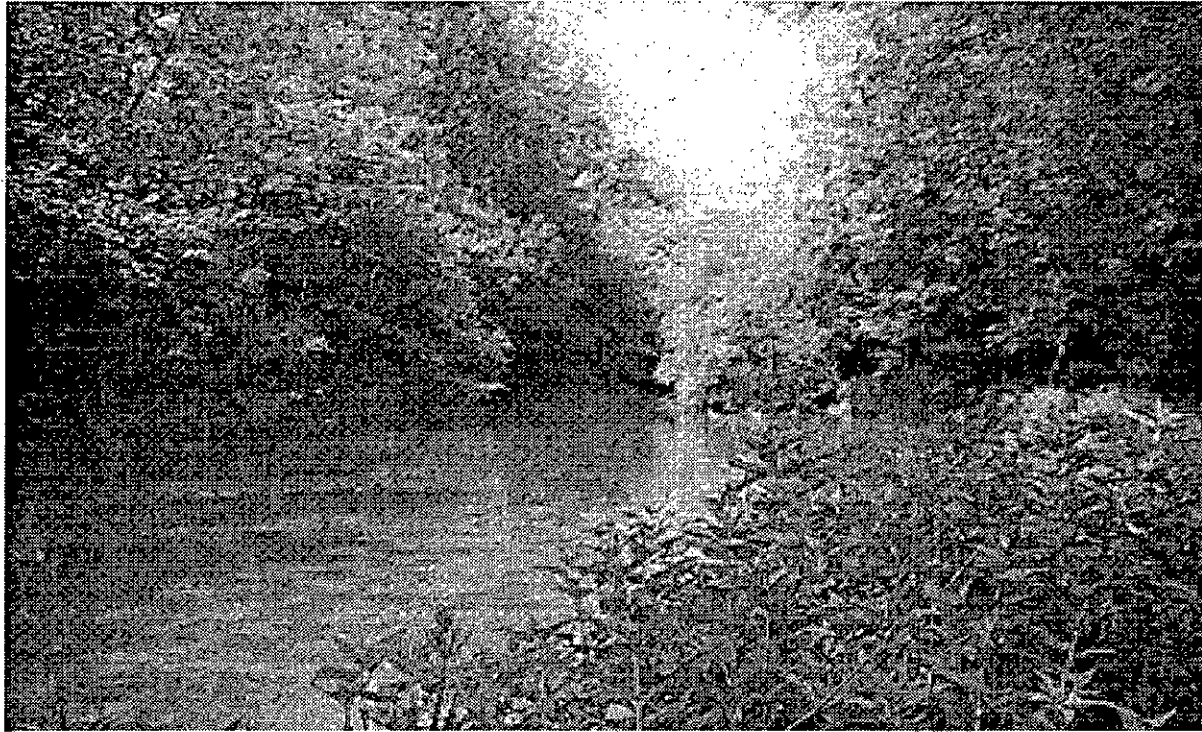
Knighton SU 295 710

Knighton was the most downstream site examined and is the point at which the discharge of the river is gauged. The water was clear and the bed of the river was entirely visible. The site was surveyed from the left bank and the channel appeared to lie in a symmetrical flood plain. The flow was essentially a shallow glide over the entire length and may have been affected in the downstream part of the reach by the presence of a weir. The steep banks were essentially of earth and showed no evidence of recent modification although it is likely that in the past they had been resectioned. The channel was 12 -13 metres wide and the banks about 1.2 - metres in height. Water was generally about 0.3 metres deep. The bed of the stream in the surveyed section was essentially sand downstream and irregular flint gravel and pebbles upstream. The flow was a smooth glide and there were no obvious channel features or modifications. The left bank consisted of a broad mown access/fishing path and the right bank was essentially backed by broadleaved woodland. The right bank was of earth and had a more or less vertical profile while the left bank sloped less steeply. The entire section was heavily shaded. The bankside vegetation was often dominated by nettles (*Urtica*) but other plants which were represented included *Petasites*, *Filipendula*, *Agrimonia*, *Carex*, *Iris*, *Acorus*, *Typha*, *Glyceria*, *Myosotis*, *Symphytum* and others. The river bed gravels in the downstream end of the reach (nearer the weir) were colonised by patches of *Ranunculus* with small amounts of *Callitriche*. No water plants were present downstream of the weir despite the broad unshaded nature of the gravel bed. A wide range of invertebrates were collected by the simple 1 minute kick sample technique, and examined in the field giving a BMWP score of 96

and and an ASPT of 5.33. *Gammarus pulex*, *Ephemerella ignita* and *Micronecta poweri* were all extremely abundant. Lots of large stocked trout were present as were grayling of all sizes. A grass snake was observed swimming across the river.

**Assessment** - It is always difficult to assess the effects of past management but it seemed obvious that the left bank of the channel had been cleared of trees close to the water's edge and was again regularly mown in order to facilitate angling. It is also likely that the channel had at some time been straightened and/or resectioned. In the absence of weed the superficial silt and sand deposits were widespread over the gravel bed. From the point of view of management it would seem that some reduction of tree shading along the south bank might enhance weed growth and, in doing so, could generate more clean gravel runs and thus, by creating instream cover, increase the number of potential trout territories. Heavy stocking with farmed fish appeared to have taken place and the impact of this on native fish populations must be considerable. The general impression was that less shading, less stocking and more water in the summer months would be beneficial in sustaining the character of a natural chalk stream.
