A Building Stone Assessment of The Engine Shed, Stirling

Commissioned Report

CR/14/088N

LJ Albornoz-Parra, EA Tracey and MR Gillespie

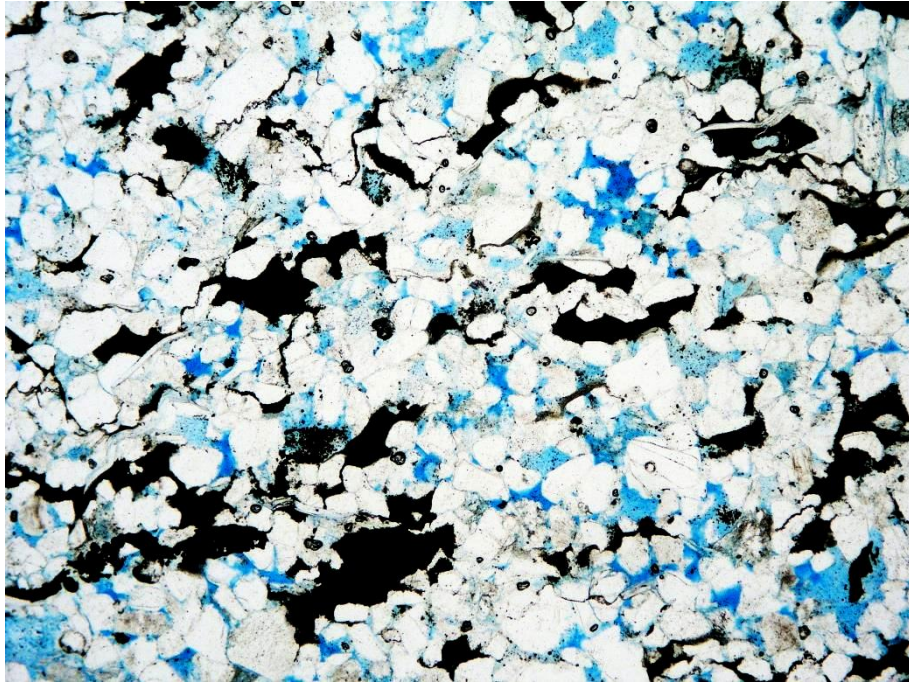
Thin section photographs of sample ED11316. The images were taken in plane-polarised light, and the field of view is c.3.3 mm wide. White grains are mainly quartz, with a small proportion of feldspar and rock fragments. Black patches are iron oxide and carbonaceous material. Pore space appears blue.

The stone is very light greyish buff, strongly cohesive, fine- to medium-grained, quartz-rich and mica-bearing sandstone, with uniform texture (i.e. lacking obvious bedding in the hand specimen). The stone contains numerous fragments up to 5 mm long of black carbonaceous matter (fossilised plant fragments), and particles of dark brown iron oxide which give the stone a ‘speckled’ character. The mica flakes and fragments of carbonaceous matter are aligned and indicate the bedding orientation. The sand grains are bound by a mineral cement comprising small proportions of silica (~3%) and calcite (~2%). The stone has a moderate proportion of pore space for building stone sandstone (~15% of volume), and high permeability.

- 1) The minerals zircon and tourmaline are present in accessory proportions (<<1%).
- 2) The sample reacts strongly to 10% hydrochloric acid (HCl) solution, indicating that the carbonate mineral is likely to be largely or entirely calcite.

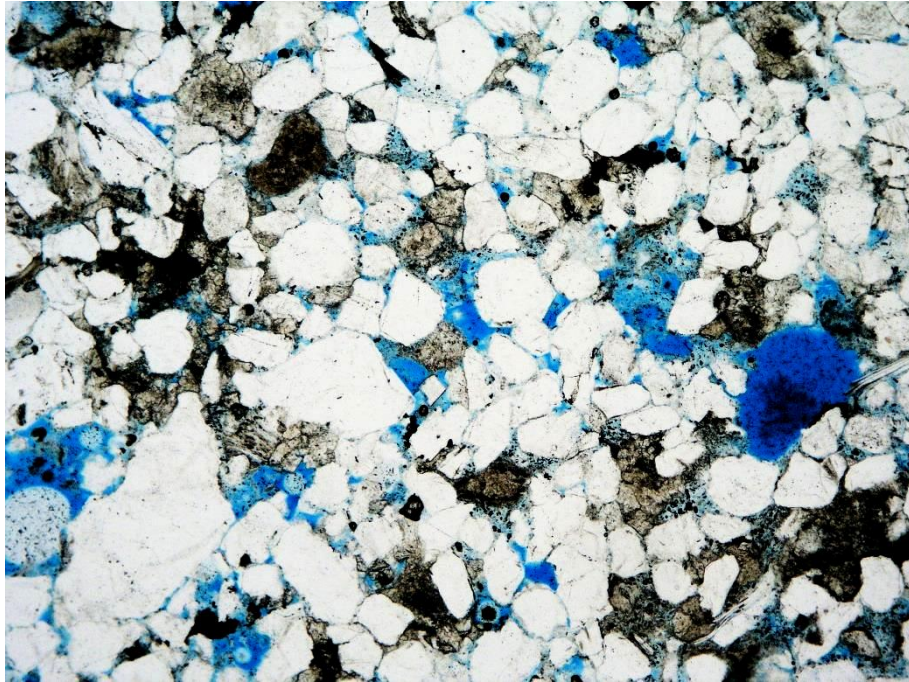
Thin section photographs of sample ED11317. The images were taken in plane-polarised light, and the field of view is c.3.3 mm wide. White grains are mainly quartz, with a very small proportion of feldspar and rock fragments. Grey, dirty looking grains are carbonate mineral, and black patches are iron oxide; The iron oxide is largely a product of alteration of the carbonate mineral, and the two minerals commonly occur together. Pore space appears blue.

The stone is light buff, strongly cohesive, medium-grained, quartz-rich sandstone with uniform texture (i.e. lacking obvious bedding in the hand specimen). The sand grains are bound by a mineral cement comprising a small proportion of silica (~2%) and large proportions of calcite (~14%) and clay (~11%). The stone has a moderate proportion of pore space for building stone sandstone (~12% of volume), and high permeability. The stone is in good condition (not weathered).

- 1) The mineral zircon is present in accessory proportion (<<1%).
- 2) The sample reacts strongly with 10% HCl solution, indicating that the carbonate mineral is likely to be largely or entirely calcite.
- 3) The weathered stone appears reddish brown to a depth of c.2mm, probably due to alteration of iron-bearing carbonate mineral, with the released iron crystallizing as iron oxide on and just below the surface.
- 4) The colour of the exterior surface is greenish grey due to a combination of biological colonization (algae) and soiling.

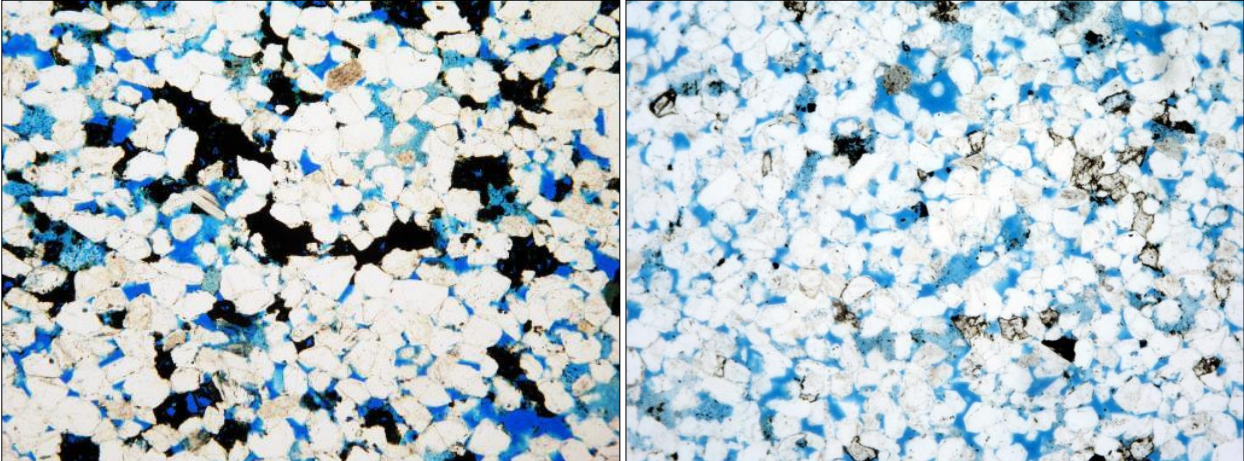
| Drumhead sandstone | |
|---|--|
| <p>Drumhead buff (left) and Drumhead very light buff (right). The photographs were taken in plane-polarised light, and the field of view is c.3.3 mm wide. Pore space appears blue.</p> | |

| Drumhead sandstone | |
|---|--|
| Distinctive features: | The buff stone contains occasional orangeish iron oxide banding/staining. |
| Comments: | Drumhead sandstone is produced from a quarry in the Upper Limestone Formation, near Denny. Samples of both variants of Drumhead sandstone should be obtained for on-site comparison. |
